TECHNICAL TOPICS

BODY/CHASSIS

2 nd Row Seat Deployable Heel Rest Lower Level Assembly	17MY-Onwards Range Rover
<p><u>Customer Voice:</u></p> <ul style="list-style-type: none">A customer may report that the heel rest for the 2nd row executive seats is not operating properly. <p><u>Technical Description:</u></p> <ul style="list-style-type: none">This may be caused by a heel rest motor malfunction or damage to the heel rest frame. <p><u>Status:</u></p> <ul style="list-style-type: none">The heel rest motor and frame have now been released as a lower level service part, preventing the need to replace the front seat back frame assembly to service the heel rest motor or frame.Please refer to the lower level assembly service parts to conduct repairs wherever possible upon diagnosis of a heel rest motor or frame failure.The service procedure has been added to the Workshop Manual, section 501-10: Seating > Removal and Installation > Front Row Passenger Seat Heel Rest Motor And Mechanism.

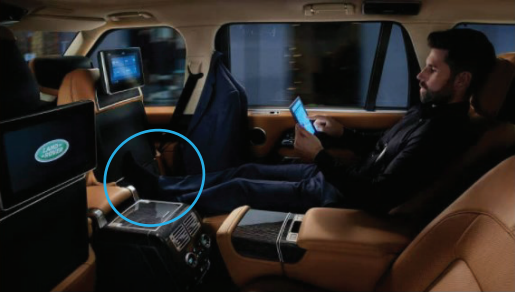
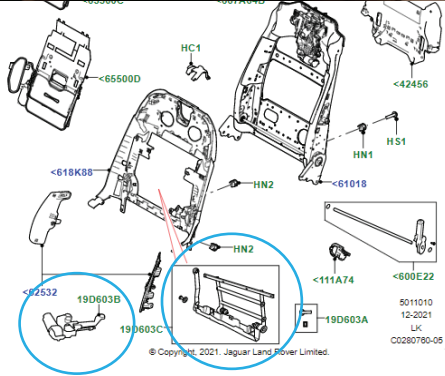
<p>Exploded view diagram of the heel rest lower level assembly. Key components and part numbers shown include: HC1, <65500D, <42456, HS1, HN1, <618K88, HN2, <61018, <111A74, <600E22, 5011010, 12-2021, LAK, C0280790-05, <2532, 19D603B, 19D603C, and 19D603A. A blue circle highlights the motor and frame assembly (19D603B/C).</p> <p>© Copyright 2021, Jaguar Land Rover Limited.</p>
