02246 Version 3

Fluttering Noise From Behind Dashboard

Supersedes 15-042, Dated November 6, 2015; to revise the information highlighted in **yellow**.

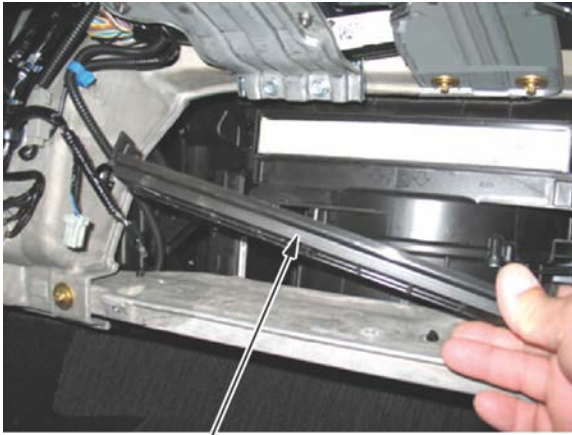
Remove HVAC filter cover.

1. Remove the glove box according to the service information.
2. Remove the HVAC filter cover.

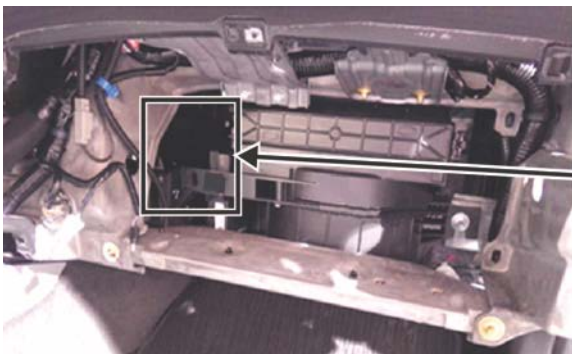
View of Heater Case with Defrost Damper Door Shaft

3. Install the self-tapping screw (P/N 90132-SR3-003), into the defrost damper door shaft on the passenger side of the heater case. Start the screw by hand to minimize the chance of dropping and losing it. Tighten the screw until the head is seated against the plastic heater case.

NOTE: Do not over torque the screw or you can damage the heater case.
