HYUNDAI Technical Service Bulletin	GROUP CAMPAIGN	NUMBER 22-01-023H-1
	DATE APRIL 2022	MODEL(S) APPLICABLE VEHICLES BELOW
SUBJECT: DTC P1326 - ENGINE BEARING INSPECTION / ENGINE REPLACEMENT (SERVICE CAMPAIGN T6G)

Description: Certain vehicles listed below may experience the Check Engine warning lamp illuminated with DTC P1326 and/or an engine concern/noise related to connecting rod bearing wear or damage. Follow the procedure to inspect the vehicle and replace the engine and/or update the engine ECU software (if new ROM is available) based on the inspection results.

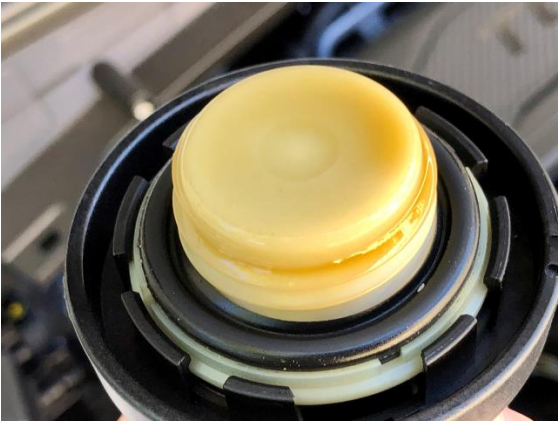
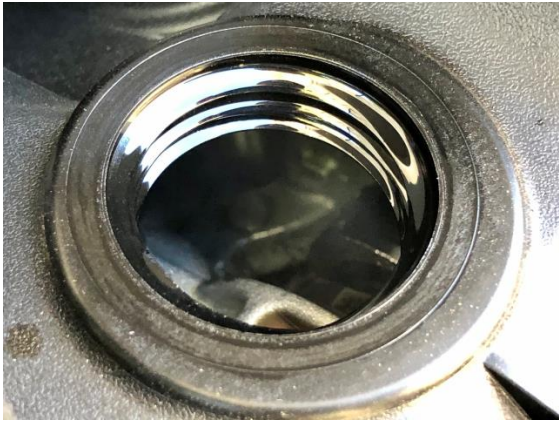
1. Scan for DTC P1326 using the GDS.
 - ❖ If DTC P1326 (or any other code) is present, take screenshot of Freeze Frame data for PA using GDS screen capture if any DTCs are present and proceed to Step 2.
2. Take pictures of the dipstick, engine oil filler cap, and inside the valve cover oil filler opening.
 - Using STUI on the GDS, take and submit pictures of the following with the VIN in the background of the photo (RO or last 6 digits written on paper). **VIN must be legible.**

Oil filler cap: Clear view of cap underside	Oil filler opening: Clear view inside opening.

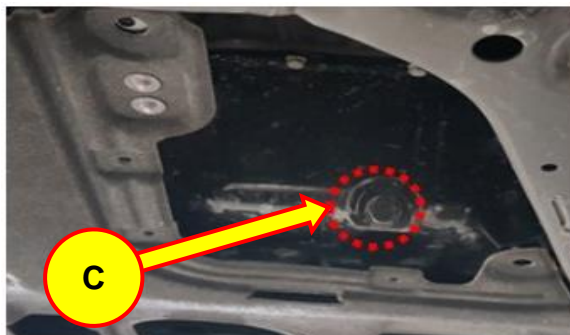
2. Lift up the vehicle and remove the oil drain plug (C).

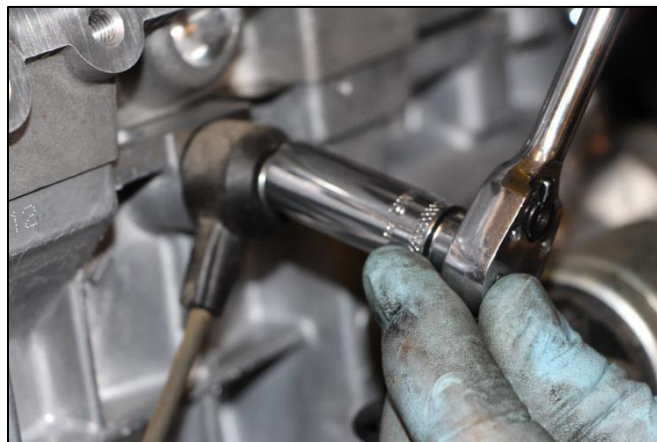
3. Remove and reinstall the engine knock sensor (if not newly supplied) from the old engine to the new engine.

Knock Sensor Fastener Tightening torque:
21Nm (15.5lb-ft)

Ensure the knock sensor is torqued to specification using a torque wrench.

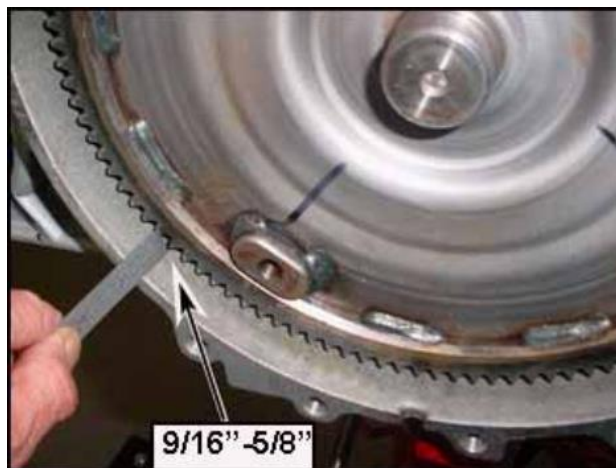
(For Automatic Transmissions equipped w/ torque converters only) If the torque converter has moved from the fully inserted position, carefully push inward and rotate the torque converter until the converter is recessed approximately 5/16" - 9/16" (8 -14 mm) into the transaxle case when reinstalling the automatic transaxle.

Check the depth of the torque converter to confirm it's fully installed in the transmission otherwise the oil pump may be damaged resulting in transmission failure.

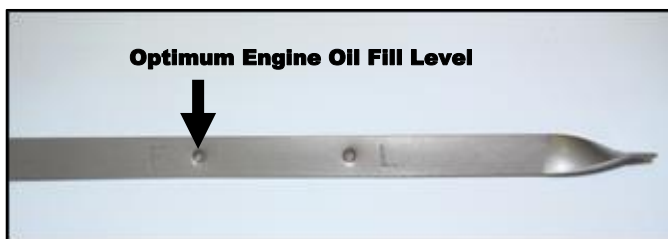
- Check for any leaks during this time.
 - After the engine has warmed up to normal operating temperature, turn the engine off, wait a few minutes, and then **adjust the engine oil level to near the “F” mark as shown.**
