GROUP BODY	NUMBER 22-BD-006H		
	DATE APRIL 2022	MODEL(S) TUCSON/TUCSON HYBRID (NX4/NX4A/NX4 HEV)

SUBJECT: LED LICENSE PLATE LAMP REPAIR PROCEDURES

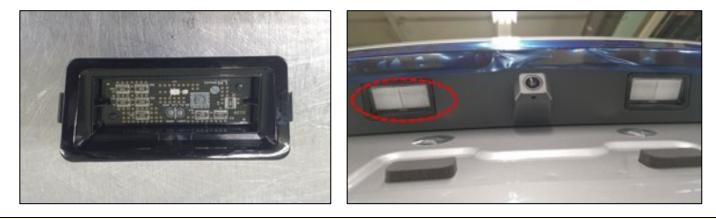
Description: Certain 2022MY Tucson (NX4/NX4a) and Tucson Hybrid (NX4 HEV) vehicles equipped with LED type lamps may exhibit loose license plate lamps, caused by out of specification lamp housings. This bulletin provides the procedures to repair the condition by replacing the affected license plate lamps.

- 1. Record radio presets and disconnect the negative (-) battery terminal.
- 2. Remove the lift gate trim (A).

3. Remove the rear center combination lamp (B).

- 4. Press the upper tabs (C) to disconnect the license plate lamp(s) from the rear center combination lamp.
- 5. Replace the affected license plate lamp(s).
- 6. Install parts in reverse order of removal.
- 7. After connecting the negative (-) battery terminal, be sure to reprogram radio presets.
- 8. Verify that the license plate lamps are not loose and functioning properly.
- 9. The service procedure is complete.
