TECHNICAL SERVICE BULLETIN

Rubbing Noise At Front Of Vehicle While Driving And/Or DTCs C0031 And/Or C0034 - Built On Or Before 14-Jun-2021

22-2118

Ford 2021 F-150	Built on or before 14-June-2021
---------------------------	---------------------------------

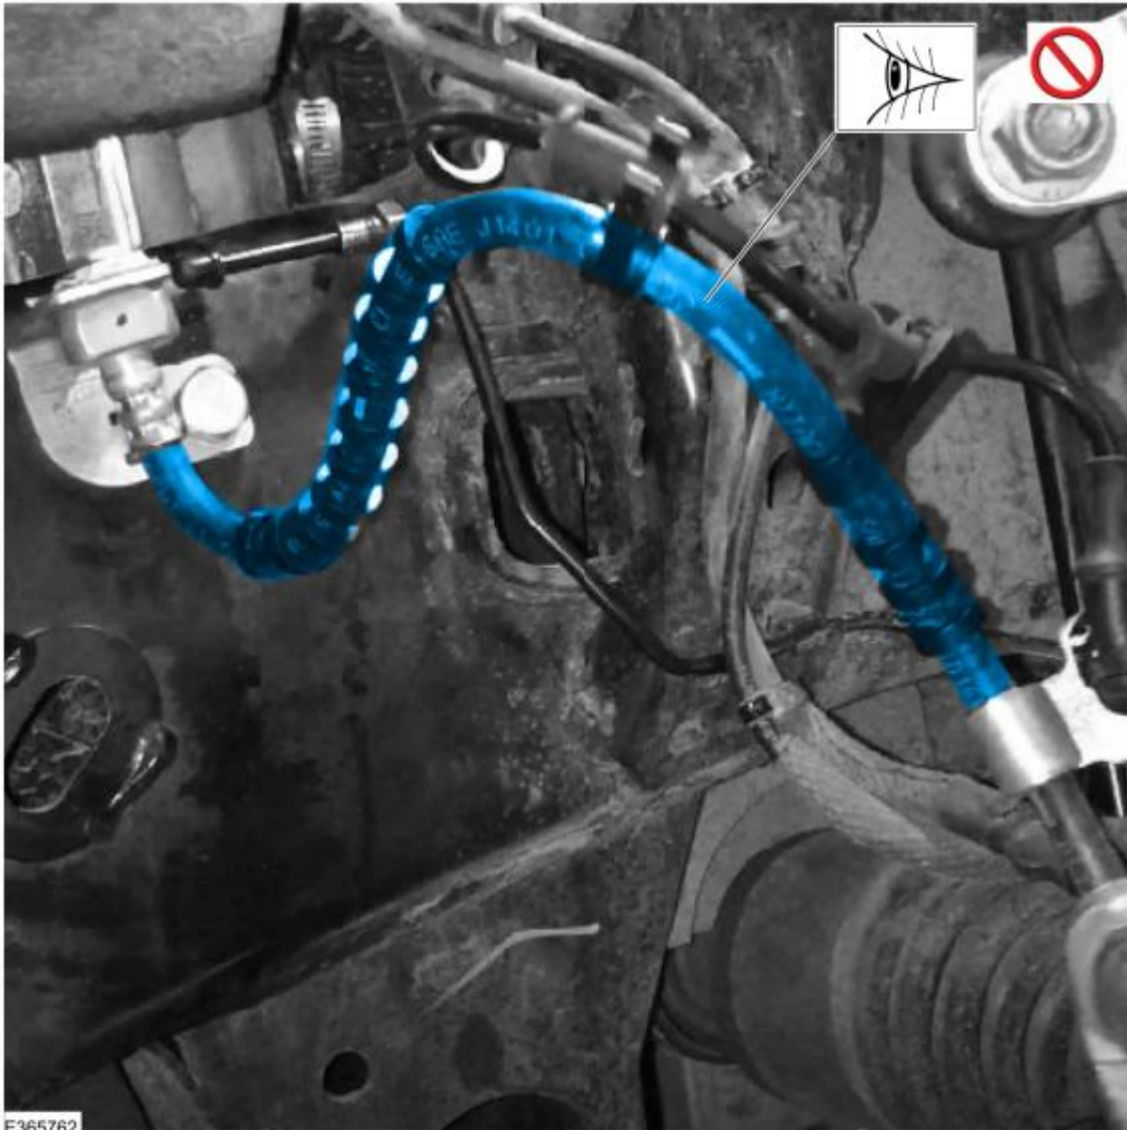
Figure 2 - Incorrect routing

Issue: Some 2021 F-150 vehicles built on or before 14-June-2021 may exhibit a rubbing noise at the front of the vehicle while driving and/or diagnostic trouble codes (DTC) C0031 and/or C0034 in the anti-lock brake system (ABS) module. This may be caused by an incorrectly routed front brake flexible hose. To correct the condition, follow the Service Procedure to inspect the front brake flexible hose routing.

2. Are both front brake flexible hoses routed correctly? (Figure 1)
 - (1). Yes - this article does not apply.
 - (2). No - proceed to step 3.
3. Replace the affected front brake flexible hose(s). Refer to Workshop Manual (WSM), Section 206-03. When installing the new hose(s), they must travel downward on the frame side before bending toward the steering knuckle and then bend near the bracket secured to the steering knuckle. (Figure 1)
4. Inspect the affected wheel speed sensor harness(es). Is the wheel speed sensor harness damaged?
 - (1). Yes - replace the affected wheel speed sensor.
 - (2). No - repair is complete.
