Technical Service Bulletin

69 Airbag warning light on, DTC B1225F1 stored in the airbag control module

69 22 86 2051242/6 May 4, 2022. Supersedes Technical Service Bulletin Group 69 number 19-41 dated July 24, 2019, for reasons listed below.

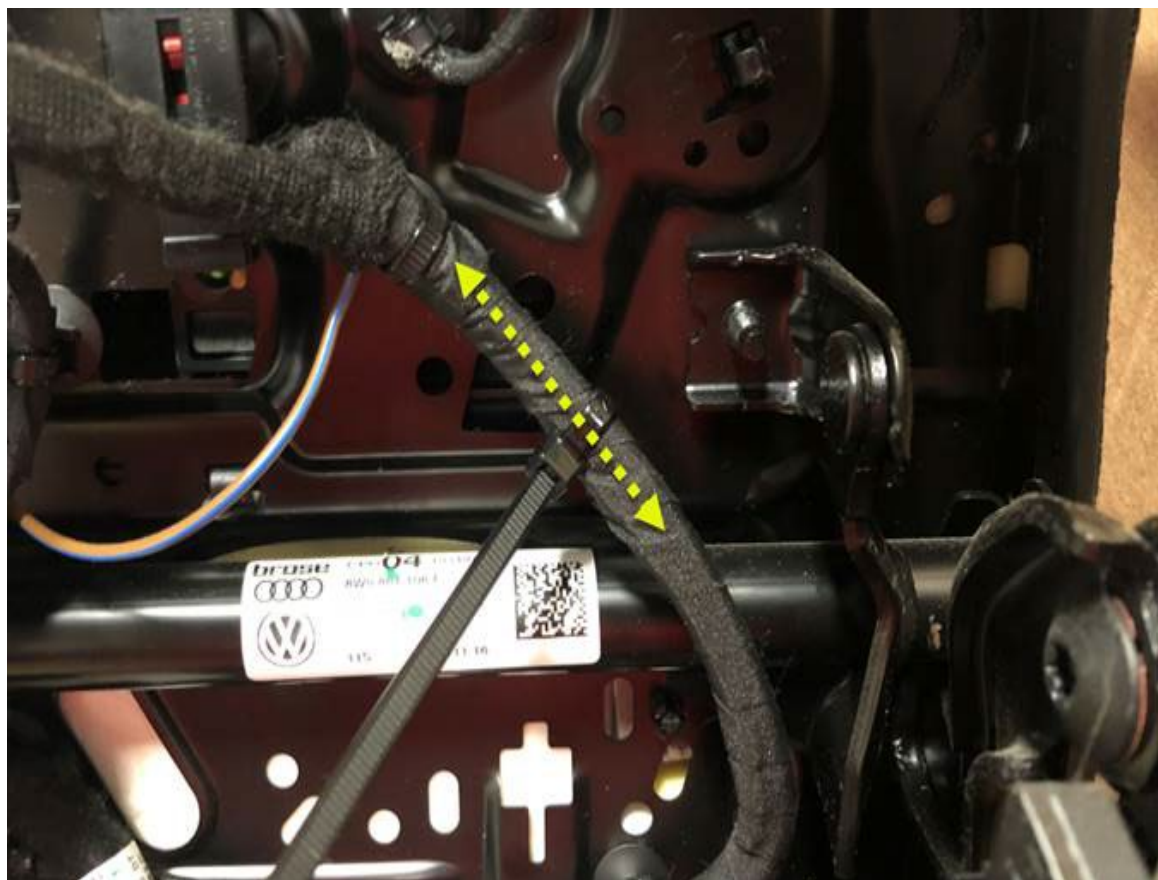
2. You will attach the first cable tie in the yellow marked area on the harness between the cable tie clip and the crossbar tube as shown below (Figure 2).

Figure 2. Attach the first cable tie in the yellow area.

When tightening the cable ties, only tighten them with your hands, do not use any tools to tighten the cable tie as this can damage the harness. Check that the cable ties cannot be rotated on the harness by hand, to ensure that proper tension is achieved. Then cut off the excess length from the tie wrap.

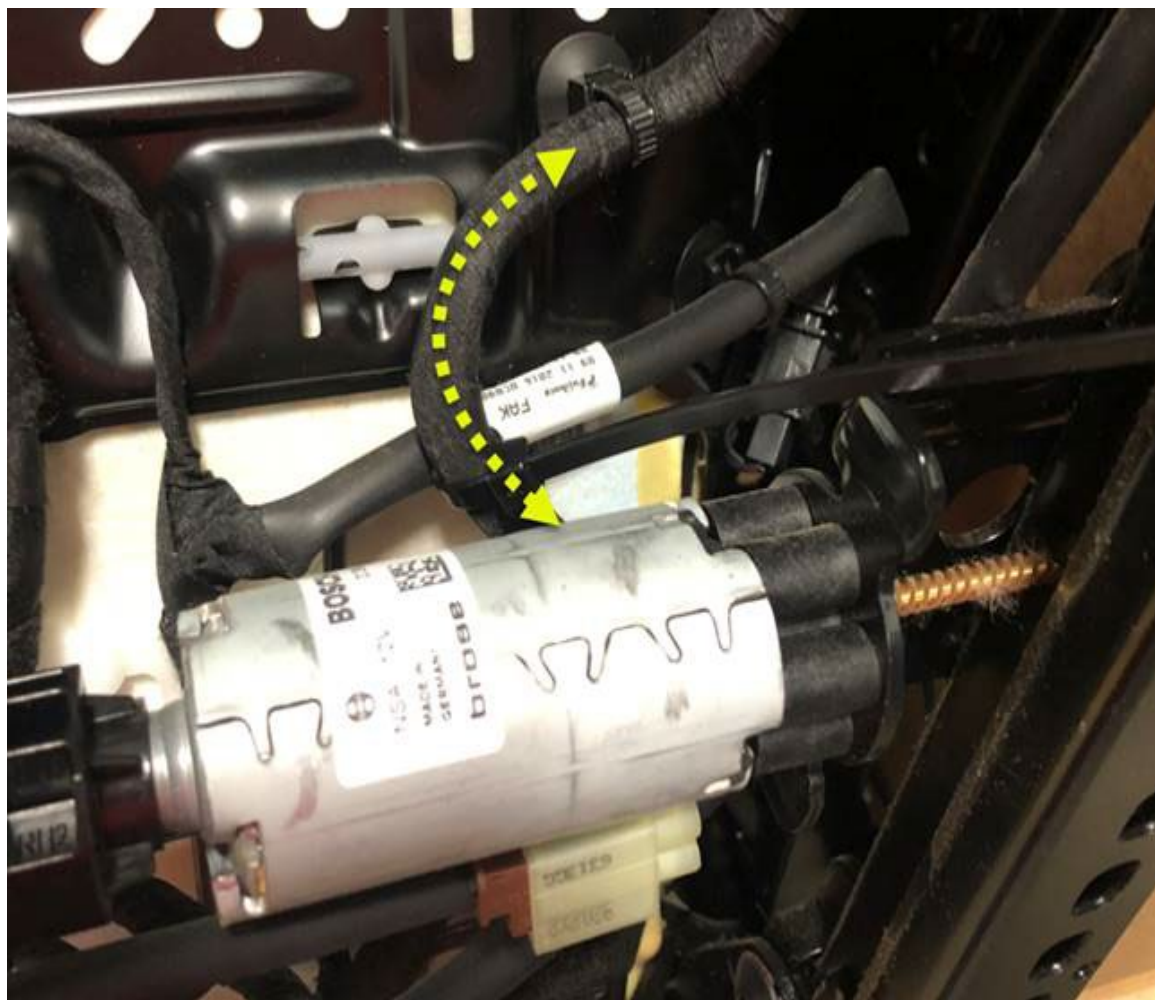
3. The second cable tie position is to the rear of the crossbar tube where the harness drops down from the frame. Place the cable tie in the yellow marked area shown below (Figure 3).

Figure 3. Attach the second cable tie to the yellow marked area.

4. Once you have the cable ties properly secured and installed, return the seat to the original position and clear the faults stored in the system.
