SIB 16 01 22

SERVICE ACTION: CHECK THE ROUTING OF THE FUEL EVAPORATIVE LINES

E-Series	Model Description	Production Date	Affected Option Code
G05	(X5 Sports Activity Vehicle)	June 6, 2020 – October 19, 2020	PHEV

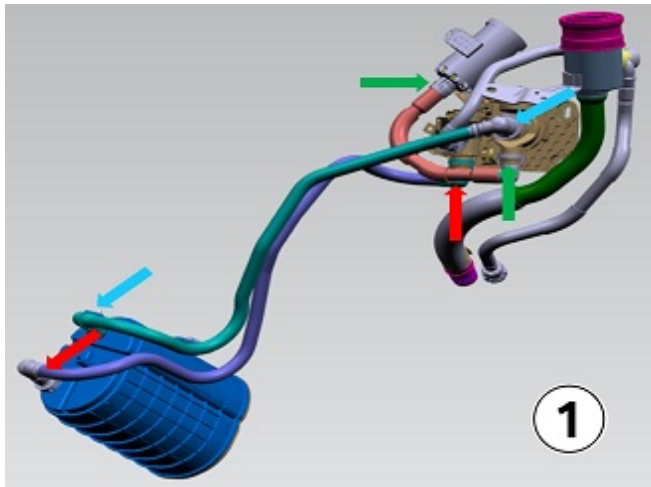
Check the routing and positions of all the EVAP line connections and correct if necessary (arrows) (1).

During manufacturing, the evaporative lines for the EVAP system may have been routed incorrectly. This could result in a Service Engine Soon (MIL) lamp turning on.

Check the routing of the evaporative lines and correct the routing/connections if necessary.

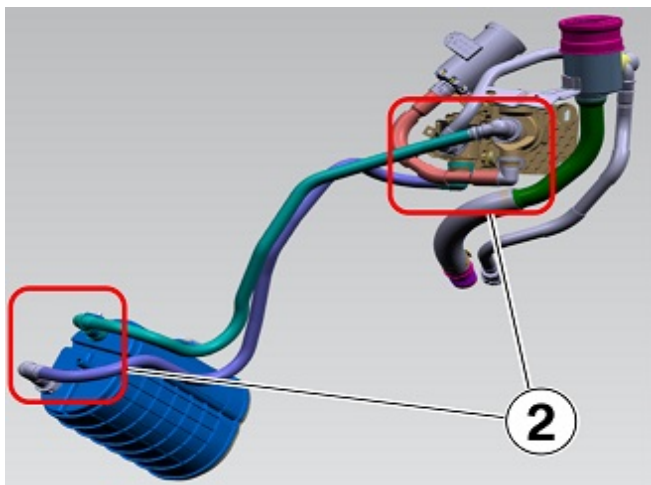
Also check to ensure all connections are locked or secured correctly (2).

After checking and correcting, reassemble the wheel well.
