## 44 Q5 MY 22 Suspension Alignment - Repair Authorization

44 22 94 2066483/2 May 24, 2022. Supersedes Technical Service Bulletin Group 44 number 22-90 dated March 16, 2022, for reasons listed below.

Model(s)	Year	VIN Range	Vehicle-Specific Equipment
Q5, Q5 e quattro, Q5 Sportback, SQ5, and SQ5 Sportback	2022	All	Not Applicable

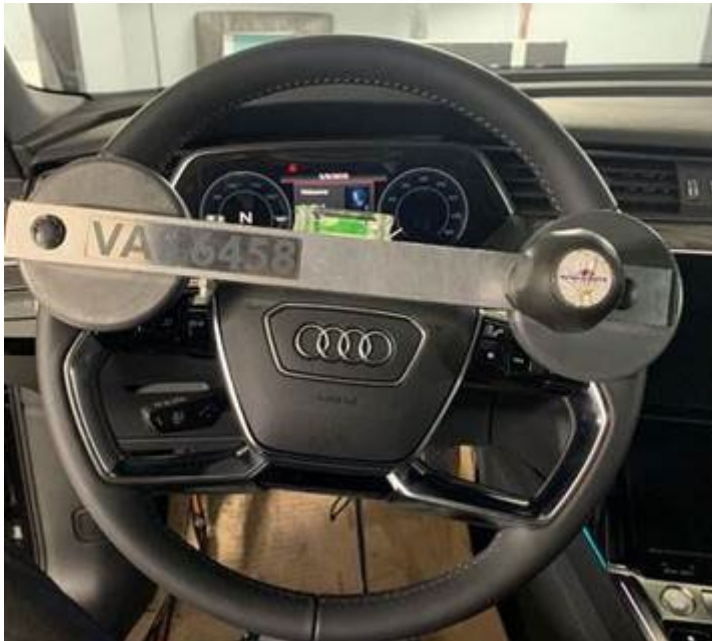
*Figure 1. VAS 6458 installed with steering wheel off-center.*

7. Install VAS 6458 (Steering wheel scale), and set the steering column all the way up and as far as possible from the dash panel. With the wheels straight take a clear picture in front of the steering wheel (Figure1).
