Subject: Fuel Tank Fuel Gage Improvement      Bulletin Type: Field Fix Mandatory

Bulletin No: TS35-FC-2104

Vehicle Model: TS35

This bulletin aims to improve the fuel tank gage of the fuel tank.

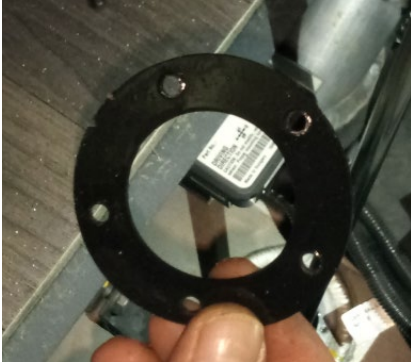
1	Piece
2	RP160127	FUEL TANK FLANGE SEALER

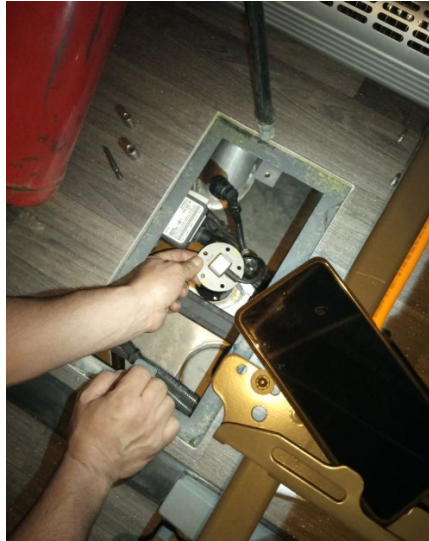
**Figure 3**

3. Disassemble the fuel gage. (See Figure-3)

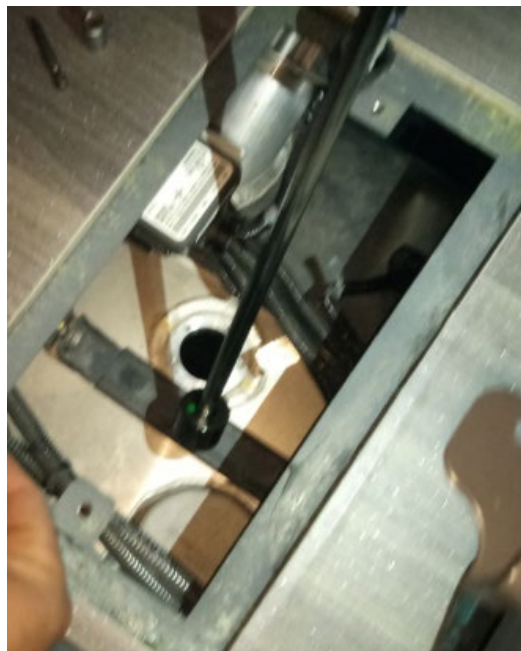
**Figure 4**

4. Pull the fuel gage out completely. (See Figure 4)

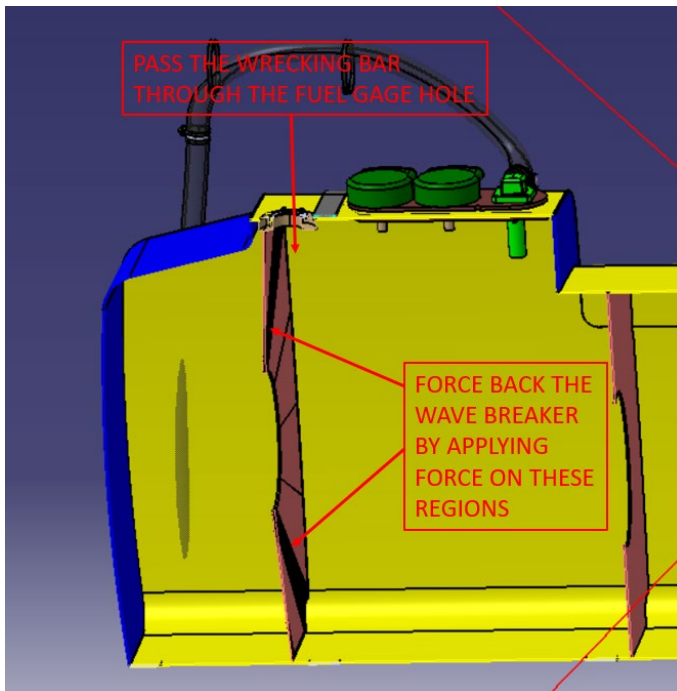
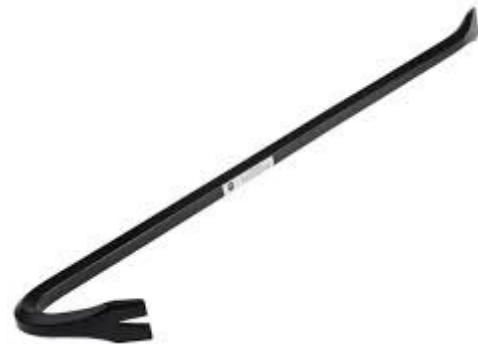
Figure 5 and 6

5. Use the wrecking bar to force back the wave breaker in order to increase the space between the wave breaker and the fuel gage. (See Figure-5 and Figure-6)

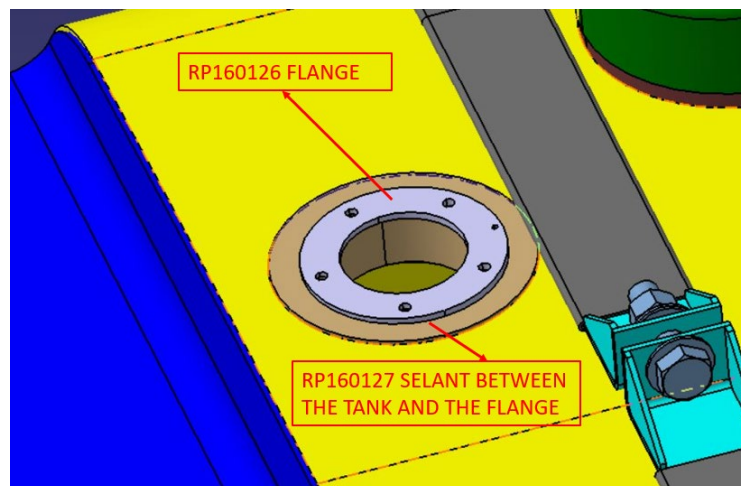
Figure-7

6. Insert the fuel tank flange above the sealer. Make sure that the small hole points the exact opposite of the fuel tank fill neck. (See Figure-7)

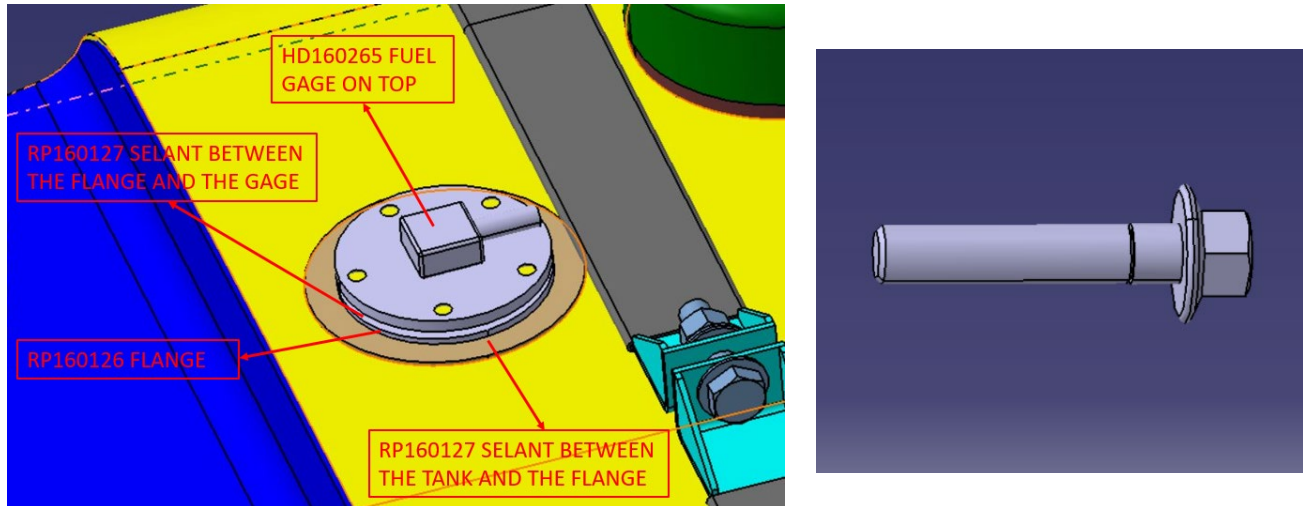
**Figure-8 and 9**

- Put the extra sealer above the fuel tank flange and place the sealer above it and place the fuel gage on top of them. Then assemble the new 5 pieces of M5x0.8x0 screws. **(See Figure-8 and 9)**
