Technical Service Bulletin

91 MIB2+ High: sporadically or permanently no sound from all sources

91 22 05 2060464/3 June 6, 2022. Supersedes Technical Service Bulletin Group 91 number 22-01 dated May 25, 2022, for reasons listed below.

Model(s)	Year	VIN Range	Vehicle-Specific Equipment
A6, A7, A8, Q3, and Q8	2019 – 2020	All	MIB 2+ High
S6, S7, A8 e quattro, S8, Q7, SQ7, SQ8, and RS Q8	2020

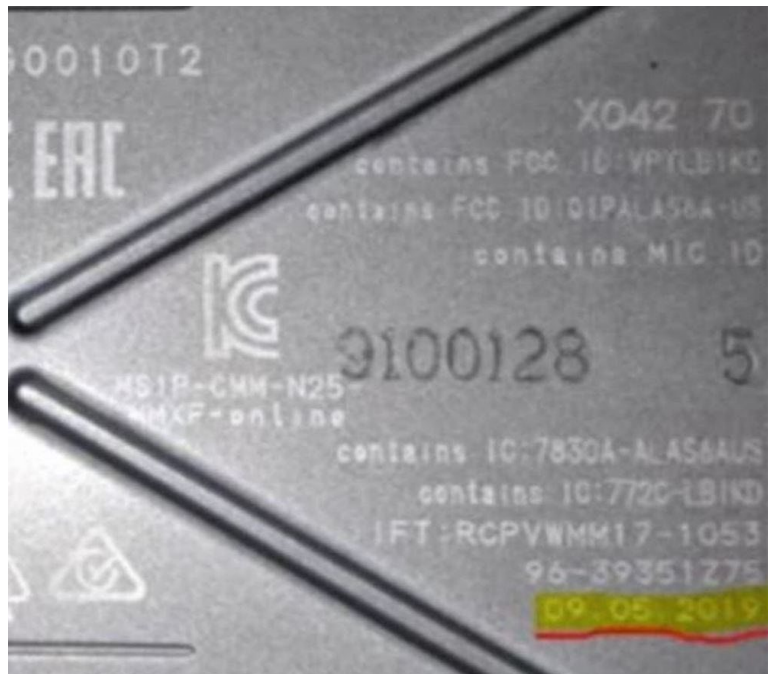
1. Check the production date of information electronics control module 1, J794 (address word 005F) on the housing of the control module. The production date is printed on the bottom right (Figure 1).

Tip: The date on the J794 is in DD.MM.YYYY format.

Figure 1. Production date, located on the right side.

If the date is between 03/16/2019 and 05/22/2019, then replace the control module.

2. If the production date is between 05/22/2019 and 02/27/2020, please contact TAC.
- 3.. If the production date is after 02/28/2020, this TSB is not applicable. Continue diagnosis for the root cause of the concern.
