# Technical Service Bulletin

## 87 Air Conditioning is inoperative, DTC B11AE15

97 22 84 2067362/1 June 22, 2022.

Model(s)	Year	VIN Range	Vehicle-Specific Equipment
Q8	2019 – 2023	All	Not Applicable
SQ8, and RS Q8	2020 – 2023

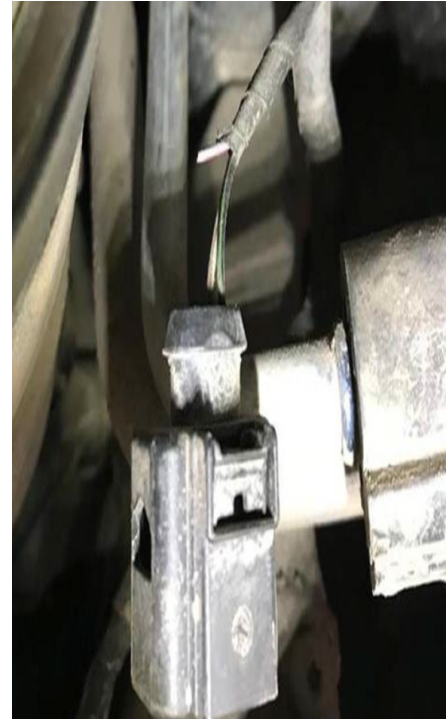
The wiring to the A/C compressor connector T3r is not long enough. Wires may become stretched, break, or pulled from the connector as a result.

If DTC B11AE15: A/C compressor regulator valve Open circuit/short circuit to B+ is stored in the onboard supply control unit J519 diagnostic address 0009, inspect the wiring at connector T3r in the area of the A/C compressor as seen in Figure 1.

*Figure 1. N280 control wire damaged at T3r connection*

If damage is found in this area all 3 wires will need to be extended following the directions below.

1. Cut back the damaged wire(s) until the wires are clean and free of any corrosion.
2. Extend all 3 wires so that a length of approximately 110 mm is achieved when measuring from the base of the connector to the first branch in the harness. See Figure 2.
3. Ensure there is enough slack to keep the harness from stretching however not so much the wires hang down.
4. Repair and modify the harness using VAS 1978 B
5. Wrap the harness section using fabric adhesive tape **N 107 920 02**.  
Wrap wires up to 20 mm from the base of the connector housing, as seen on the original harness in Figure 1.

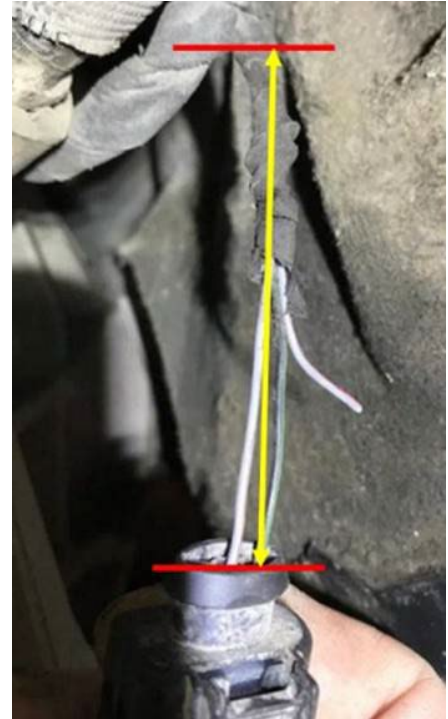
**Figure 2.** Measure 110 mm from T3r to the first harness branch
