## Mack Chassis - Equipped with An Automated Manual Transmission (AMT, mDrive) - SNM 19 - 002 - AMT Oil Filter Housing Corrosion

**Bulletin:** SNM19-002

## AMT oil filter housing corrosion

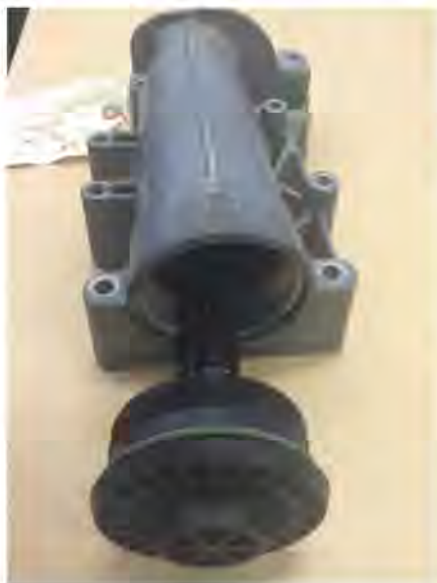
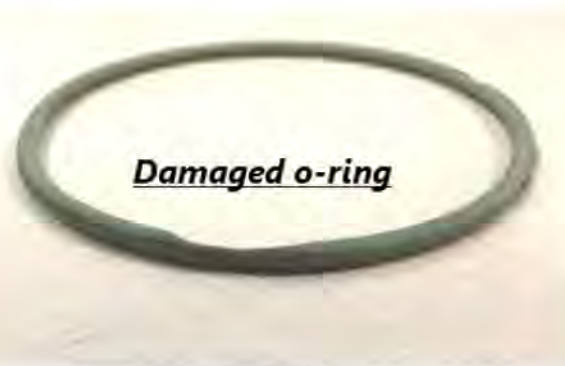
The AMT gearbox oil filter housing has been found to develop debris buildup or corrosion on the filter cover flange.

Failure to inspect and properly clean this area during a filter change can lead to a sealing ring failure during installation of the cap that may not be found during the oil change. The subsequent oil leak can lead to catastrophic gearbox failure due to loss of oil if not detected and corrected.

If you detect corrosion on the location shown above do not attempt to clean or reuse this housing. The corrosion is harder than the aluminum. This housing must be replaced.

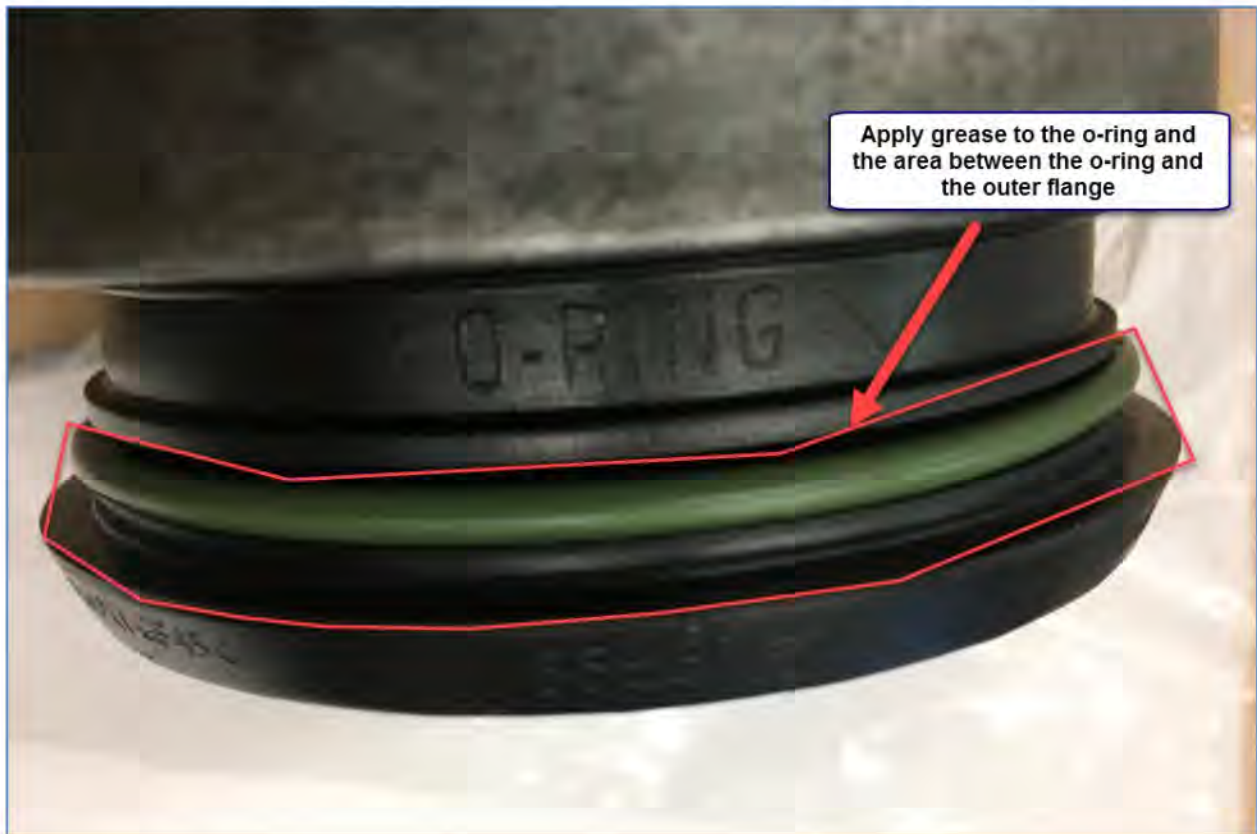
Silicone grease

Base	Silicone
Consistency	NLGI 2
Thickener	Lithium soap
Temperature range	-70°C to +160°C

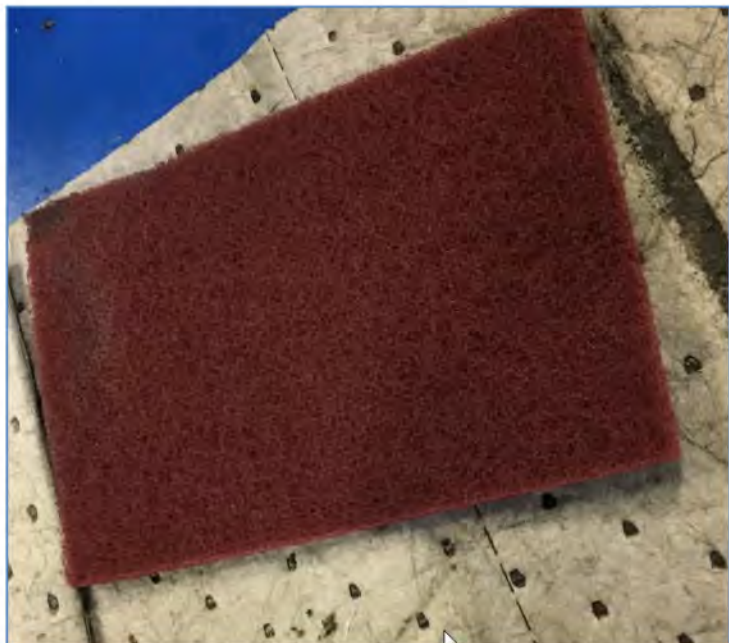
Approved cleaning pad red or green Scotchbrite pad or equal.
