Warranty Automated Manual Transmission (AMT, I-Shift, mDrive) Control Housing Assembly; Guidelines For Filing A Claim For Chassis Return Visit With Transmission Issues After A Repair Requiring Control Housing Removal And Reinstallation - US07 And N

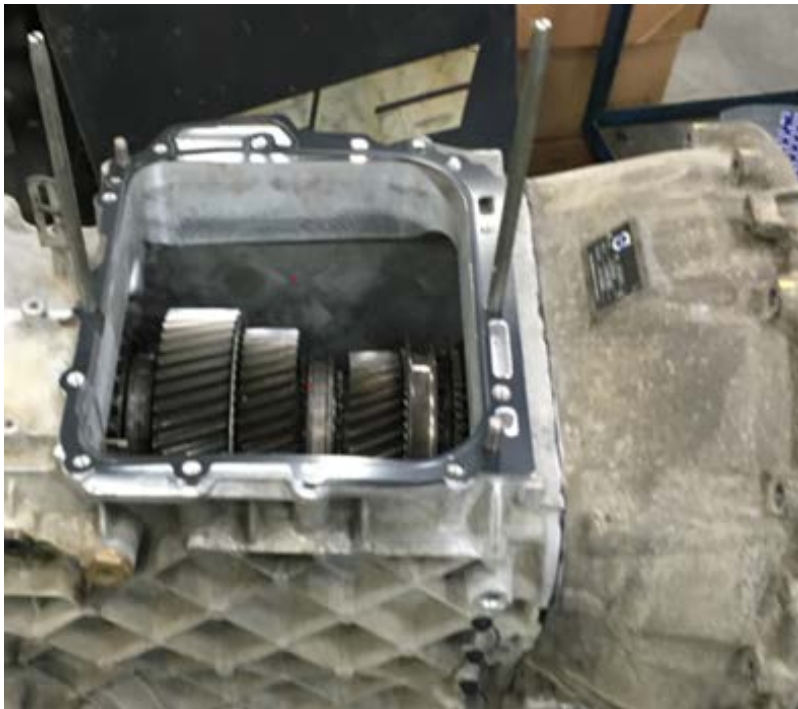
When reinstalling a Control Assembly onto an AMT following inspection or repairs, Guide Pins (Part Number 9996876) must be used to ensure proper orientation. An AMT main box with the guide pins properly installed can be seen below:

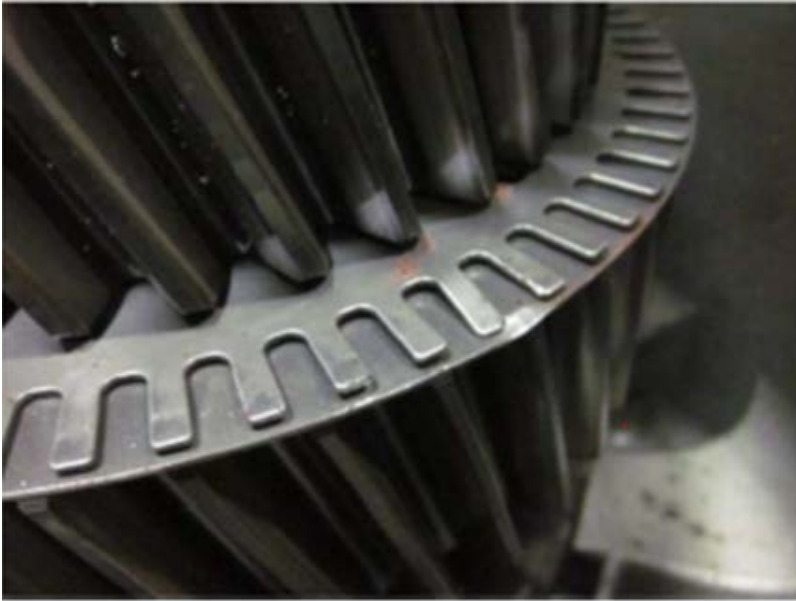
If Guide Pins are not used, misalignment of the Control Housing can cause damage to the tone ring as shown below:
