Particulate Matter (PM) Sensor Troubleshooting Guide - US14+OBD16 And Newer Emissions

SCR Fittings, One Box, Replacement

Exhaust Particulate Sensor, Repair

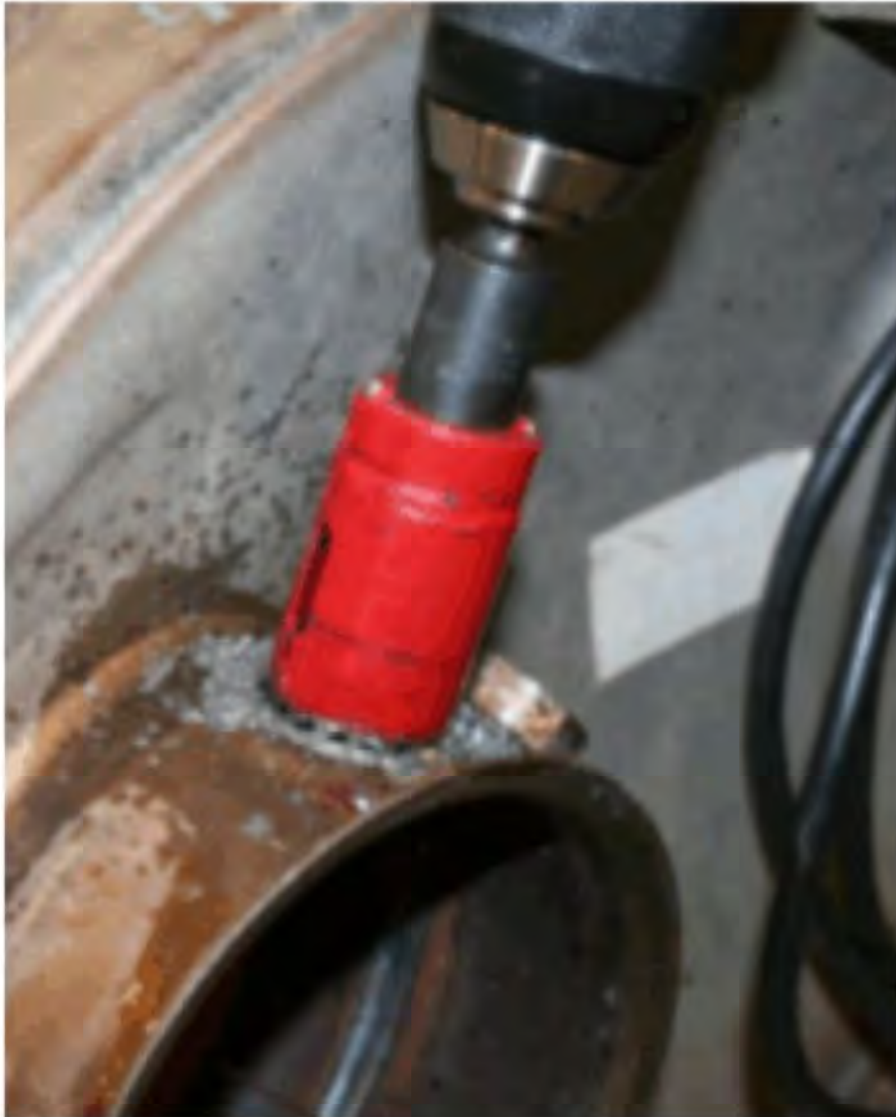
1. Remove the damaged boss welding.

Note: If the PM sensor boss is damaged as shown in the illustration mark the position of sensor boss notch before removing the boss welding. The notch of PM sensor boss is always set in the 3'o clock position.

Note: Use the sensor boss to pilot the hole saw.

Note: When removing the sensor boss weld, check the depth frequently to prevent the damaged sensor boss from falling inside the aftertreatment muffler. Also ensure that the notch mark is not removed.

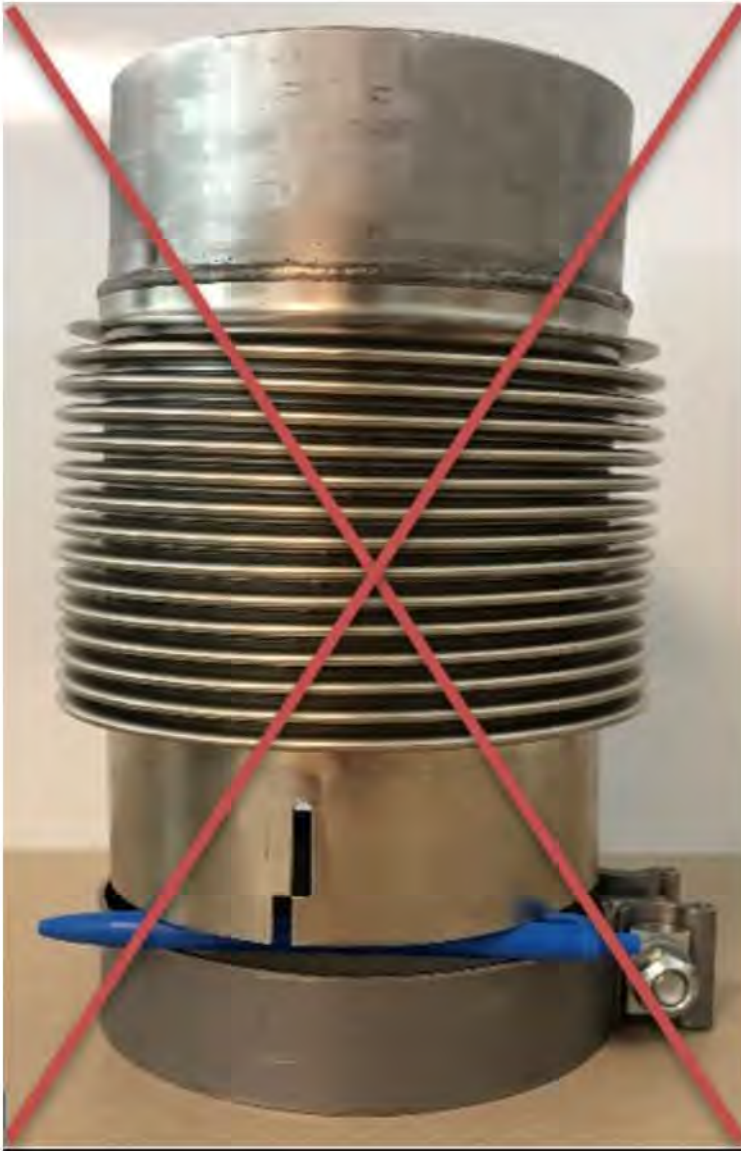
<p>Scenario 1</p> <p>This style Flex Pipe and Clamp will no longer work with the upper adjacent connecting pipe. The below parts in scenario 2 are required to perform this FSB.</p> <p>Follow the repair below that is applicable for your configuration.</p>
--	--

Determine which Flex Pipe and Clamp the truck currently has installed on it. If the truck you are repairing has the Flex Pipe and Clamp shown in scenario 1, you will need to order the improved Flex Pipe (P/N 21142254) and Clamp (P/N 25172497). If the truck you are repairing has the Flex Pipe and Clamp shown in scenario 2, this truck already has the improved parts and ordering a new Flex Pipe and Clamp is NOT required.

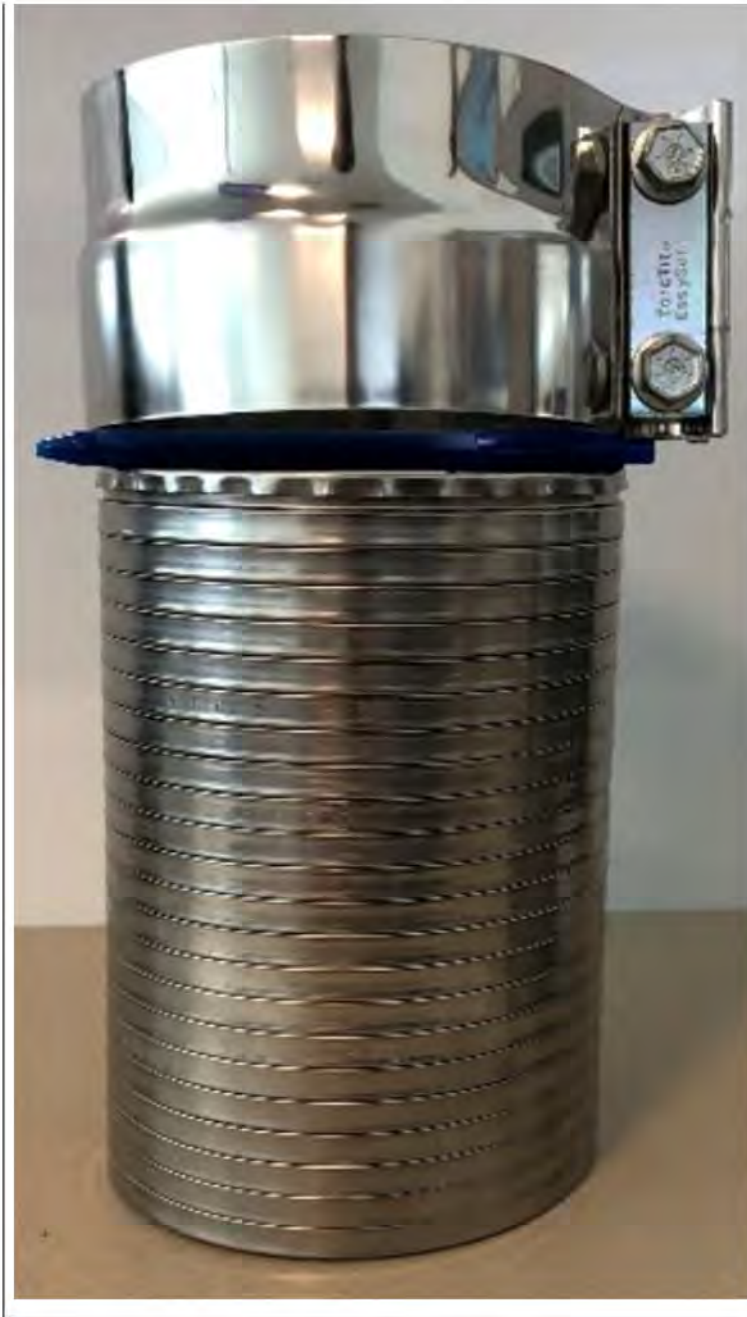
Scenario 2

This style Flex Pipe and Clamp only needs the upper adjacent pipe replaced. Reuse the existing Flex Pipe and Clamp, or order as needed.

Flex Pipe –
21142254

Clamp –
25172497
