Technical Service Bulletin

19 Coolant leak at connection of water pump and hose leading to the heater core

19 13 46 2033491/5 November 7, 2013. Supersedes Technical Service Bulletin Group 19 number 13-44 dated July 18, 2013 for reasons listed below.

Model(s)	Year	VIN Range	Vehicle-Specific Equipment
A4, A5, A5 cab, Q5, A6	2009-2013	All	2.0 TFSI

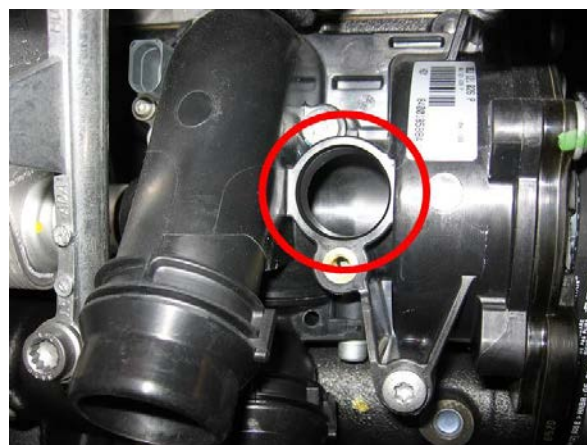
The leak can be traced to the connection of the water pump and the hose leading to the heater core (Figure 1). The seal ring is not the cause of the leak.

Figure 1. Connection of water pump and hose leading to heater core

3. After confirming that the leak is a category 3 leak, take a photograph of the leak (use leak talcum spray if necessary) and attach a printout of the photograph to your warranty paperwork.
4. Replace the water pump (**06H121026CF**), seal ring (**WHT006407**), and the hose to the heater core (**06H121065D**).

Replacing only the seal ring may not prevent the leak from reoccurring.
