July 19, 2022

Power Tailgate Wont Stay Open

Year	Model	Trim	VIN Range
2018–21	Odyssey	ALL Except LX and EX	ALL
2022	Odyssey	ALL Except LX and EX	5FNRL6H....000001 thru 5FNRL6H....044328

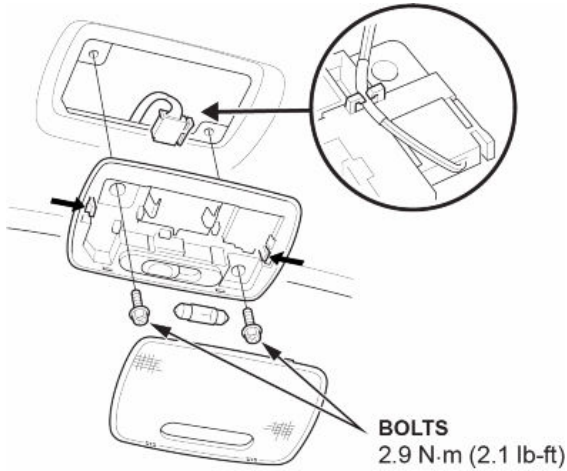
1. Remove the cargo light.

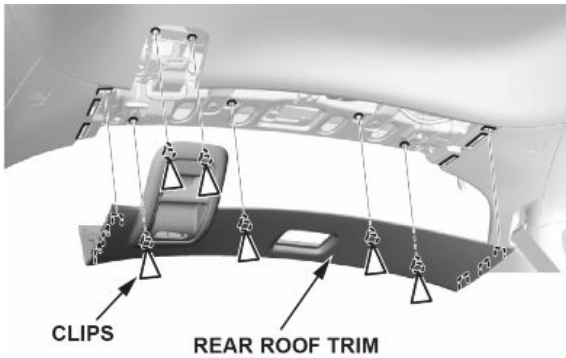
2. Remove the rear roof trim.

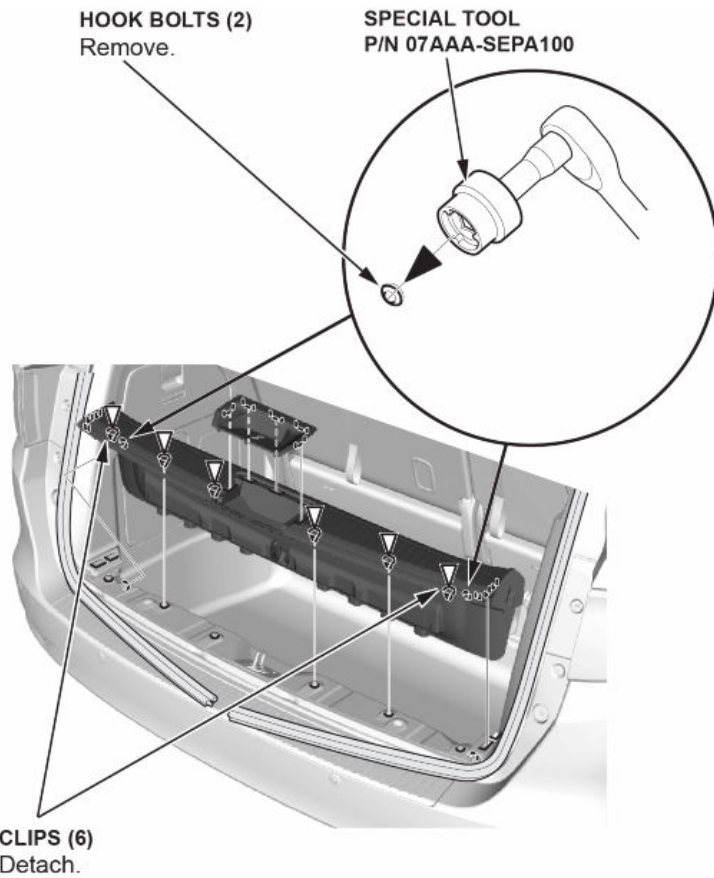
3. Remove the rear cargo area trim panel.

3.1. Set the third row seats upright.

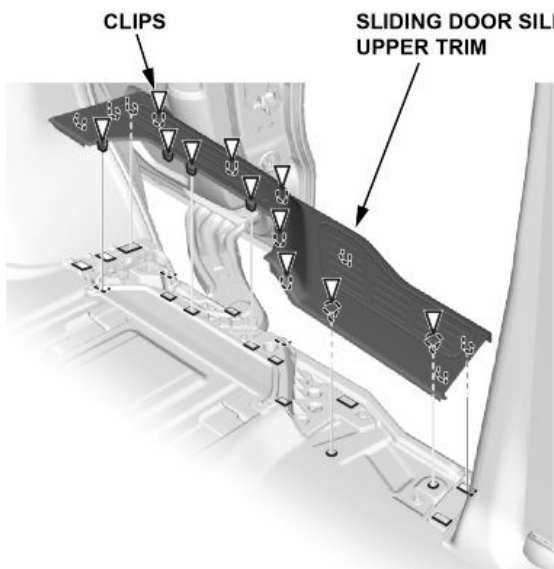
4. Remove the right and left sliding door sill upper trims.

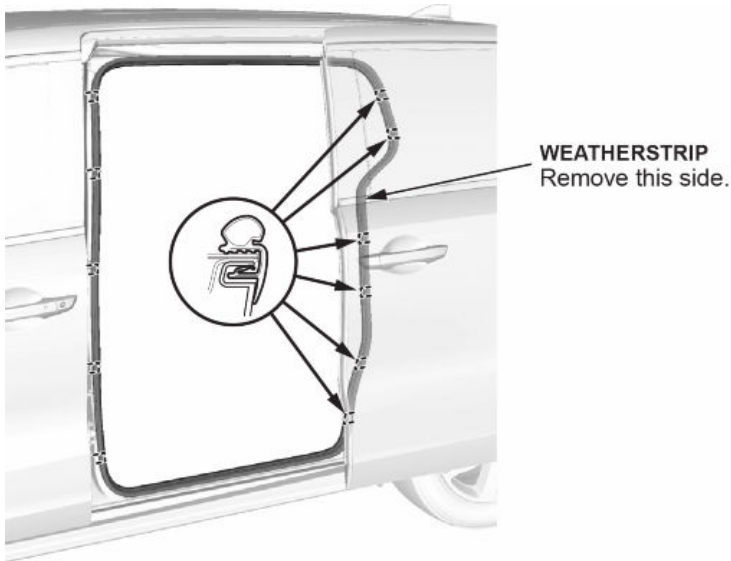
5. Remove the weatherstrip along the right and left rear side trim panels as needed to detach the side rear trim panels from the C-pillar.

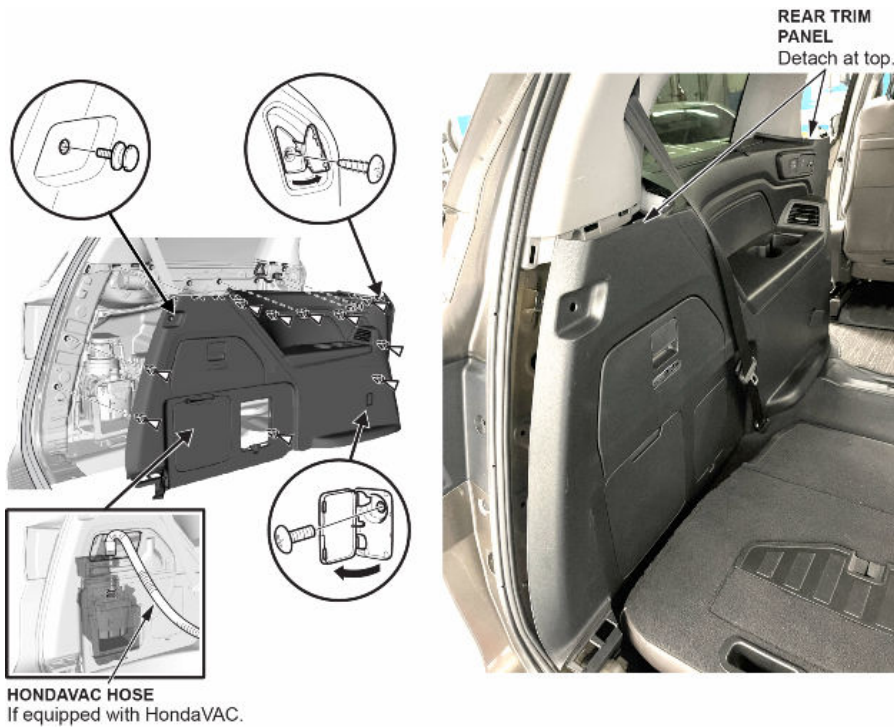
6. Detach the top of the right and left side rear trim panels from the C-pillar and D-pillar trims to create enough clearance for removing the C-pillar and D-pillar trims.

- 6.1. Remove the hook bolts and screws/fasteners behind the access panels as shown below.
- 6.2. If equipped, remove the HondaVAC hose from the vacuum.

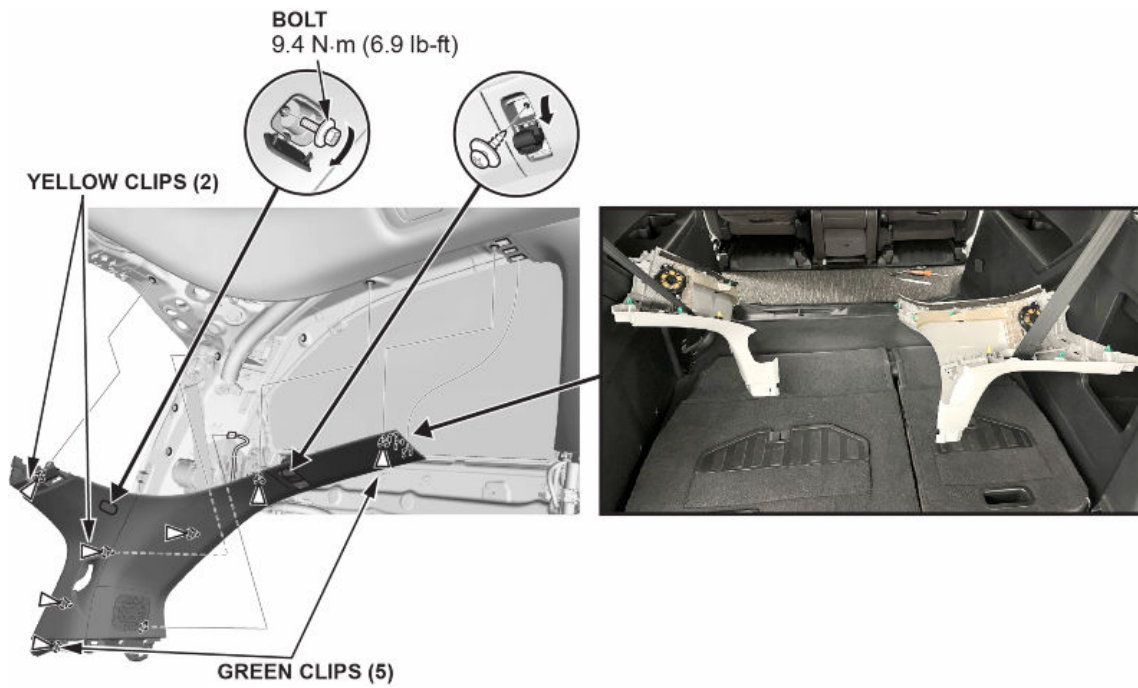
7. Remove the D-pillar trim.

- Disconnect the satellite speaker connector if equipped.
- To prevent scuffing/marring when the D-pillar trims are removed, lean them against the side trim panels as shown.

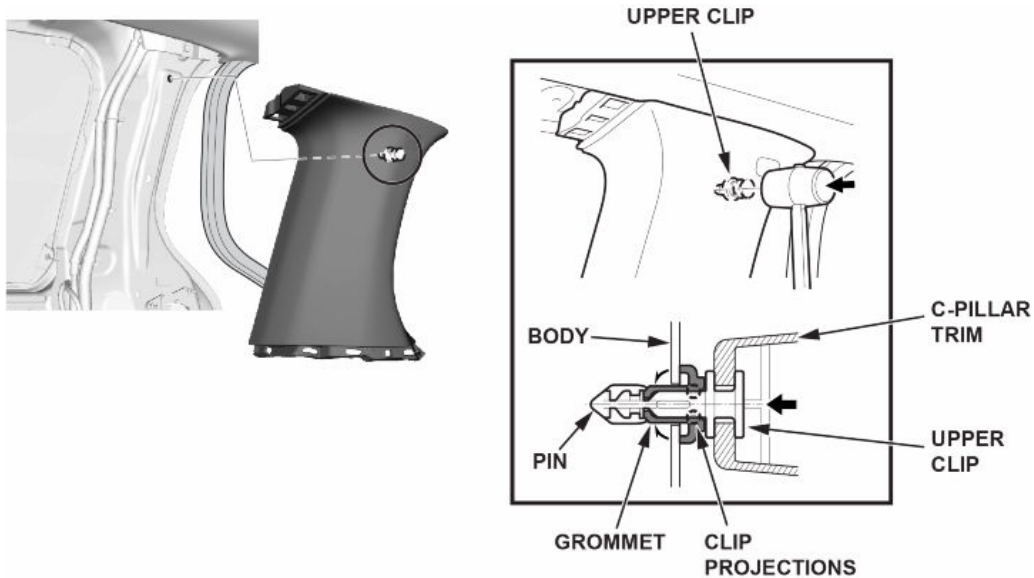
8.1. Hit the upper clip in the C-pillar trim with a rubber mallet. Hitting the clip breaks the projections on the pin, and pushes it into the grommet on the body.

- Make sure you only strike the trim in the area indicated to avoid damaging the trim.
- Place a clean shop towel over the trim to prevent a dirty mallet from discoloring the trim.
- Hitting the clip breaks the projections on the pin and pushes it into the grommet on the body.
- The upper clip must be replaced with a new one when the C-pillar trim is reinstalled.

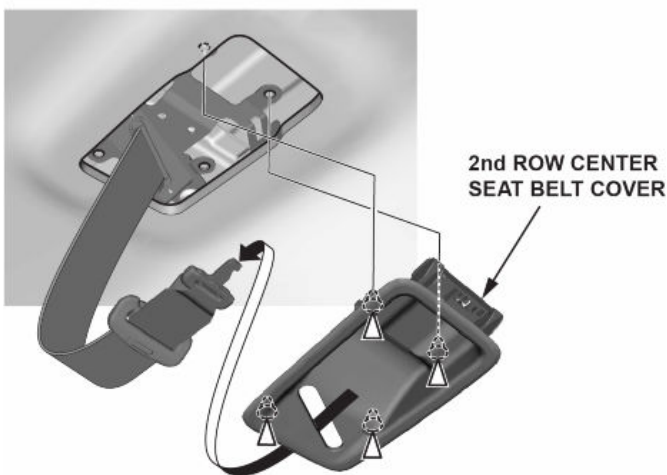
9. Remove the 2nd row center seat belt cover.

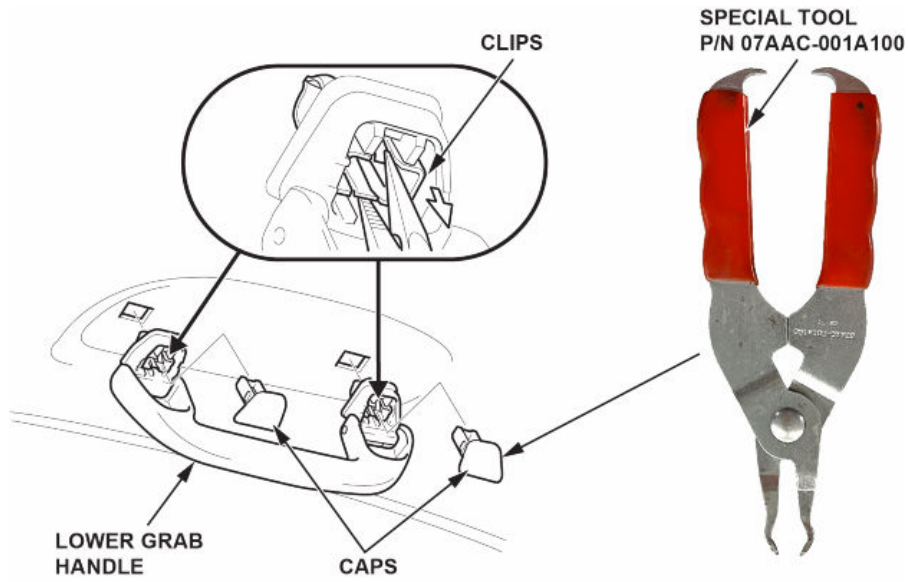
- 10. Remove the right and left rear slide door grab handles.
 - 10.1. Lower the grab handle.
 - 10.2. Using special tool (07AAC-001A100), remove the caps.
 - 10.3. Squeeze the clips with pliers, then remove the grab handle.

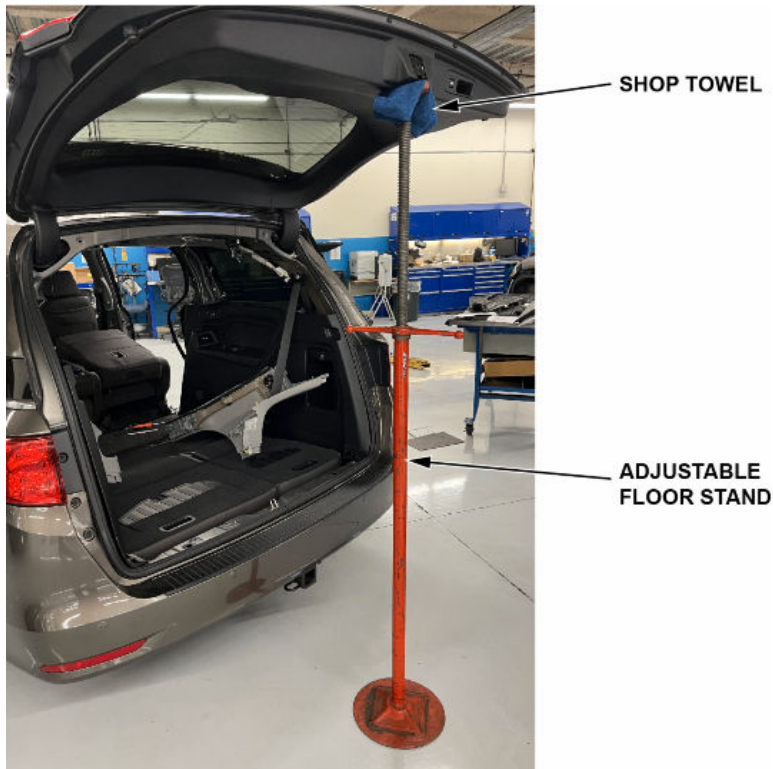
- 11. Lift the tailgate to the full open position and support it with an adjustable floor stand.
NOTE: Cover the shop stand with a clean shop towel to prevent damaging the tailgate trim.

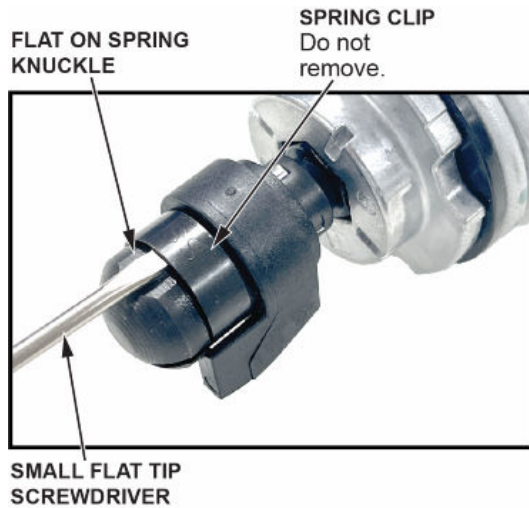
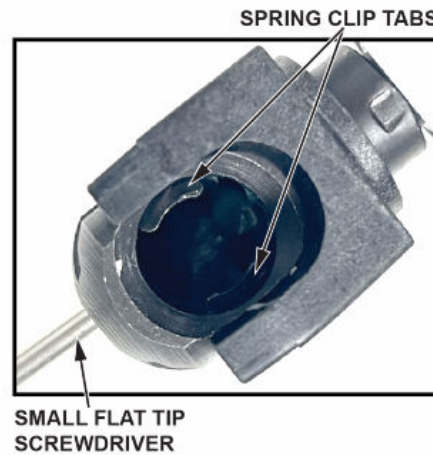
12. Remove the left side tailgate motor from the hinge ball stud.

NOTE: This step must be taken before removing the right support strut to avoid damaging the power tailgate motor. The right tailgate support strut is under additional tension which requires lifting the tailgate beyond the limits of the tailgate motor to safely release the right support strut from the tailgate hinge and bodyside ball studs.

12.1. Insert a small flat tip screwdriver in the flat area under the spring clip as shown.

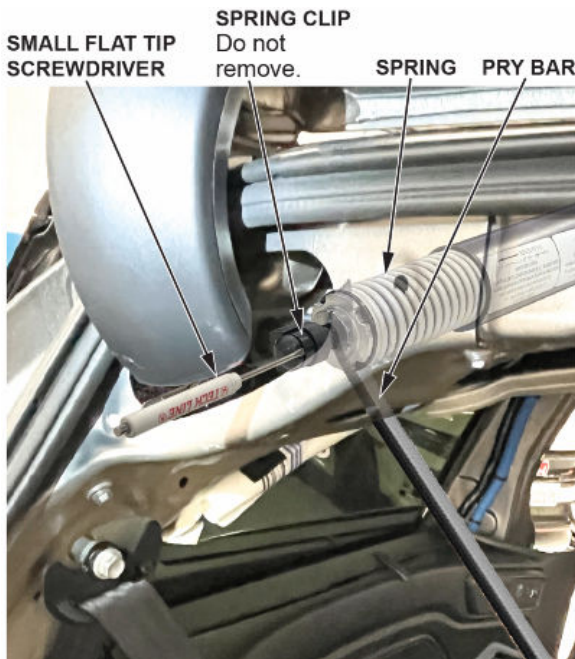
12.2. Use another screwdriver or pry tool to pull the end of the tailgate motor from the hinge ballstud.

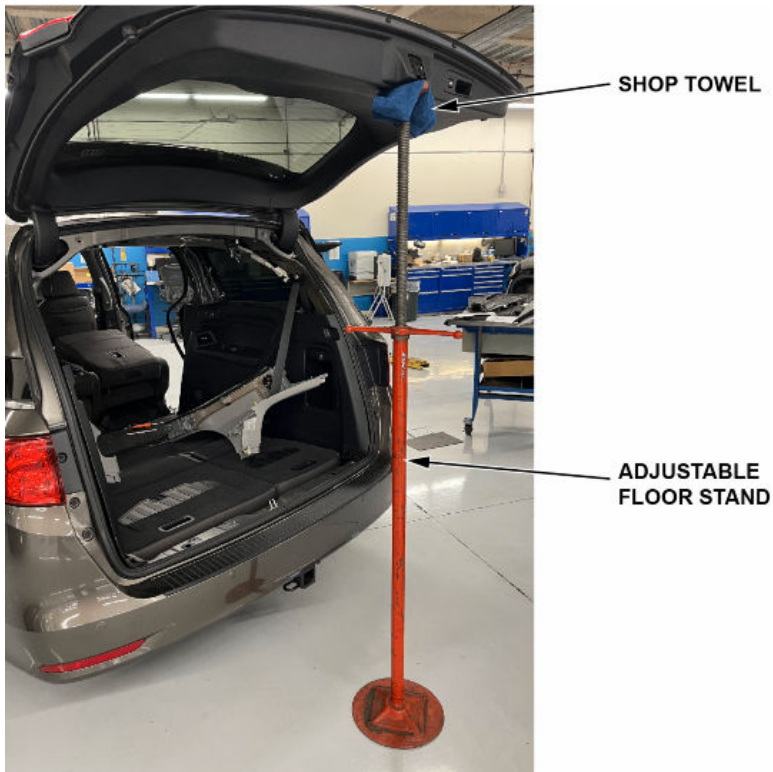
13. After the tailgate motor is released, push open the tailgate to the top of the hinge stroke and adjust the stand to support it in that position.

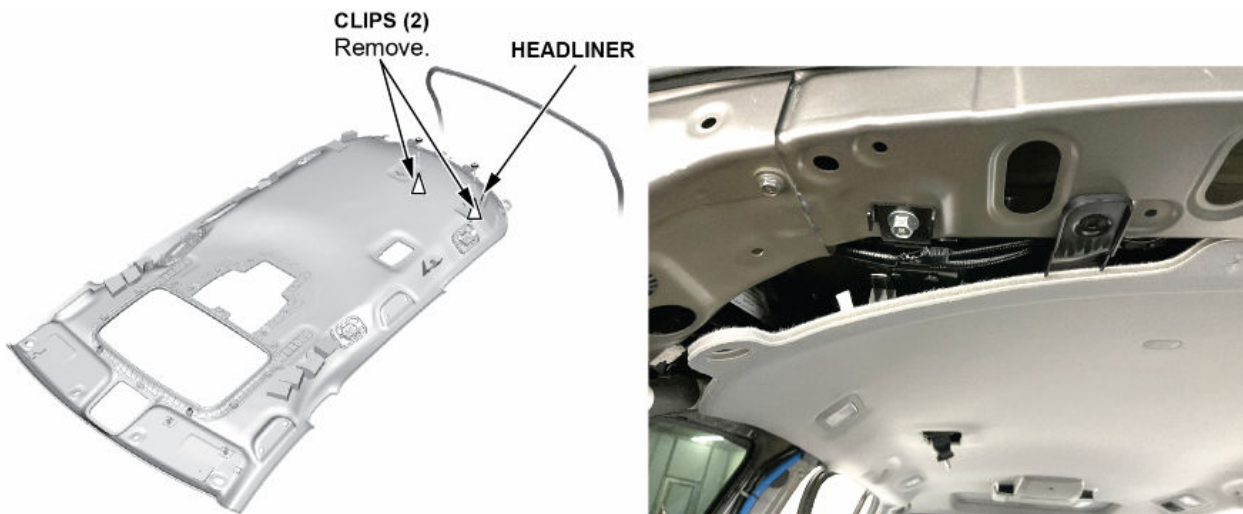
14. Pull the clips out of the roof panel.

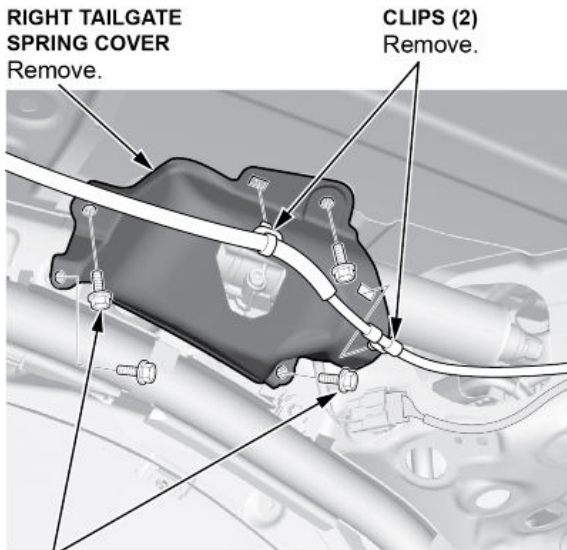
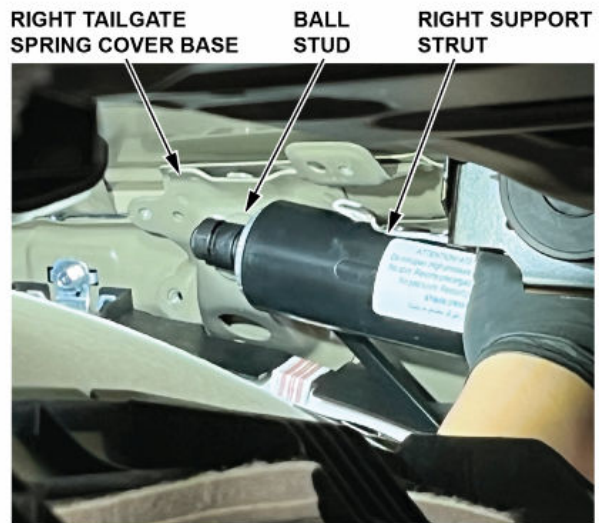
15. Remove the right tailgate spring cover base.

15.1. Gently pull down the headliner taking care to avoid creasing or damaging the headliner.

15.2. Remove clips.

15.3. Loosen the bolts and remove the cover.

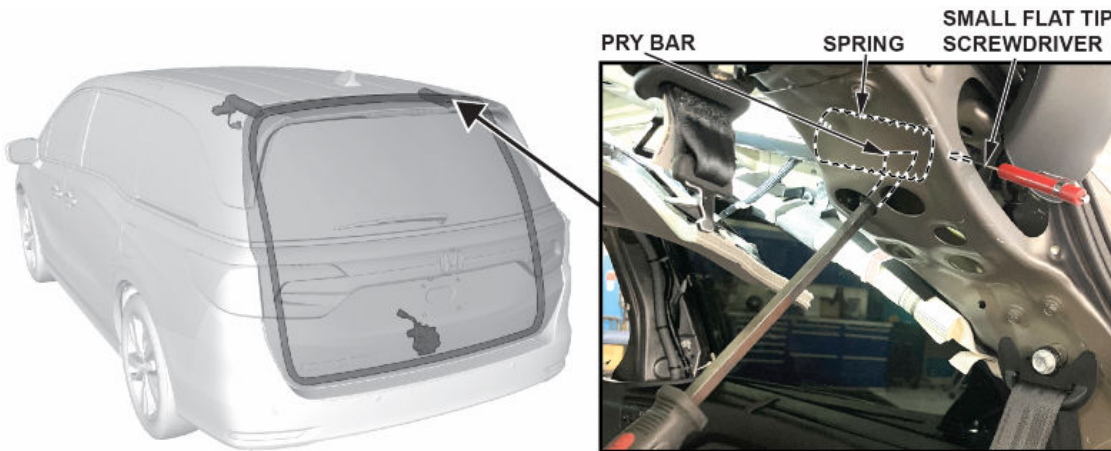
The right tailgate spring internal damper is damaged and does not have sufficient pressure to support the tailgate.

16. Remove the right support strut from the ball studs and install a new one.

Replace the right tailgate spring assembly.
