Driver's Side Door Weatherstrip is Distorted

Year	Model	Trim Level
2022	Civic Sedan, Hatchback	ALL

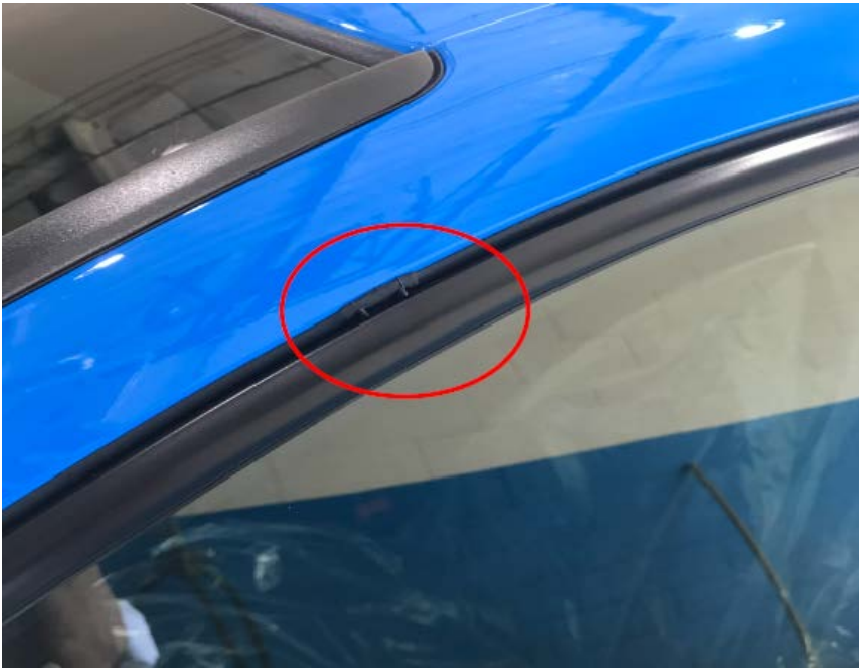
Dealers and field staff have let us know about an issue with the driver's side door weatherstrip looking distorted. We wanted to let you know there is nothing wrong.

Now, rather than just leave you wondering why it's there, here's something interesting. The two nubs found on the weatherstrip was manufactured to channel the water away from the driver when the door is opened.

So, if a customer comes in with this question, or a PDI Tech is curious about it you have the answer.
