Technical Service Bulletin	GROUP Campaign	NUMBER 22-01-060G
	DATE JULY 2022	MODEL(S) G80 (RG3)
SUBJECT:	RADIATOR RESERVOIR TANK LABEL INSPECTION AND REPLACEMENT (SERVICE CAMPAIGN T20G)

Description: Certain 2021-2022MY Genesis G80 (RG3) vehicles may have coolant leakage from the radiator reservoir tank. Follow the procedure outlined in this bulletin to inspect the radiator reservoir tank, and if necessary, replace it with a new part.

Applicable Vehicles: Certain 2021-2022MY G80 (RG3) vehicles equipped with 3.5T produced from 1/13/2021 to 2/21/2022

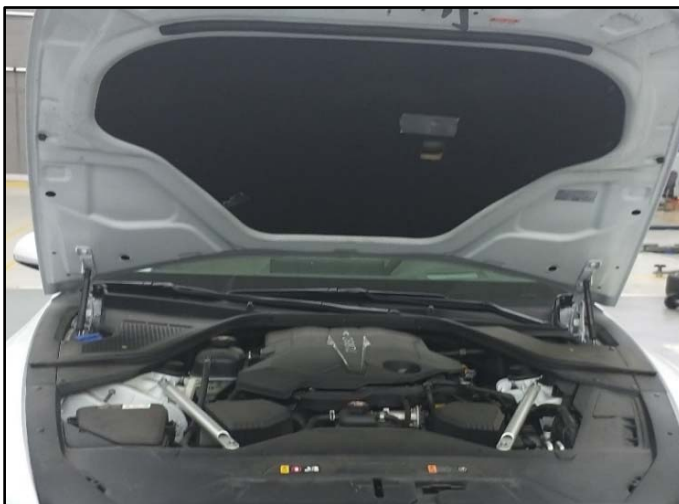
1. Open the hood of the vehicle.

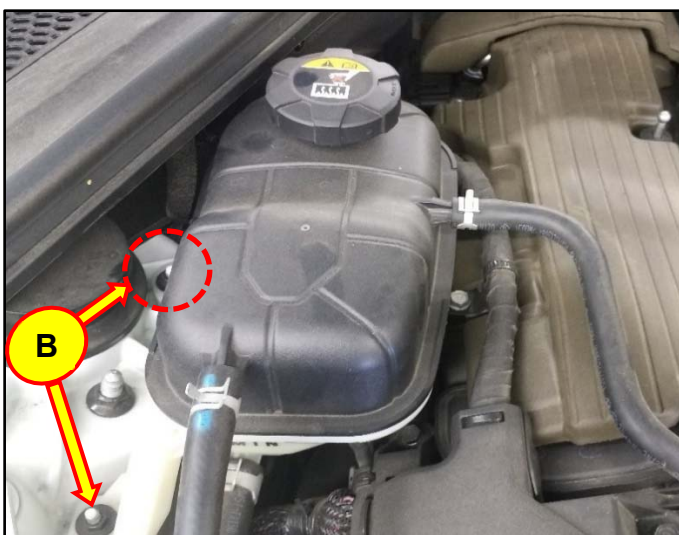
3. Loosen the radiator reservoir tank fixing nuts (B).

Tightening Torque:
7.23 lb-ft (9.8 Nm)

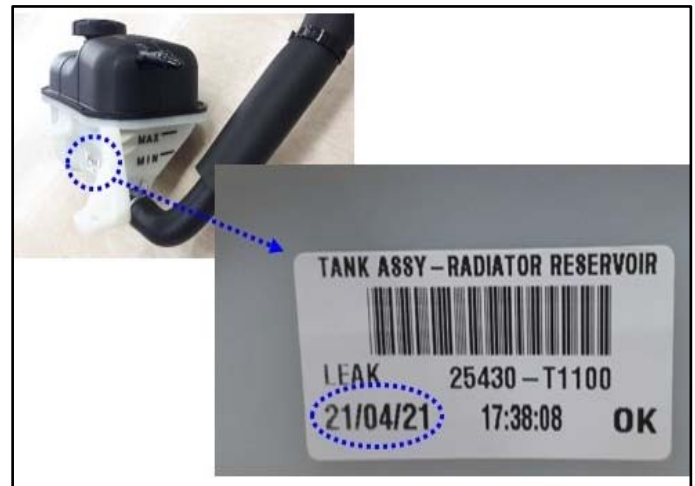
5. Check the LOT number of the label (D) on the side of the reservoir tank.

NOTE: *The date code follows the Day/Month/Year format.*

- **Replace** the reservoir tank if LOT number is on or within any of the following affected date code ranges (such as the example label picture shown on right):
 - **12/01/21 to 20/01/21**OR
 - **21/04/21 to 30/12/21**
- If it is not possible to clearly identify the date code on the label, replace the radiator reservoir tank following the procedure on page 4.
- If it is outside any of the affected date code ranges, then the inspection is complete. **DO NOT** replace.

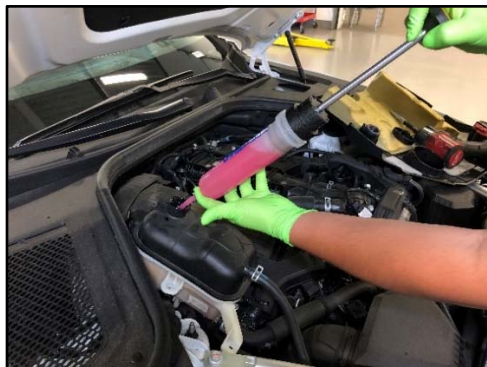
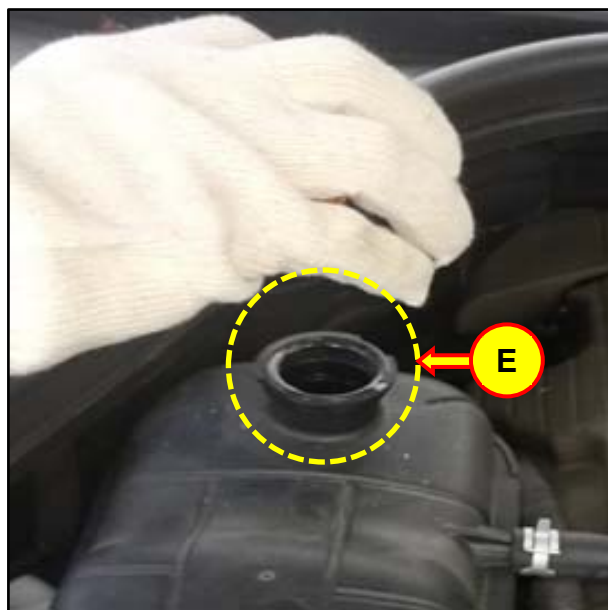
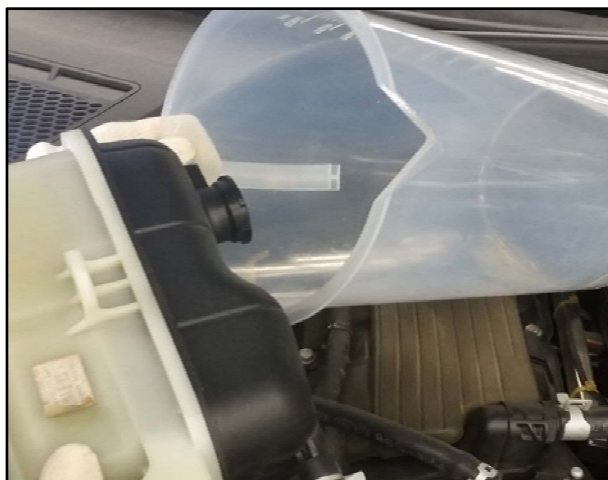
1. Open the radiator reservoir tank cap (E).

2. Pour (or suction out as shown below) the coolant from the reservoir tank into a clean container.

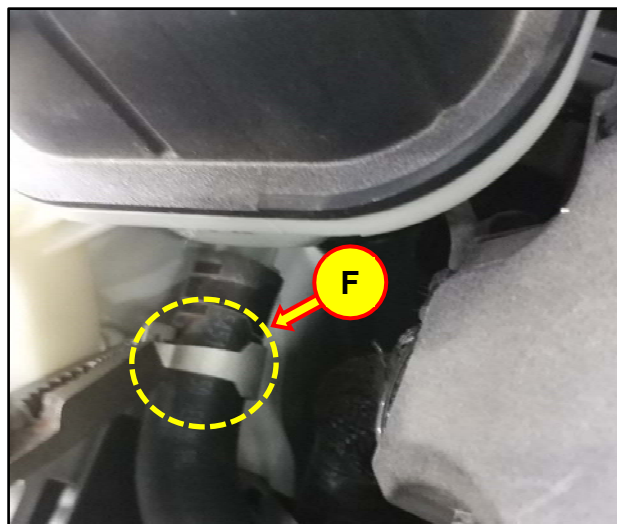
3. Remove the hose clamps (F) connected to the reservoir tank.

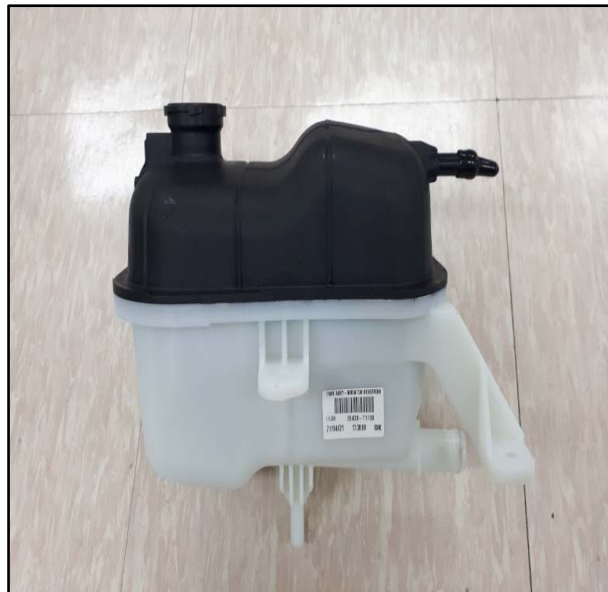
4. Remove the reservoir tank and replace it with a new radiator reservoir tank.

In the process of removal, be sure to contain any coolant spillage with shop towels as much as possible.

Wipe off the remaining coolant residue completely after installing the new reservoir tank.

5. After reservoir replacement,
 - Install parts in reverse order of removal.
 - Refill the coolant to the MAX level.
6. The service procedure is now complete.
