Technical product information

Topic	Bentayga, Mulsanne and New Flying Spur - Rear Entertainment Tablet - Battery Replacement
Market area	Russische Föderation (5RU),Australia E04 Bentley rest Asia and Australia (6E04),China 796 VW Import Comp. Ltd (Vico), Beijing (6796),Germany E02 Bentley rest Europe (6E02),Japan E03 Bentley Japan (6E03),Korea, (South) E08 Bentley South Korea (6E08),United Arab Emirates E06 Bentley Middle East and Africa (6E06),United Kingdom E01 Bentley UK (6E01),United States E05 Bentley USA and rest America (6E05)
Brand	Bentley
Transaction No.	2067538/1
Level	EH
Status	Approval
Release date

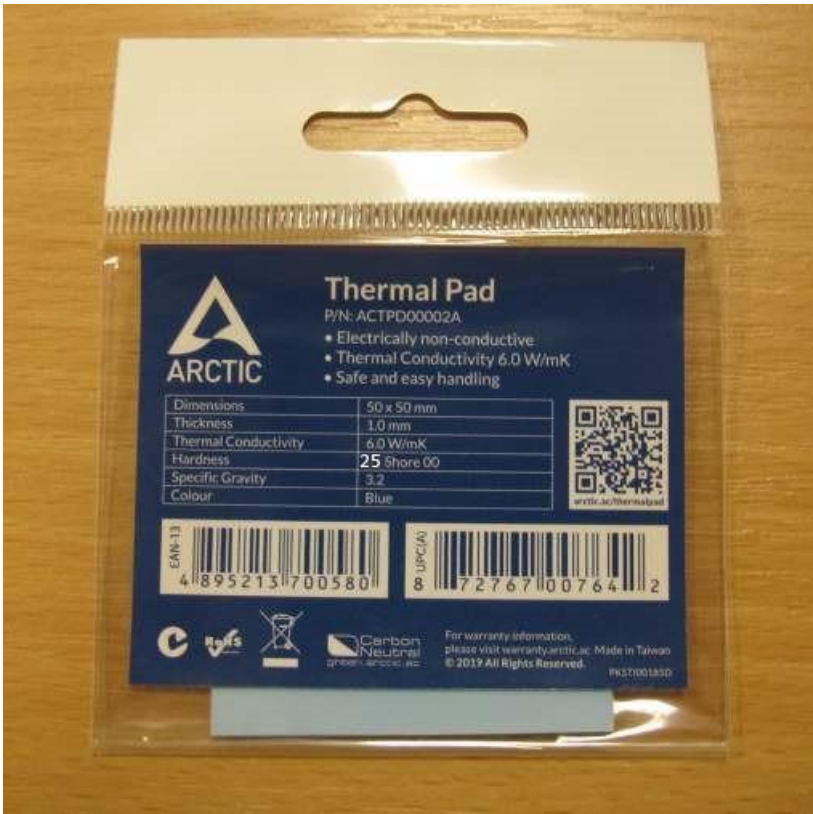
Dimensions (mm)	50 x 50 mm
Thickness (mm)	1 mm
Thermal Conductivity (W/mK)	6 W/mK
Hardness (Shore)	25 Shore 00
Specific Gravity	3.2

Note: It is critical that the specification of the Thermally Conductive Pad is correct, DO NOT use a Thermally Conductive Pad that has any deviation from the specification above. It is permissible to cut down a larger Thermally Conductive Pad to achieve the 50 x 50mm dimension, providing all other specifications are correct.

The Thermally Conductive Pad is “one time use”, and should be replaced every time the Tablet casing is opened.

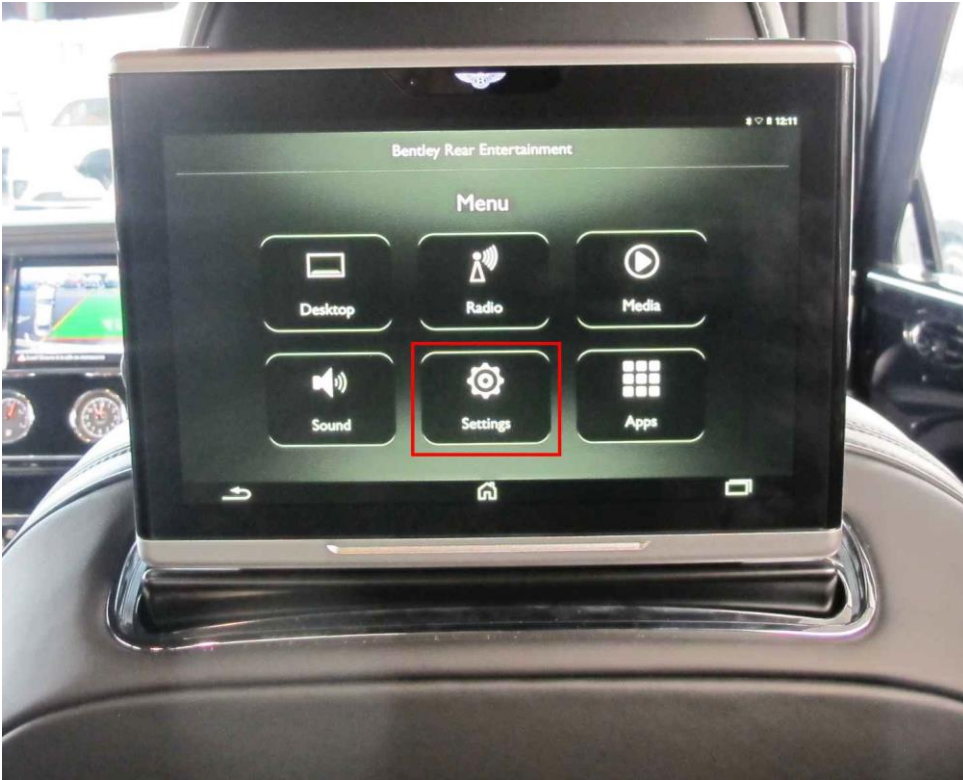
Figure 1.

- From the Rear Entertainment “Menu” screen select “Settings” – figure 1.

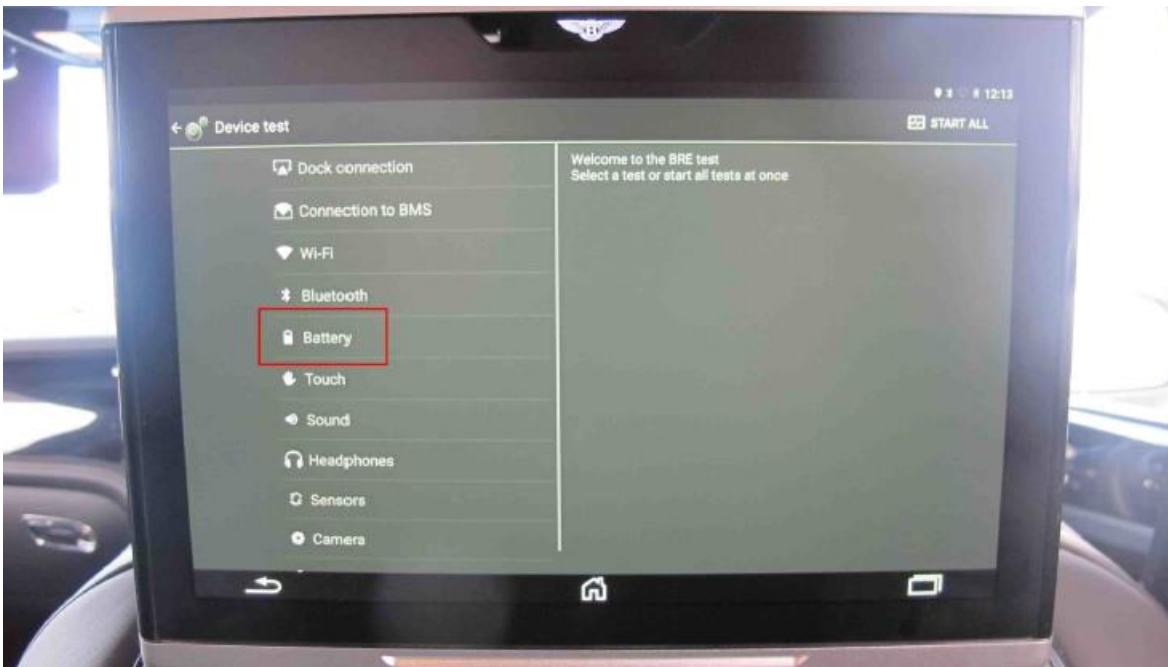
Figure 3.

- Select "Battery" –figure 3.

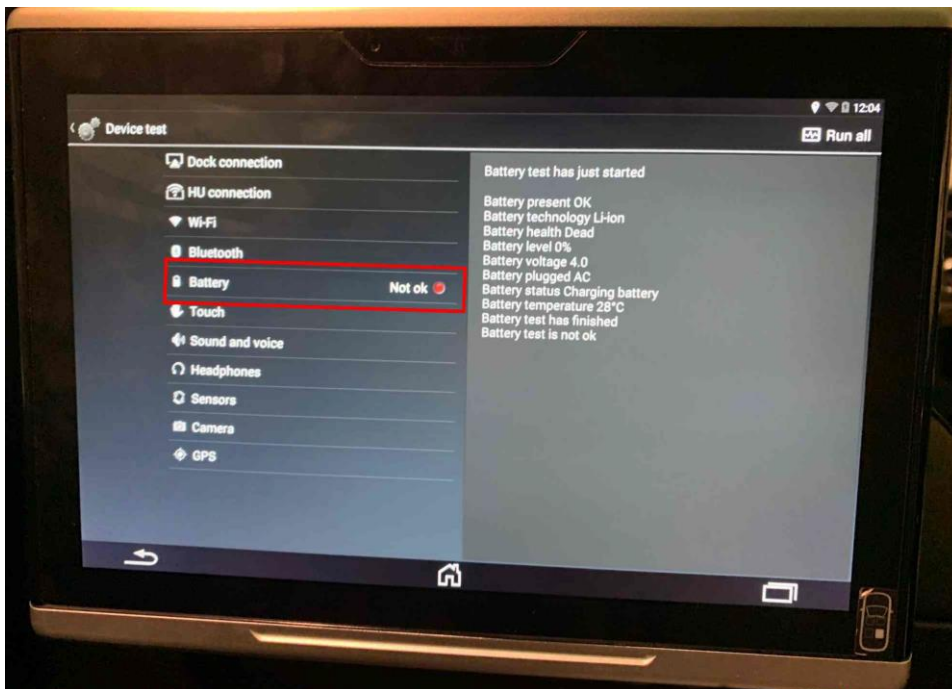
Figure 4.

The test result will show either “OK” and a green indication or “Not ok” and a red indication, the Rear Entertainment Tablet internal battery pack should only be replaced if the test result is “Not ok” – figure 4.

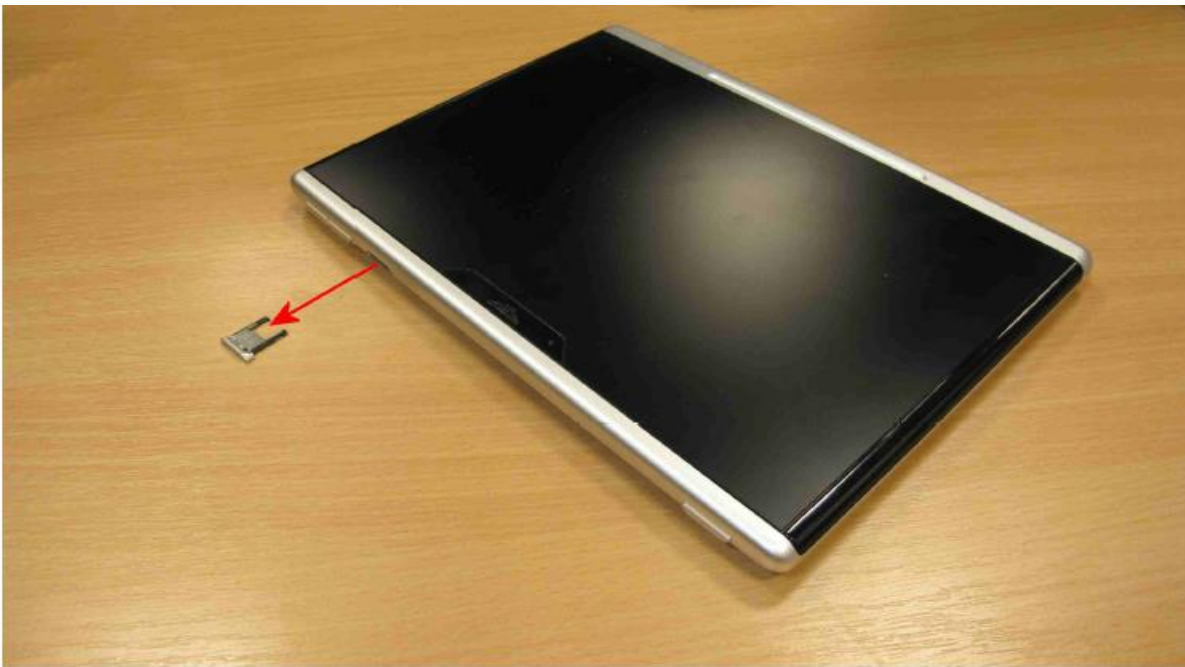
Figure 5.

- Ensure the work surface to be used is clean and has a soft surface to prevent damage to the Tablet screen and casing.
- Remove the SIM card holder from the Tablet – figure 5.

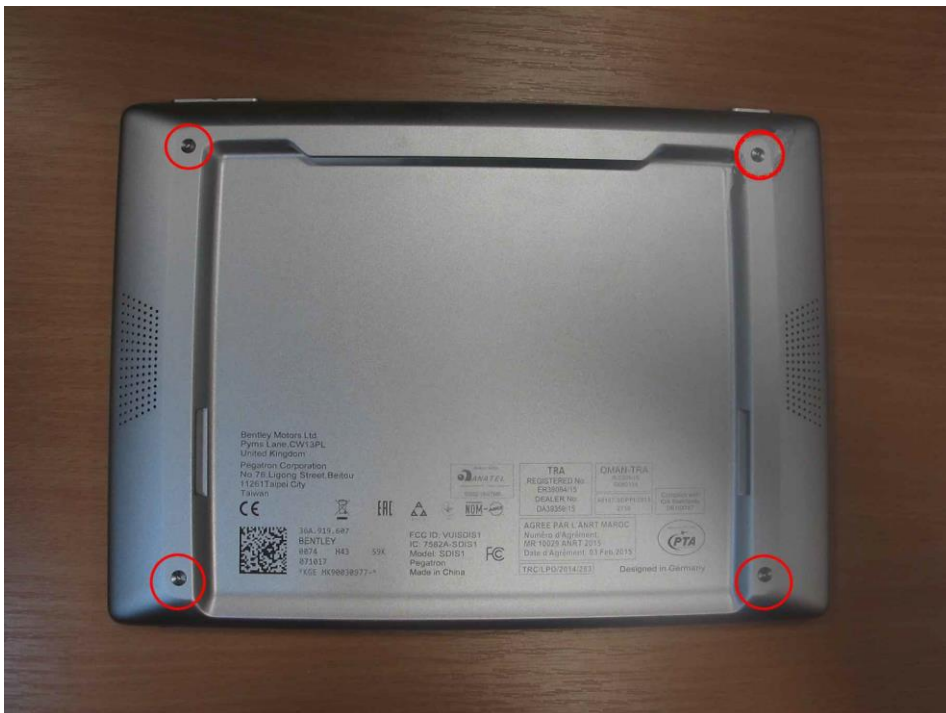
Figure 6.

- Remove the four T6 Torx head screws from the rear of the Tablet – figure 6.

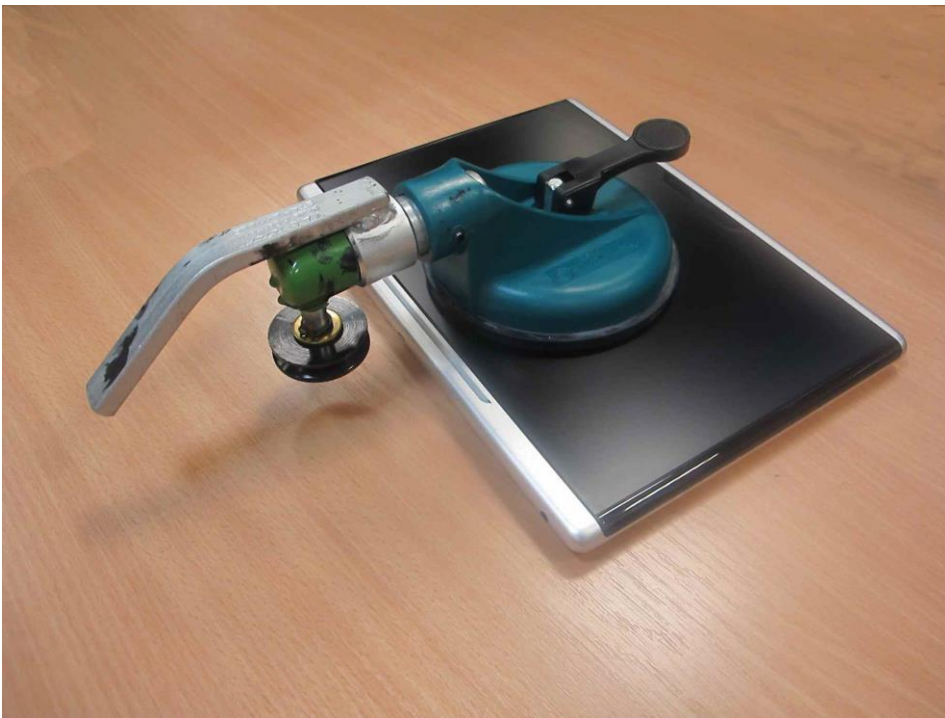
Figure 7.

- Attach a suction device tool of approximately 100mm diameter to the Tablet screen – figure 7.

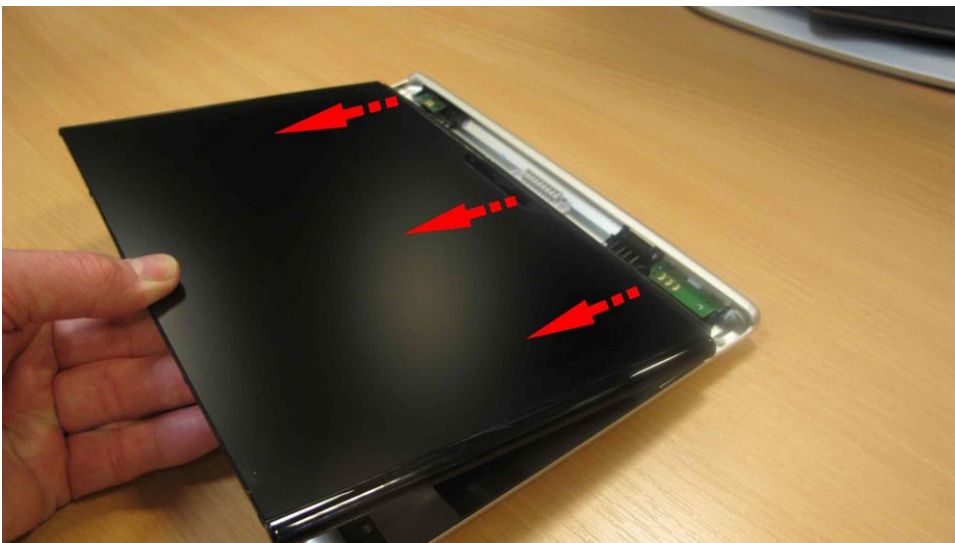
Figure 10.

- Slide the screen free from the casing – figure 10.

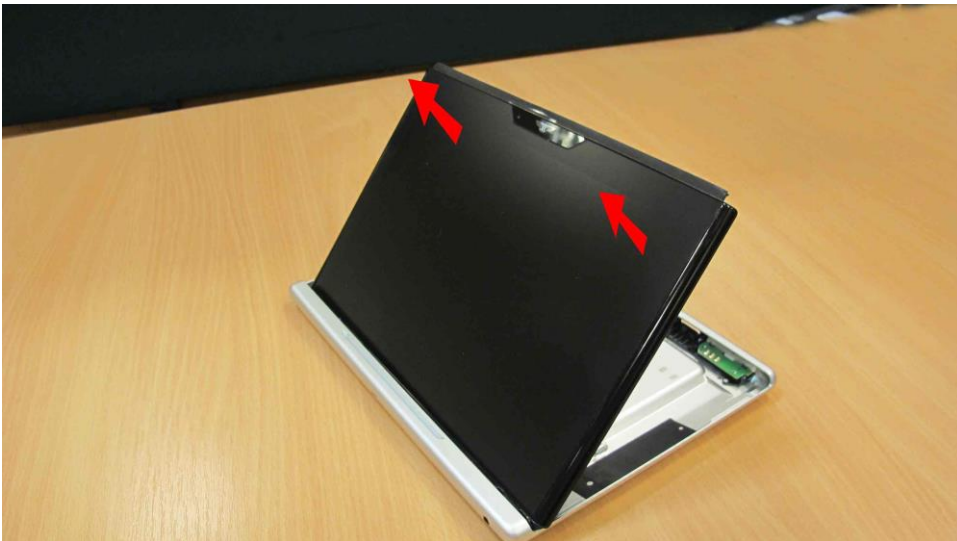
Figure 11.

- Lift the top edge of the screen, continue to “open” the assembly – figure 11.

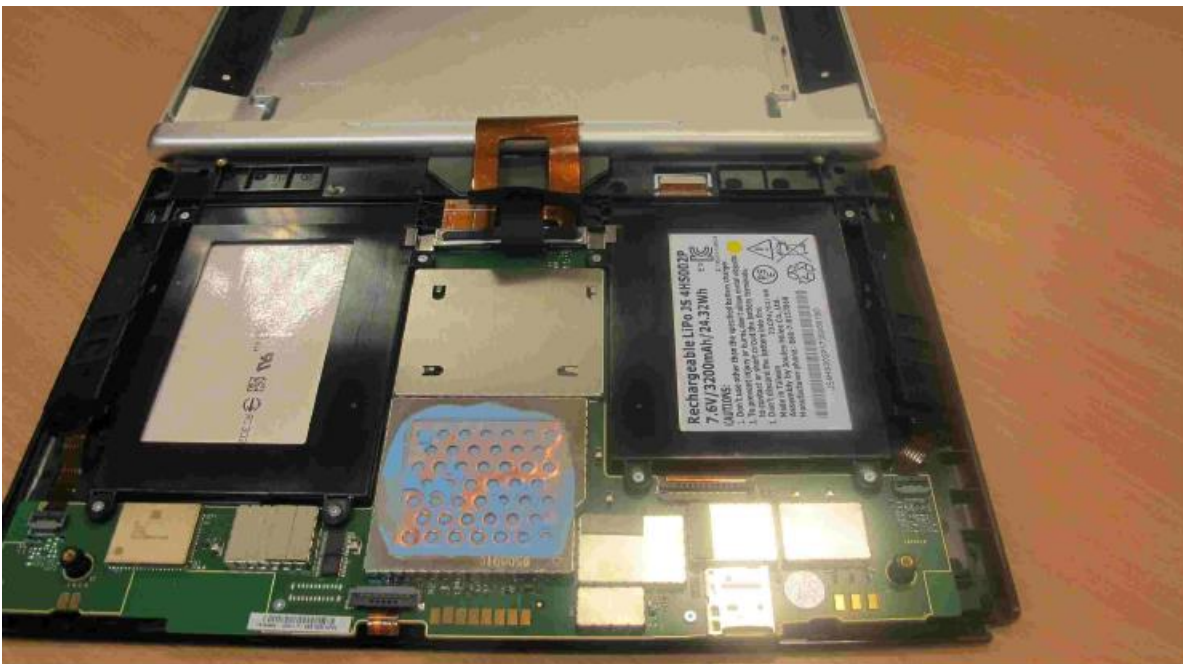
Figure 12.

- Place the screen face down – figure 12.

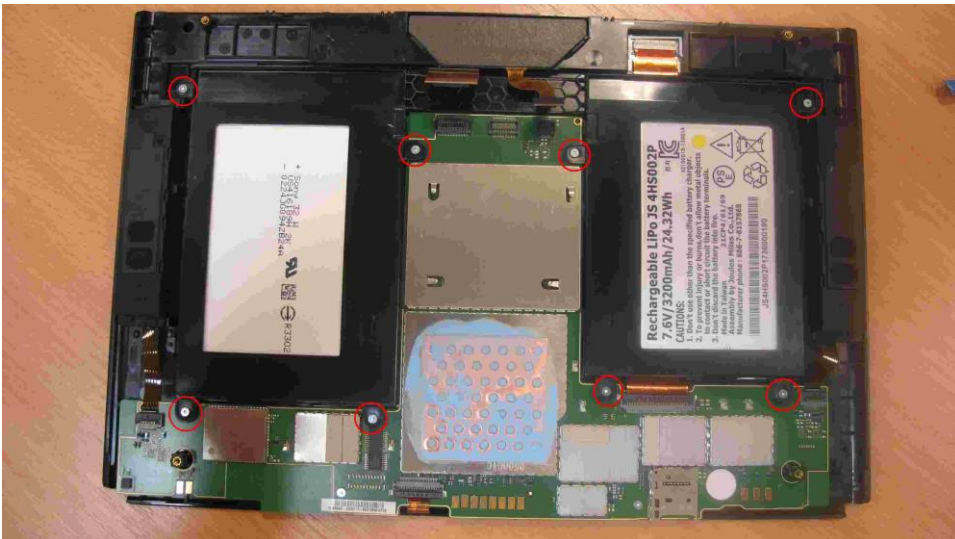
Figure 16.

- Remove the eight T3 Torx head screws securing the battery pack, discard the battery pack in accordance with local regulations – figure 16.
