**NUMBER:** 23-039-15

Driver Door Glass Moves Slow And/Or Binds

2012 - 2015 (MK74) Jeep Patriot

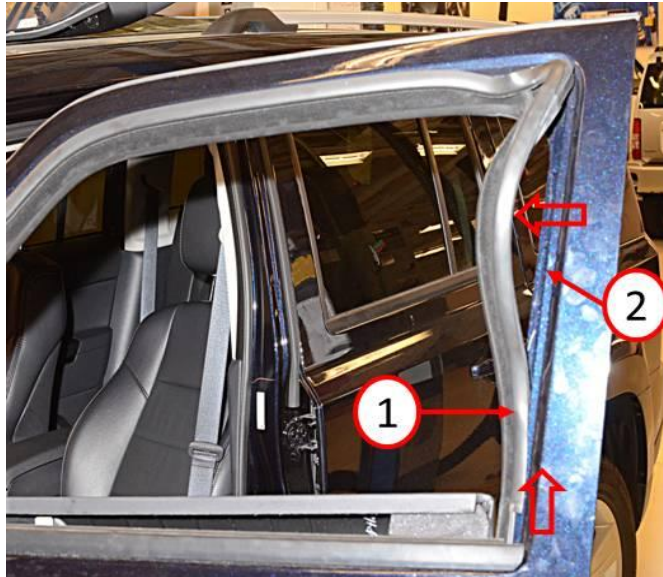
**Fig. 1 Weatherstrip Removal**

- 1 - Weatherstrip Run  
2 - Door Channel
-

1. Remove the driver door glass and door module. Refer to the detailed procedures available in DealerConnect>TechCONNECT> under: Service Info> 23-Body> Door - Front> GLASS, Door> Removal.
2. Replace the driver door glass weatherstrip run. Pull weatherstrip run (1) out of metal door channel (2) at the B-pillar side of the door by pulling inward and up on the weatherstrip (Fig. 1).
