Technical product information

Topic	High pitched whistle from the engine - Warning light within the DIP - Engine not running smoothly - Numerous DTC's
Market area	Bentley; worldwide (2WBE)
Brand	Bentley
Transaction No.	2059379/2
Level	EH
Status	Approval
Release date

High pitched whistle from the engine - Warning light within the DIP - Engine not running smoothly - Numerous DTC's

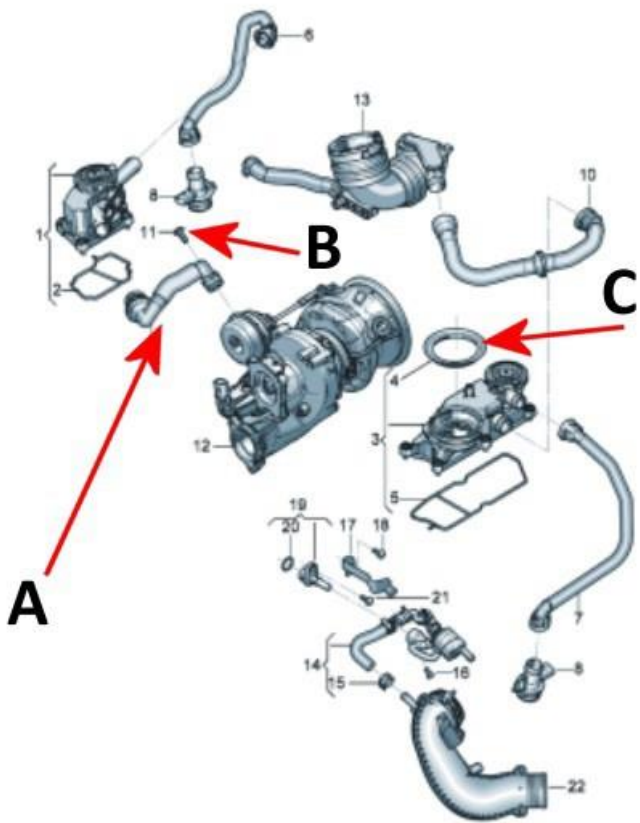
Air intake leak due to a broken one-way diaphragm valve from within the Bank 1 breather line

2) Referring to Figure 2 - Replace the Bank 1 breather line (Point A) and fixing (Point B) – Refer to applicable sections from Rep.Gr 10 - Oil mist separator bank 1 - To remove and fit

- Replace the oil filler pipe seal to the Bank 2 oil separator (Point C)
