**SUBJECT:** **Customer Satisfaction Program 22N02 – Supplement #1**  
 Certain 2015-2019 Model Year Edge and Lincoln MKX Vehicles and 2013-2018  
 Model Year Fusion and Lincoln MKZ Vehicles  
 Front Brake Flexible Hose Replacement

## CERTAIN 2015-2019 MODEL YEAR EDGE AND LINCOLN MKX VEHICLES AND 2013-2018 MODEL YEAR FUSION AND LINCOLN MKZ VEHICLES — FRONT BRAKE FLEXIBLE HOSE REPLACEMENT

### SERVICE PROCEDURE

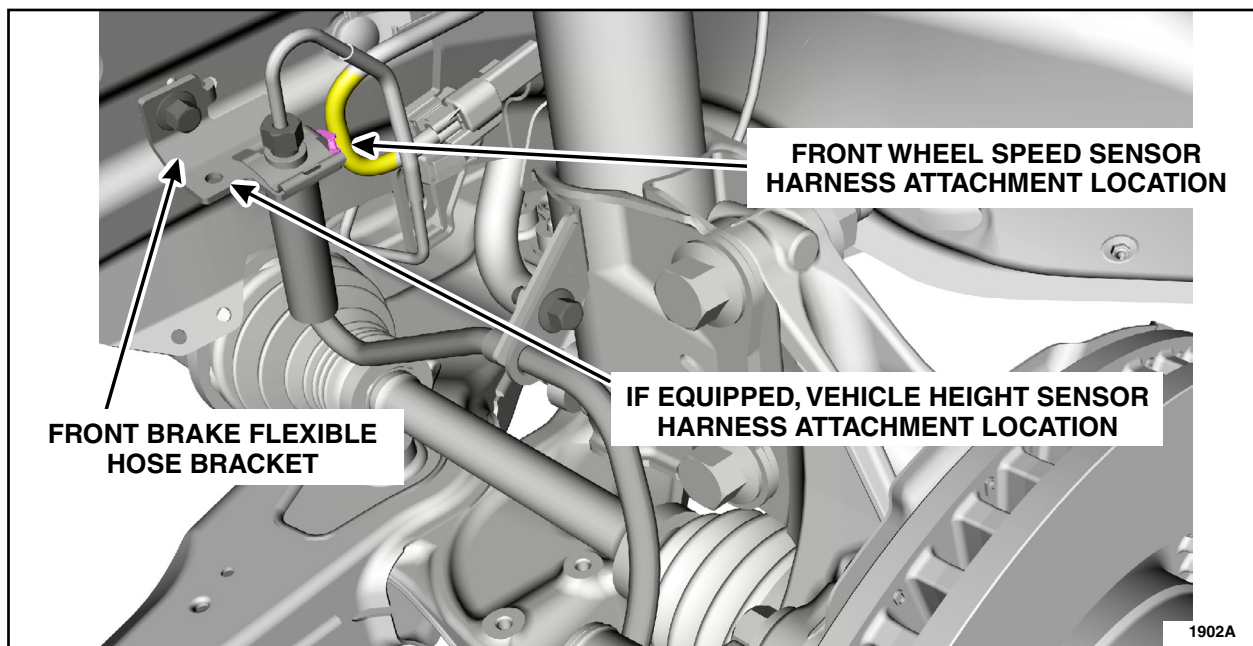
FIGURE 1

**NOTE:** The wheel speed sensor wiring harness and if equipped, the front suspension height sensor wiring harness attach to the front brake flexible hose bracket. Ensure the harness retainer(s) are reinstalled into their original positions. See Figure 1.

**NOTE:** LH side shown, RH side similar.

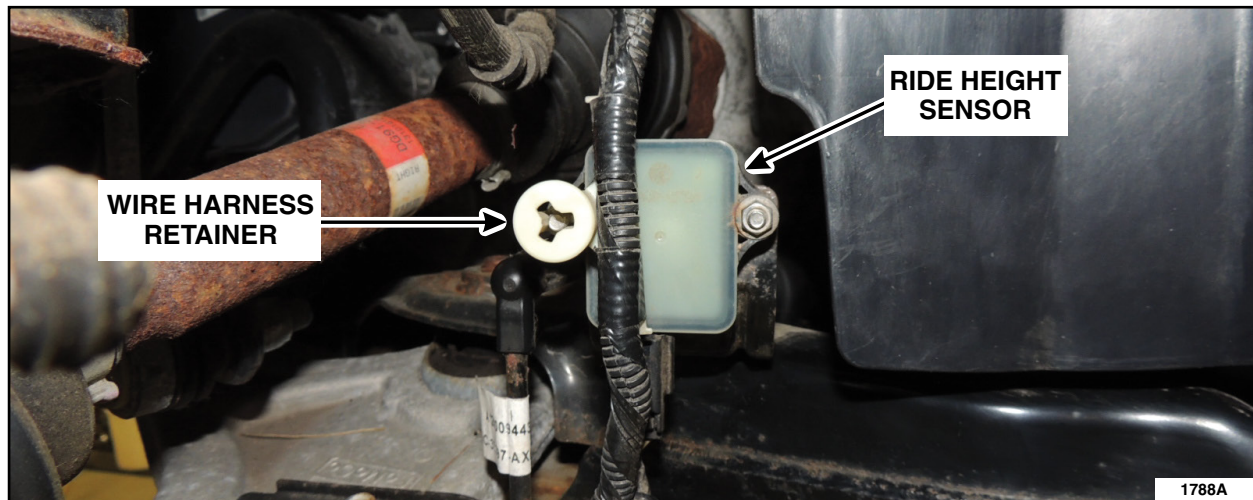
**FIGURE 1**

1. Remove the wire harness retainer from the ride height sensor stud on the RH and LH sides of the vehicle. See Figure 1.

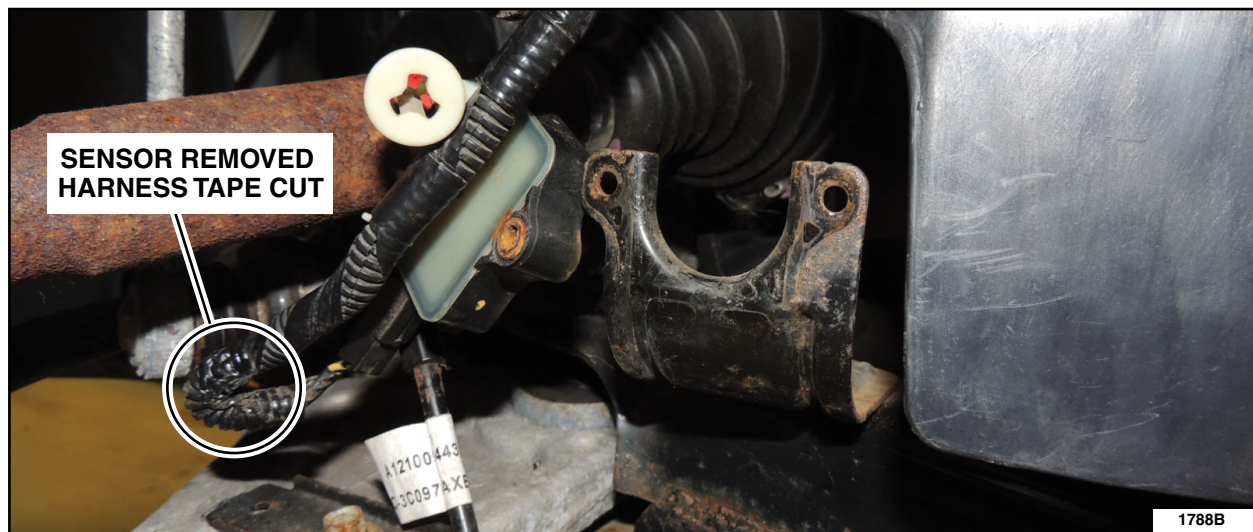
**FIGURE 2**

2. Remove the nuts and bolts from the RH and LH ride height sensors and position aside. See Figure 2.

3. Cut the RH and LH ride height sensors harness tape at the harness bend. See Figure 2.

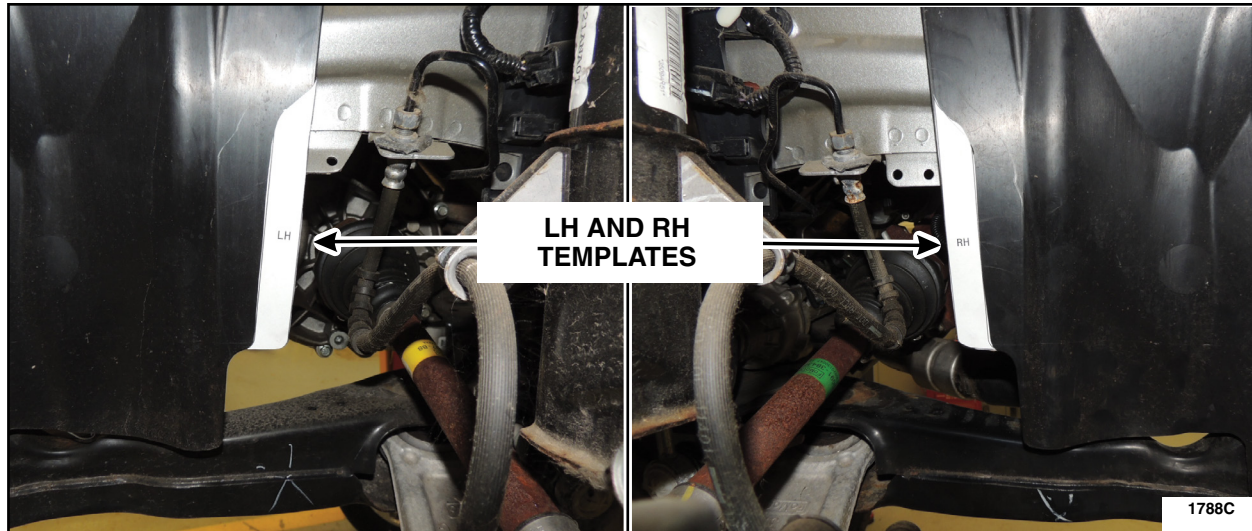
**FIGURE 3**

4. Attach the cut out templates (See Attachment IV) to the RH and LH front fender splash shields. Using a suitable cutting tool, cut the front fender splash shields at the locations shown. See Figure 3.

**NOTE:** The front fender splash shields should remain on the vehicle during cutting.

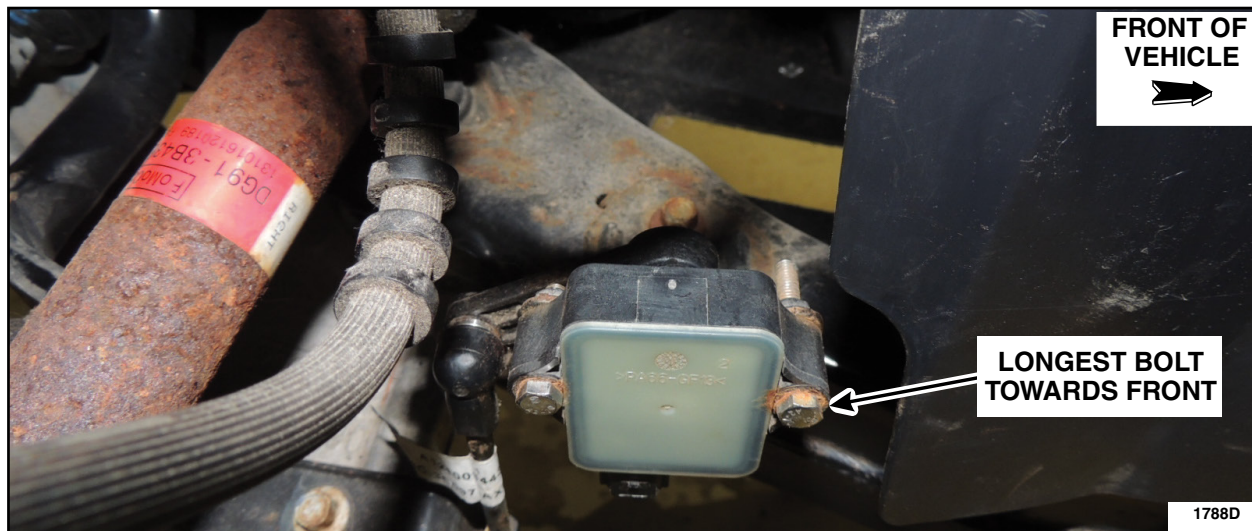
**FIGURE 4**

5. Position the RH and LH front ride height sensors back onto the brackets and install the nuts and bolts with the long bolt in the front bracket hole. See Figure 4.

- Tighten bolts to 7 lb.ft (9 Nm).

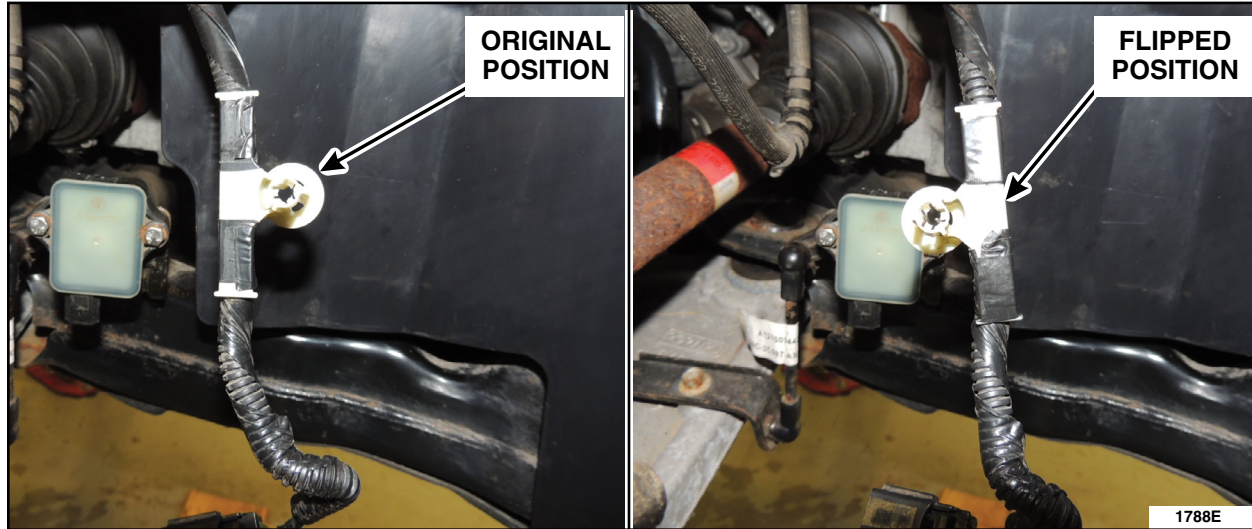
**FIGURE 5**

6. Mark the location of the RH and LH clip on the ride height sensors wire harness. See Figure 5.
7. Remove the tape and clip from the RH and LH ride height sensors wire harness. Rotate the clips 180 degrees and reinstall onto the ride height sensors wire harness with electrical tape. See Figure 5.

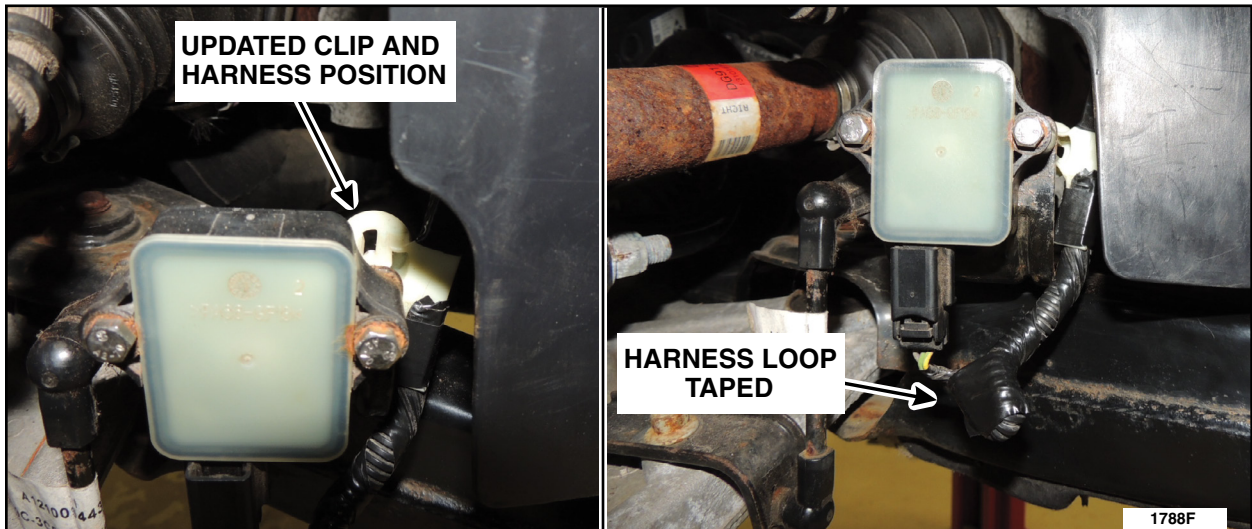
**FIGURE 6**

8. Attach the RH and LH ride height sensors wire harness clips to the front bracket bolt (long bolt) and secure the harness loop using electrical tape. See Figure 6.

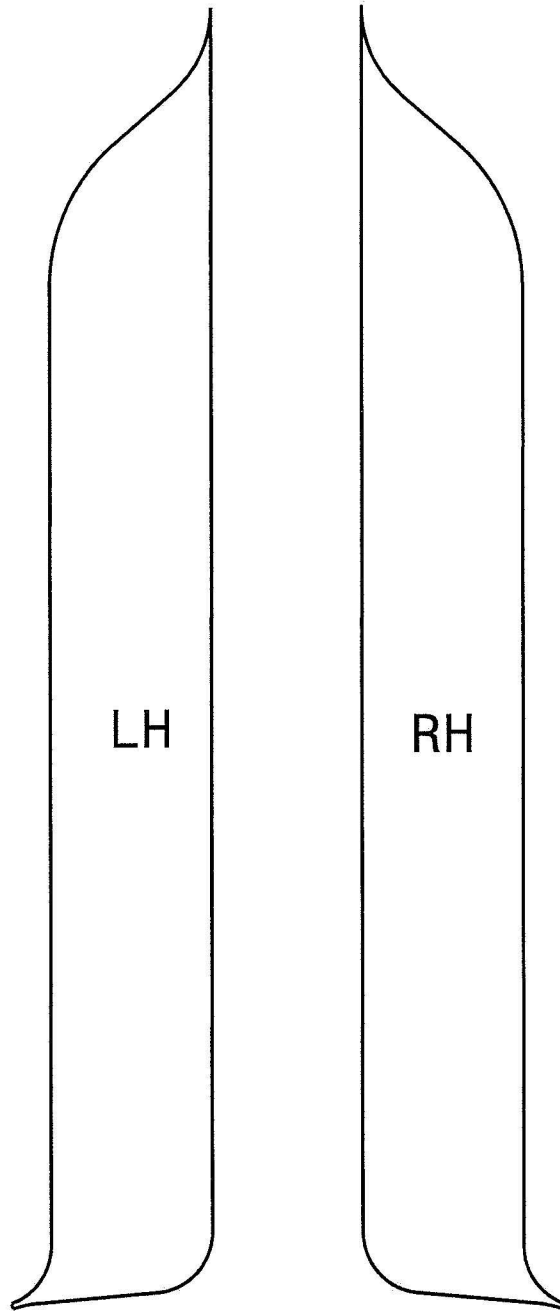
### Front Fender Splash Shield Templates

Print on 8.5" x 11" paper in portrait orientation only
