# FSB 431-010, Range Synchronizer, Repair

(October 2017)

This procedure is to repair mDrive transmissions in the field that exhibit a grinding noise when the transmission range shifts (for example: between 6th and 7th gear) built between 01/01/2013 and 08/18/2014.

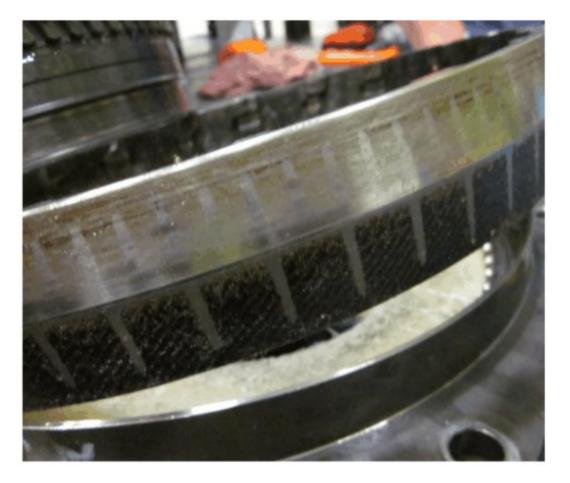
#### **Failed Parts**

The synchronizer ring is missing the high range friction material and the low range side is wearing away.

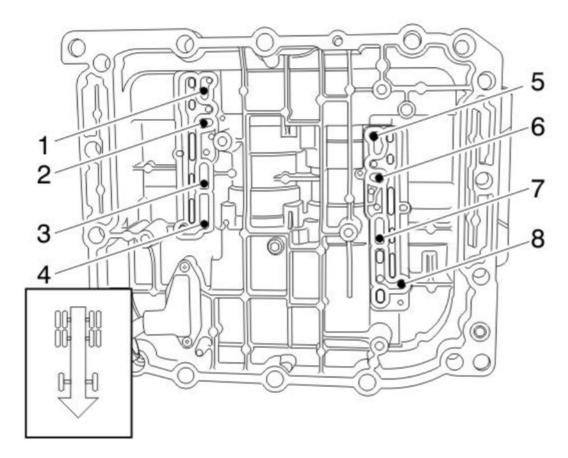
#### Over Drive Transmission

Note: For over drive transmissions, the transmission must be positioned as follows:

- \* Low Split
- \* High Range
- \* 2nd/3rd Neutral Position
- \* 1st/Reverse Reverse Position

- 1 High Range
- 2 3rd Gear
- 3 Low Range
- 4 2nd Gear
- 5 1st Gear
- 6 High Split
- 7 Reverse Gear
- 8 Low Split

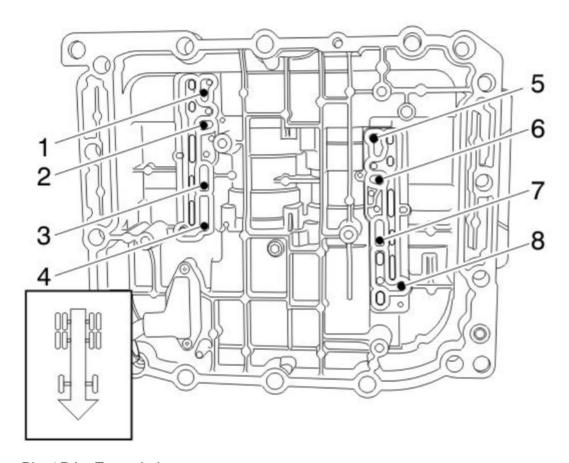
#### **Direct Drive Transmission**

Note: For direct drive transmissions, the transmission must be positioned as follows:

- \* High Split
- \* High Range
- \* 2nd/3rd Neutral Position
- \* 1st/Reverse Reverse Position

- 1 High Range
- 2 3rd Gear
- 3 Low Range
- 4 2nd Gear
- 5 1st Gear
- 6 Low Split
- 7 Reverse Gear
- 8 High Split

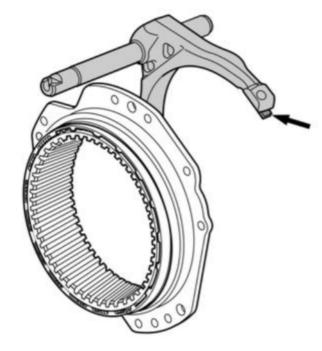
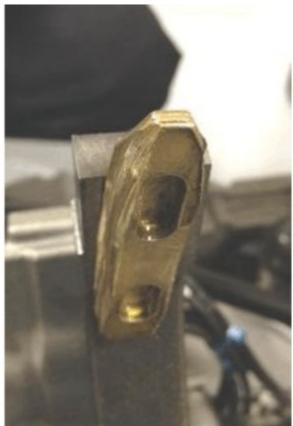
. Remove the selector fork. Check the brass shifter pads. If the brass shifter pads are damaged or worn, replace the fork. Tighten the set screws to  $75 \pm 7$  Nm ( $55 \pm 5$  lb-ft) and stake set screws.

The fork should be replaced if there is this type of damage.

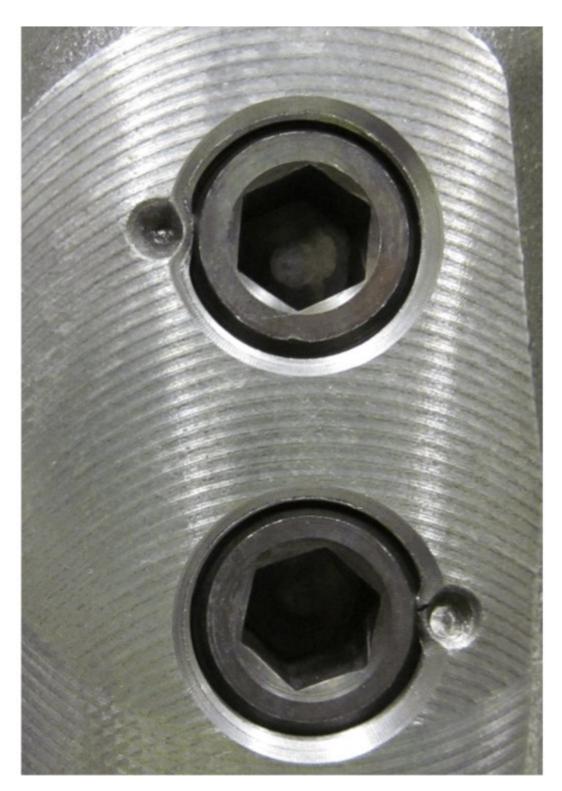
Note: After staking, set screws are one time use only.

Properly Staked Set Screws
. Remove the oil return pipe.

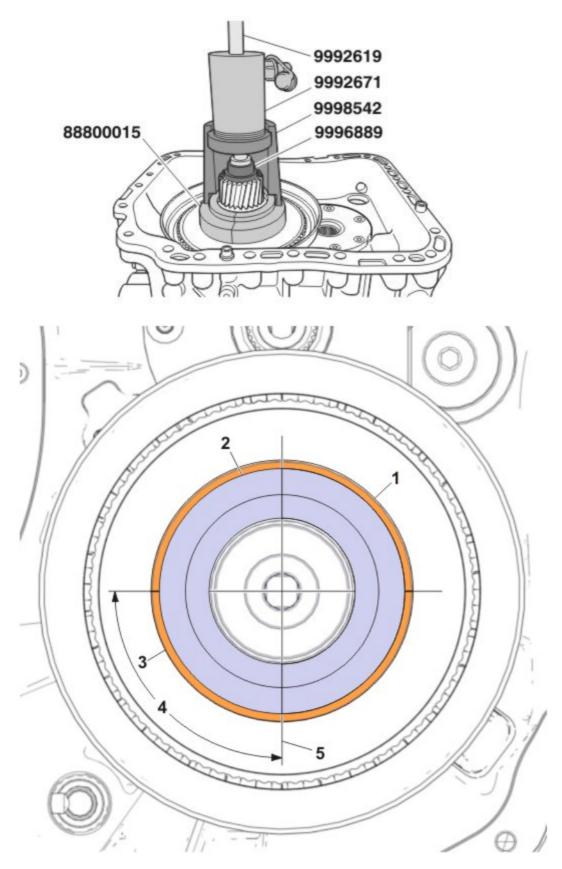
Note: Check that the divide in the puller rings is at 90° to the divide in the puller.

- 1.88800015
- 2. Puller Ring
- 3.9998542
- 4. 90° Position for Tool
- 5. Tool Set on Puller Ring

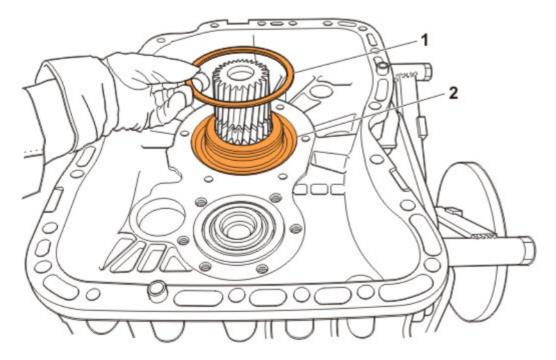
- 1. Shim
- 2. Spacer

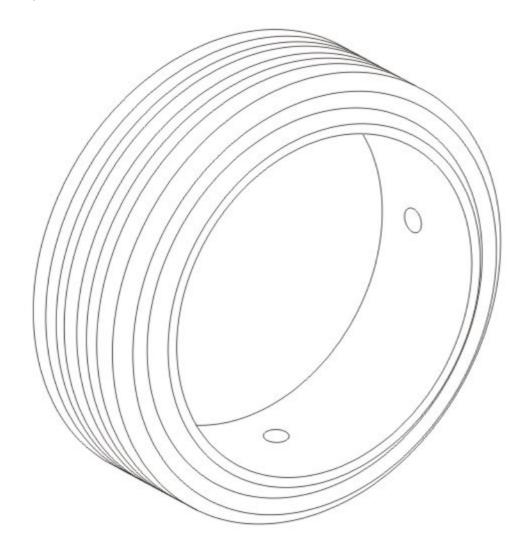
# Spacer

- . Remove the spacer with a suitable tool and replace with the spacer included in the kit.
- . Reinstall the shim and the rear cover. Tighten fasteners to 48  $\pm 5$  Nm (35  $\pm 4$  ft-lb).
- . Press in a new high range engaging ring.

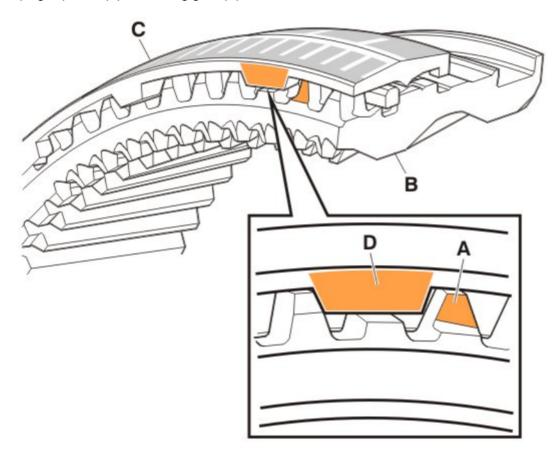
. To ensure correct operation, it is important that wide tooth (D) on the synchronizing ring (C) line up with a chamfered (angled) tooth (A) on the ring gear (B) as illustrated below.

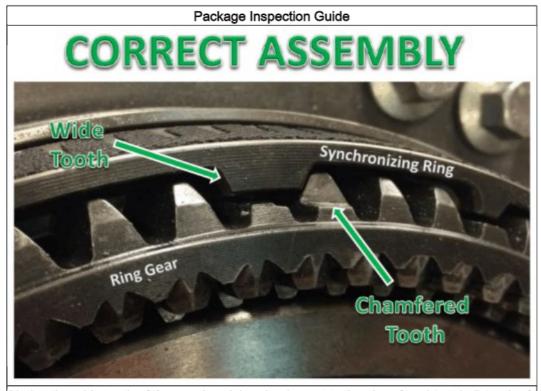
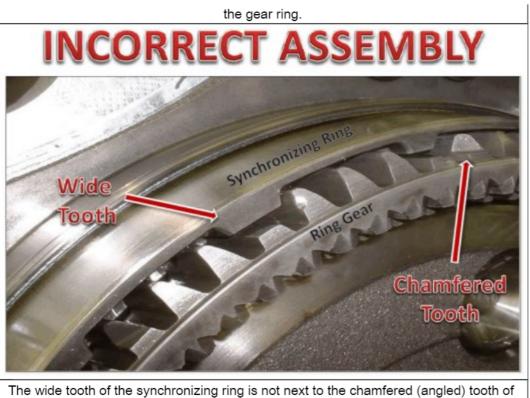
. Use the inspection guide in the figure below to ensure proper assembly before installation of the package into the range housing.

Note: Improper assembly of these components will cause gear clash on range downshifts.

Notice the wide tooth of the synchronizing ring is next to the chamfered (angled) tooth of

the ring gear.

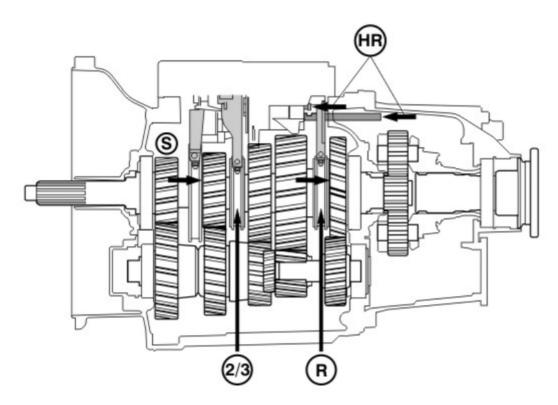
Figure 1

. Ensure that the split engaging ring is in its rear most position. Ensure that the 2nd/3rd engaging ring is in neutral or middle position and that the reverse gear engaging ring is in its rear most position (Figure 1). Also ensure that the range gear is in high range (Figure 2).

HR - High Range

S - Split

2/3 – 2nd/3rd gear in neutral

R - Reverse gear
