Staining/surface damage on door trim strips and side window trim element

Topic number	LI72.00-P-075481
Version	1
Function group	72.00 - General
Date	10/24/22
Validity	MODEL 253
Reason for change	Item number for polishing agent updated

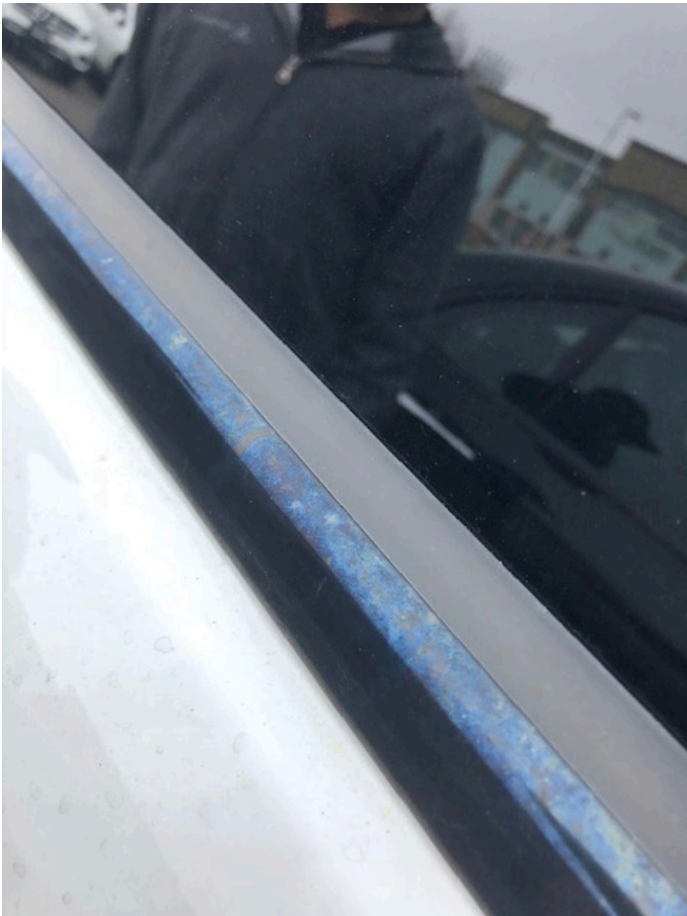
Attachments	
File	Description
Bild 3.jpg	Example of door trim bar complaint on models with code P55/P60 (Night package)

Staining on door trim strips and top and bottom trim elements on rear side windows. See example pictures 1, 2 and 3.

Damage to protective coating of door beltline trim strips, door upper trim strips and side window trim element due to strong alkaline detergent in car washes.

1. Check if the complaint cannot be rectified by polishing the trim bars with the polish.
2. If the complaint cannot be rectified, replace the door beltline trim bars, door upper trim bars and rear side window with trim element with optimized protective coating.

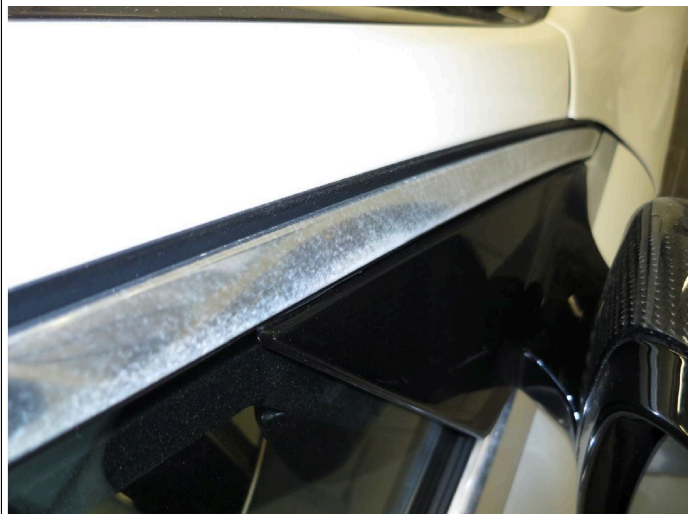
Bild 2.jpg

Example of complaint relating to door upper trim strip in silver look

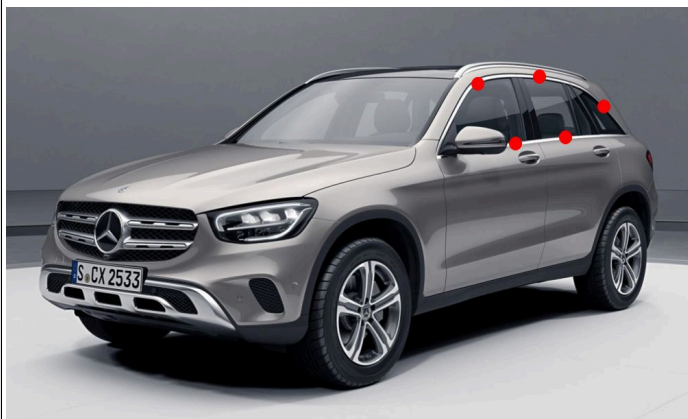
Bild 1.jpg

Overview of affected component parts
