## TECH TALK - VOLUME 270 September - October 2022

### Rattle Noise from 2nd Row Seat Back Latch -Outlander & Outlander PHEV

## Guideline for Inspection of Shock Absorber Oil Leak Complaint - All Models

## Inspection Method and Standard for Wheel Cylinder (Drum Brakes) Leakage

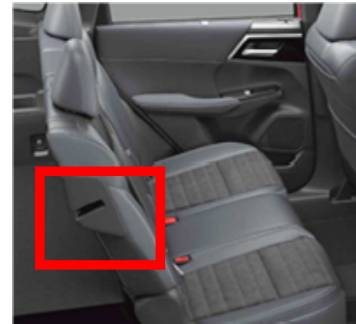
When you hear a rattle noise from 2nd row seat back of the 5 seat Outlander or Outlander PHEV, there might be a free play of seat back latch. In this case, the symptom can be improved by following the procedure below.

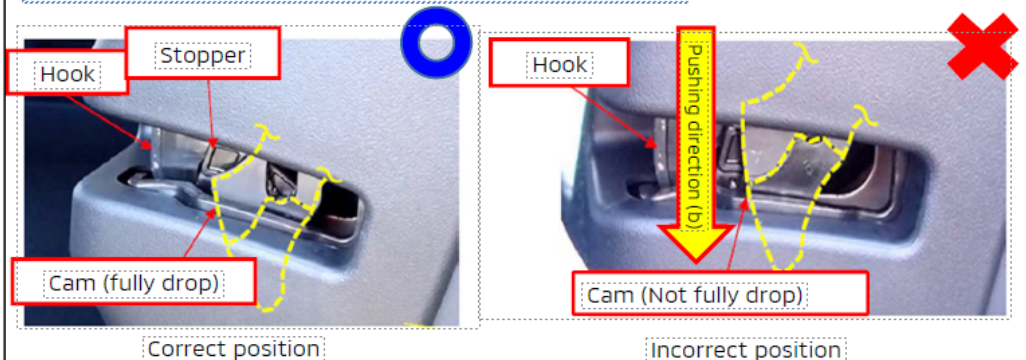
Step 2. Check if the cam fully drops into the correct position.

Step 3. If the cam does not drop into the correct position, push the cam to direction (b) using your finger until the cam fully drops.

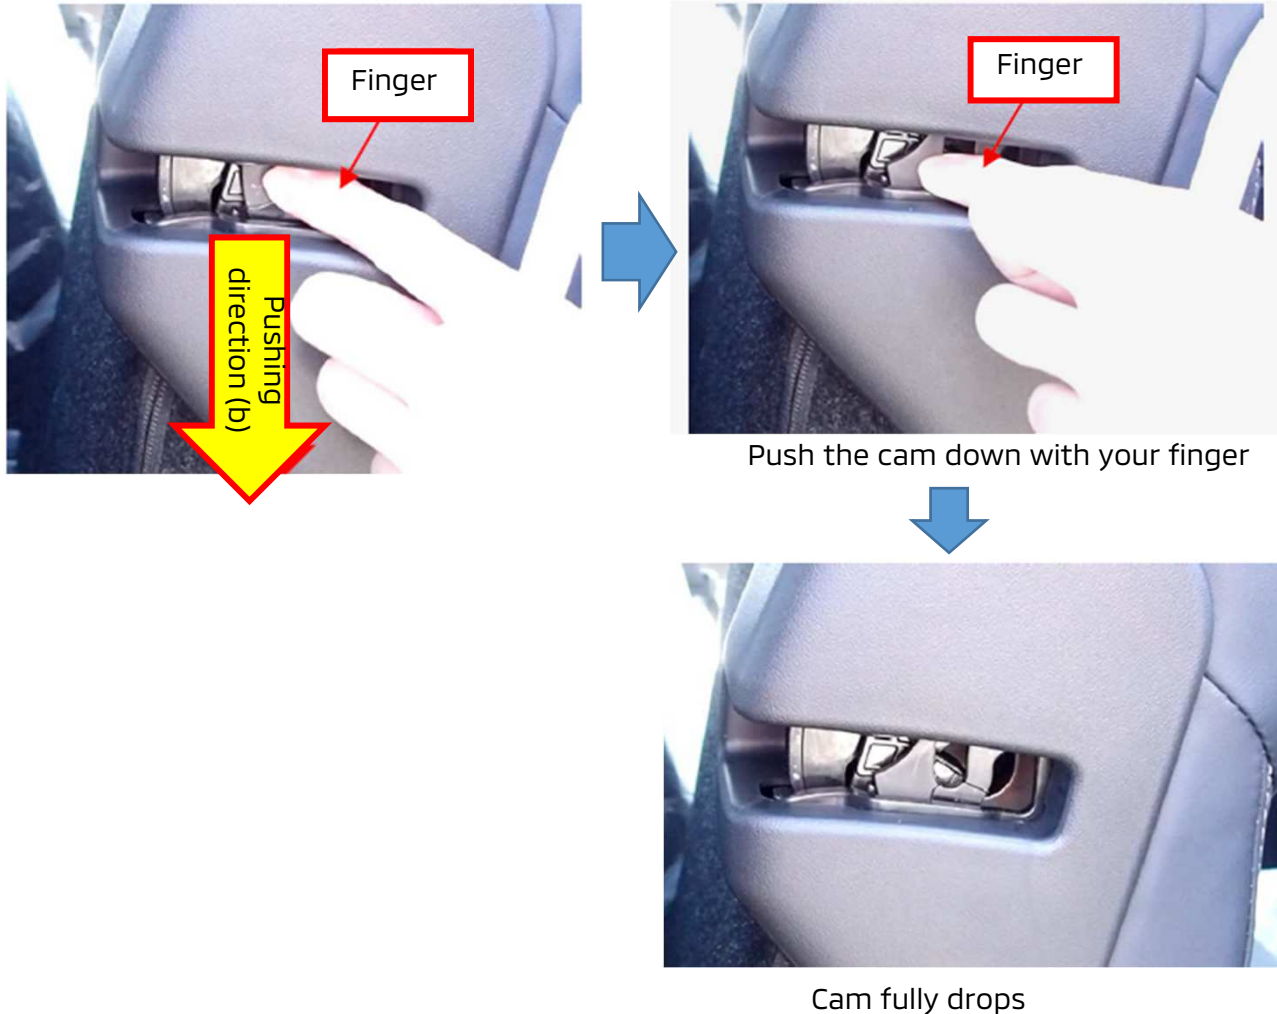
Step 4. Unlock the seat lever on the seat shoulder.

After repeating Step 1~4 approximately 10 times, check to confirm that the cam drops into the correct position by conducting Step 1 for each side of seat back latch.

When you return the seat to its initial position after finishing this procedure, do not forget to unlock the seat lever on the seat shoulder.

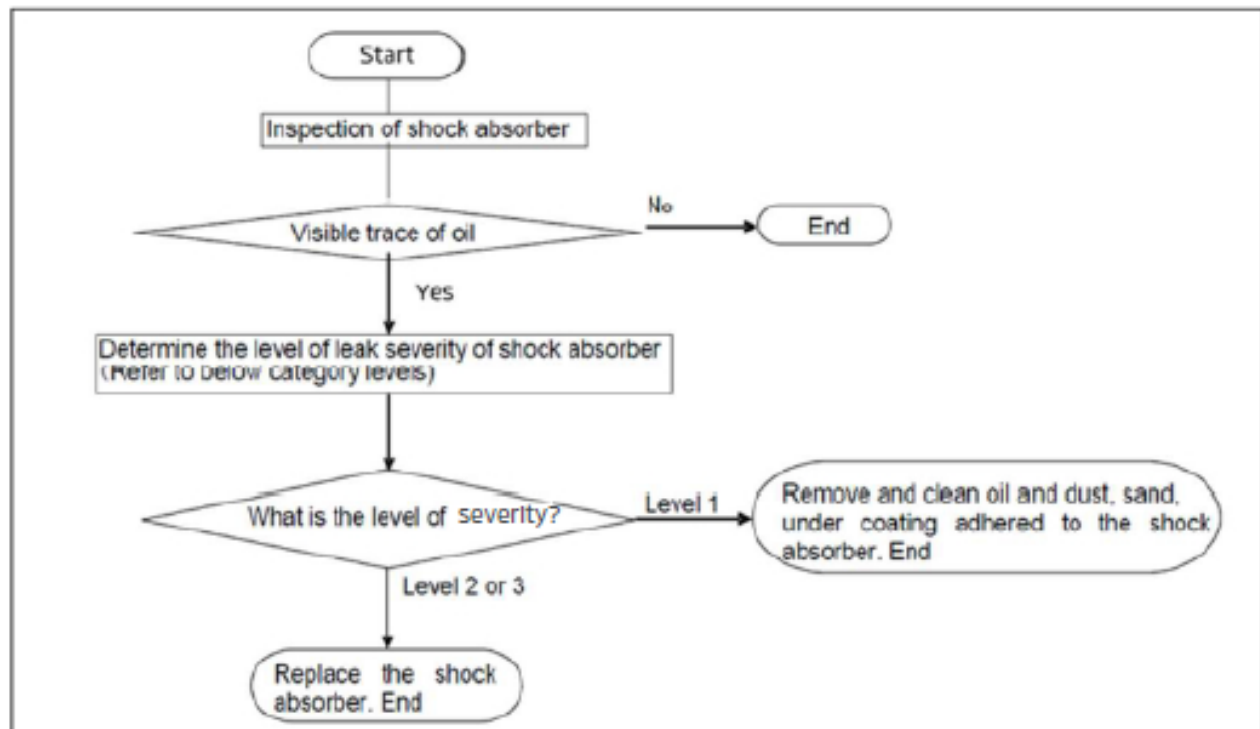
The diagnostic flowchart (below) along with guidelines will help to perform a proper shock absorber oil leak judgment. When inspecting the shock absorbers, follow the flowchart below, and determine the level of severity according to the visible oil adhesion. (See next page for the guideline of level 1, 2, 3 of oil leak severity)

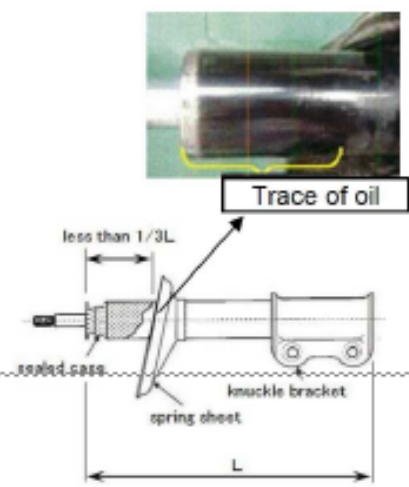
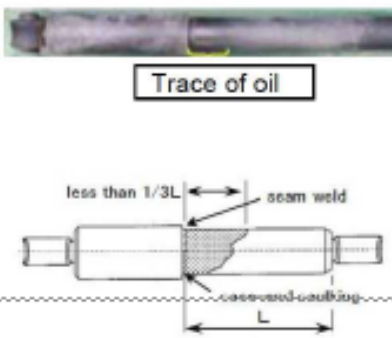
Shock absorber with spring sheet	Shock absorber without spring sheet	Remarks
Level 1, No Problem

<p>Trace of oil is less than 1/3 of case length, and generally seen all around the tube.</p> <p><b>This level of oil trace pattern is as can be expected, and does not suggest progressive oil leak.</b></p>
Level 2

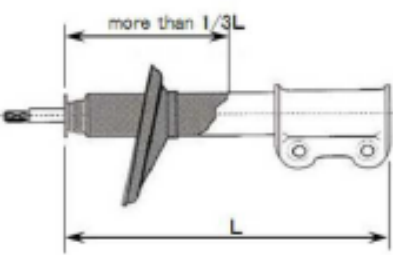
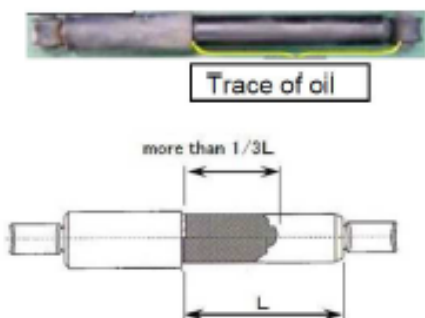
<p>Trace of oil is more than 1/3 of case length.</p> <p><b>Trace of oil of this level clearly indicating leak is progressing and the seal is faulty.</b></p>

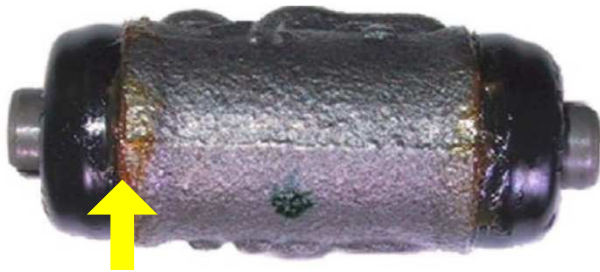
1. The normal condition is that the wheel cylinder should be "dry" and without leaks.

- Rubber Boots should be dry.
- However, in some cases there may be a presence of rust preventing grease around the mating surface between the boots and the wheel cylinder.

There may be bleeding of the rust prevention grease.

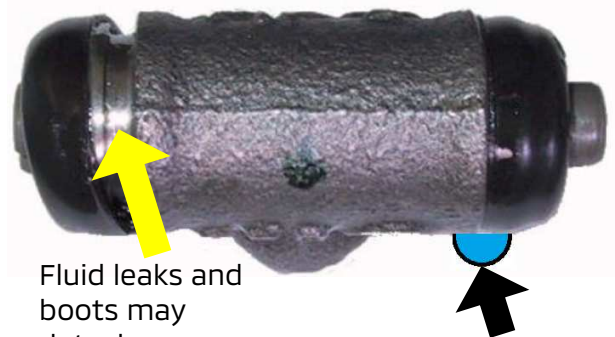
2. The wheel cylinder has leaked and needs to be replaced.

- In this case brake fluid will be present, the boots and/or wheel cylinder will be wet.
- In some cases the boots may even detach from the wheel cylinder due to brake fluid leakage.

Fluid leaks and boots may detach.

Drops of fluid will be present.

- When you flip the boots, there may be rust-preventing grease inside, this is normal and not a leak.
- If the brake fluid is leaking, there will be a large amount and the grease may also flow.
- Please refer to the maintenance manual together with this inspection procedure and replace as required.

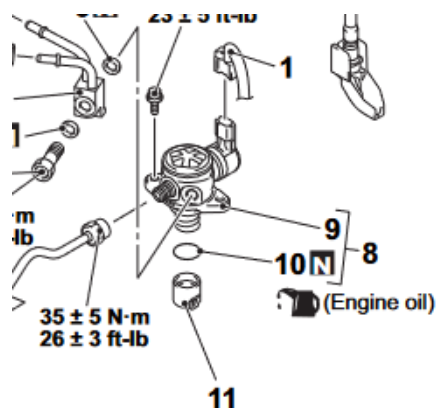
11. Fuel pump (high pressure) tappet

When replacing an engine in an Eclipse Cross with the high pressure fuel pump, be sure to move the tappet to the new engine when swapping parts from the old engine, if not removed from the old engine, the tech will get a P0087 low fuel pressure code. See attached photo.
