**87-18-08 - Air Conditioning, Cleaning of the R1234yf Refrigerant Circuit (U.S. Only)**

Release date: 11/9/2022

Debris can be dispersed throughout the refrigerant circuit after A/C component damage. In order to maintain A/C operating efficiency, it is important to flush the refrigerant circuit after A/C component repairs.

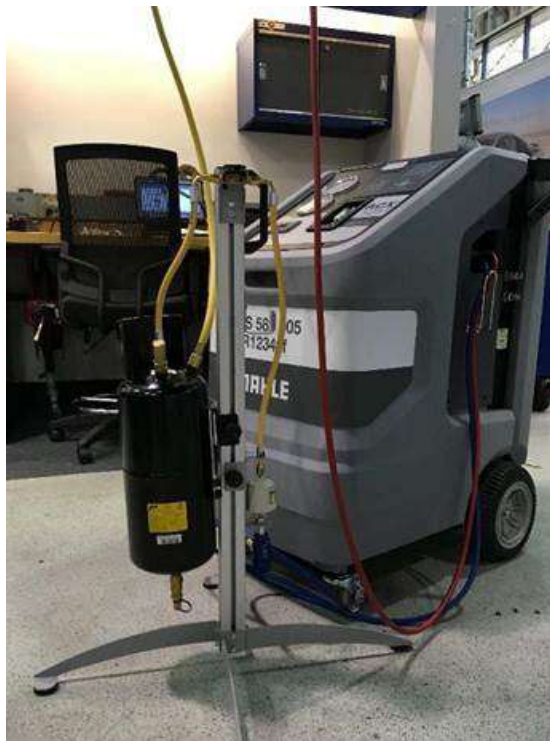
Use an approved R1234yf servicing machine and the R1234yf Flush Kit RTI360831840 (Figure 1).

Used for effective refrigerant handling and air conditioning circuit flushing after air conditioning component failure.

**Figure 1.** The VAS581005 Air Conditioning Service System with Flushing Device.

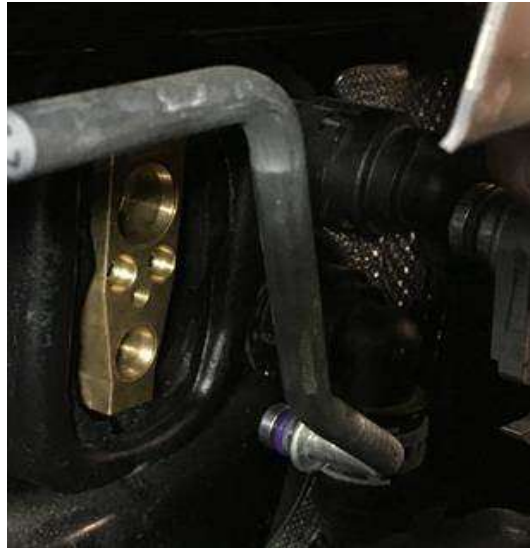
**Figure 3.** Installation of front expansion valve bypass adaptor VAS 6338/38.

7. Remove expansion valve and install flush plate VAS 6338/38. (Figure 3)

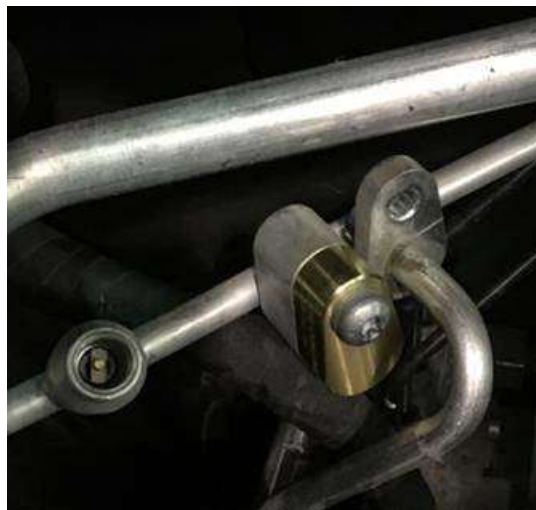
**Figure 4a.** Installation of high side rear A/C Line connection block adaptor VAS 6338/63.

(Atlas Only) The rear A/C unit refrigerant lines must be disconnected and replaced with block off adaptors VAS 6338/5 and VAS 6338/63 before performing the front A/C unit flush procedure.

8. (Atlas Only) Disconnect rear refrigerant lines and install adaptors VAS 6338/5 and VAS 6338/63 as shown. (Figure 4a, 4b)

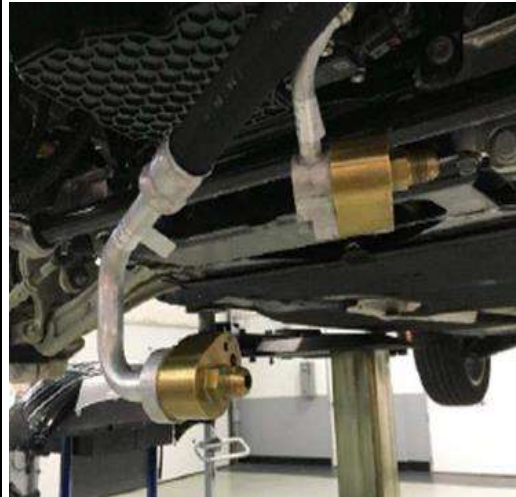
Figure 6. Installation of VAS 6338/3 and 6338/12.

10. Disconnect A/C compressor hoses from the compressor.

Install flush adaptor VAS 6338/3 on the high side compressor hose.

Install flush adaptor VAS 6338/12 on low side compressor hose. (Figure 6)

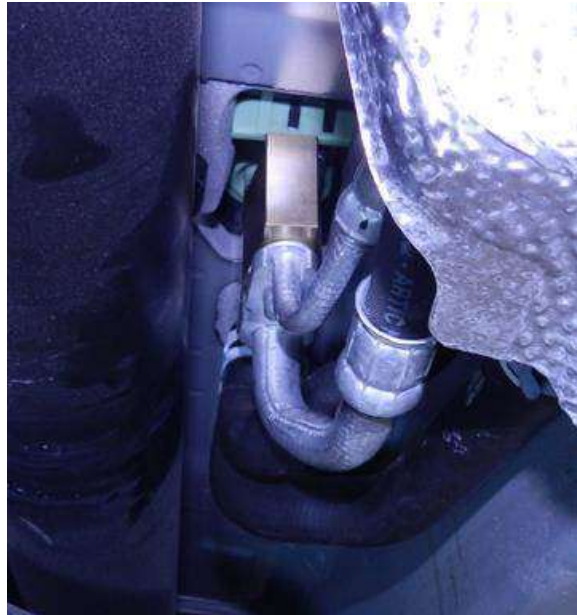
**Figure 13.** Location of rear air conditioning unit expansion valve.

23. Remove rear expansion valve and install VAS6338/38 as shown. (Figure 13)

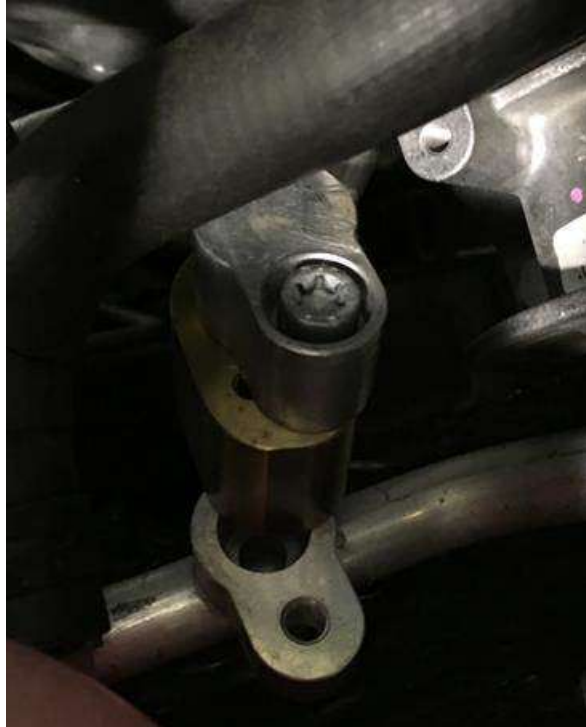
**Figure 14.** Location and connection of the adaptors for the rear unit A/C lines

24. Connect the VAS 6338/3 and VAS 6338/60 to the rear refrigerant A/C lines. (Figure 14)

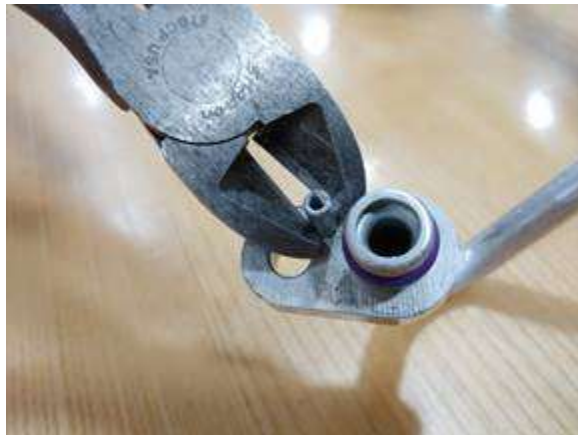
**Figure 15.** Removal of dowel pin.

Later models may have a dowel pin in the high pressure refrigerant line that does not allow the VAS 6338/60 to be installed. The pin must be temporarily removed to install the VAS 6338/60. . DO NOT cut the pin flush with the refrigerant. Side cutters can be used to remove the pin and pliers to reinstall the pin (Figure 15 and 16).

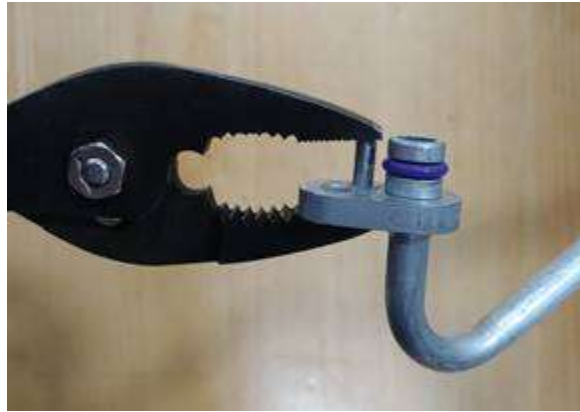
**Figure 16.** Installation of rear refrigerant line dowel pin.

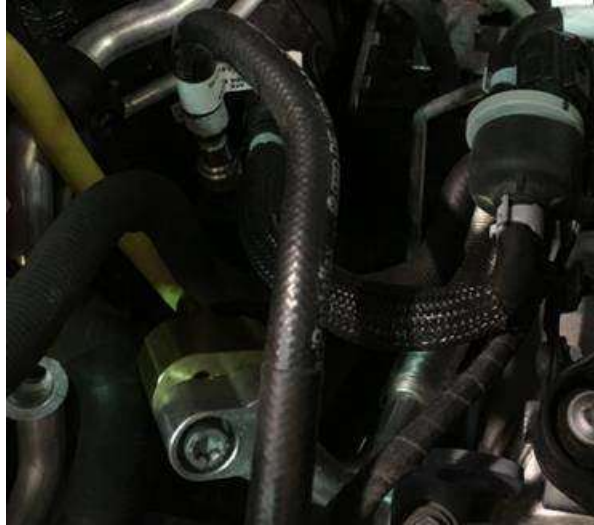
**Figure 17.** Attaching service station and flush hoses to rear A/C lines.

25. Connect the VAS 6338/48 to adaptor VAS 6338/60.

26. Connect flush tank hose (Yellow) to the high side compressor hose adaptor VAS 6338/3. (Figure 17)

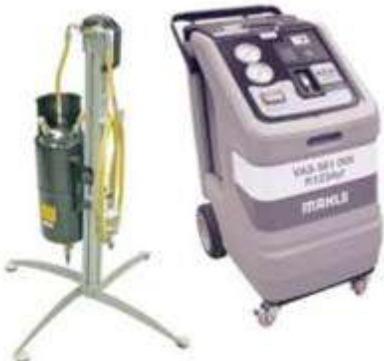
MAHLE R1234yf A/C Service Unit VAS581005
	Or
	Robinair R1234yf - ROB1234YFX
	Or
	MAHLE RTI4608046401
	Or
	Ecotechnics EEAC830BVW
	R1234yf Flush Kit RTI360831840

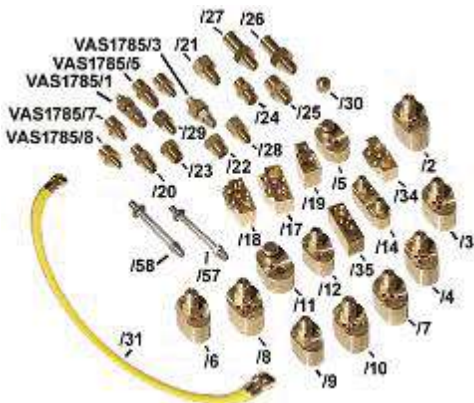
<p>VAS 6338/1</p>
<p>Refrigerant circuit adapter for MAHLE A/C Service Unit and R1234yf Flush Kit</p>  	<p>VAS6338/48</p>
