Technical product information

Topic	Rotating display/screen noise - Diagnosis for complaints relating to noise during operation and/or during a drive cycle
Market area	Russische Föderation (5RU),Australia E04 Bentley rest Asia and Australia (6E04),China 796 VW Import Comp. Ltd (Vico), Beijing (6796),Germany E02 Bentley rest Europe (6E02),Japan E03 Bentley Japan (6E03),Korea, (South) E08 Bentley South Korea (6E08),United Arab Emirates E06 Bentley Middle East and Africa (6E06),United Kingdom E01 Bentley UK (6E01),United States E05 Bentley USA and rest America (6E05)
Brand	Bentley
Transaction No.	2065895/2
Level	EH
Status	Approval
Release date

New Continental GT

Various rotating display/screen noises during operation

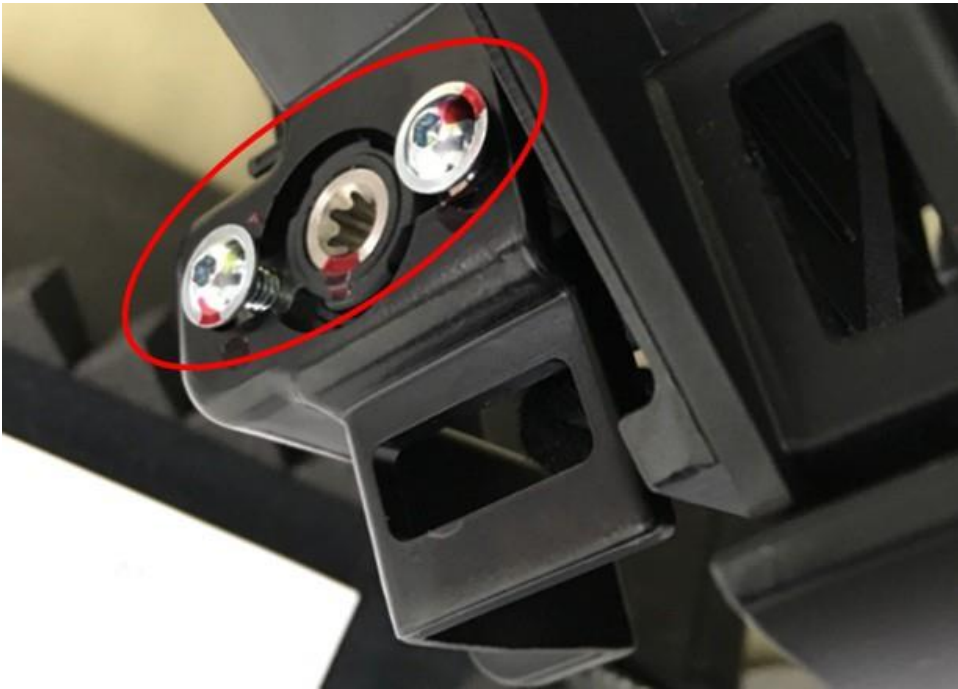
Figure 2

Scenario 2 - Rattling noise during operation

- Refer to Rep.Gr91 - Remove the rotating display
- Referring to Figures 2 and 3 - Check and if necessary tighten the fixing screws highlighted (3Nm), there are 8 fixing screws in total.

- Referring to Rep.Gr.91 - Refit the rotating display and retest.

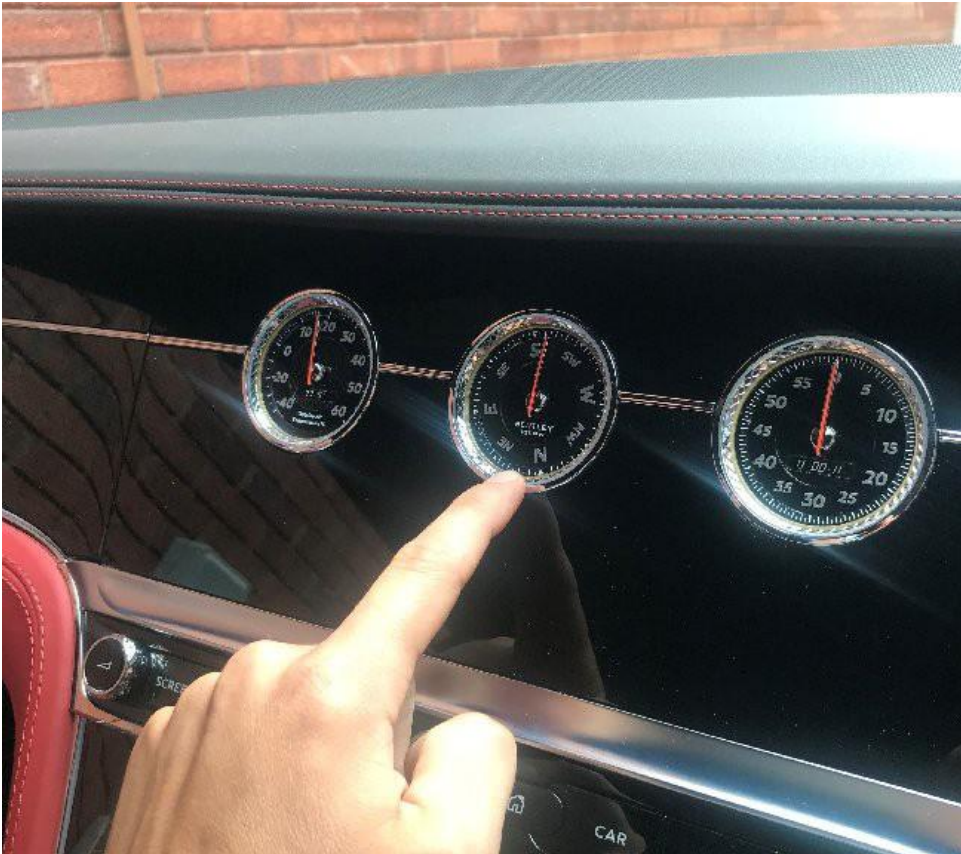
Figure 4

Scenario 3 - Squeak/creak/rattle from the dials during operation

When noise is evident from the dials, press on outer bezels (Figure 4) If the noise disappears when the bezels of the dials are pressed - Referring to Gr.91 - Replace the dials

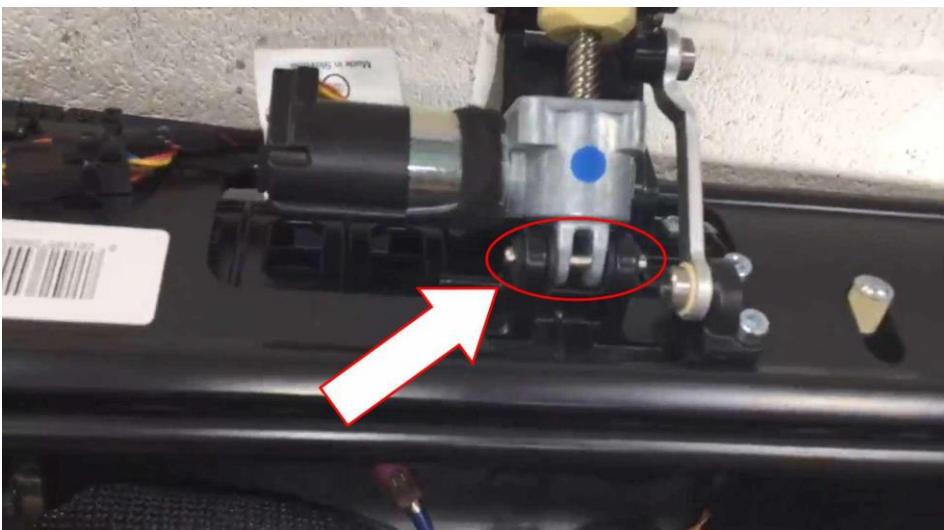
Figure 5

Scenario 4 - Creak/rattle from rotating display whilst driving

TIP: This symptom can in some cases be evident due to excessive movement within the rotating display motor pivot assembly (Figure 5)

- The operative should consider the motor pivot assembly

NOTE: To check the motor pivot assembly for excessive movement the rotating display should be removed – Refer to Rep.Gr 91

- Refer to the Bentley Hub and refer to the video referencing TPI 2065895/-
- Should the movement be as shown in the video, the rotating display unit should be replaced
