Technical product information

Topic	Service info: body/equipment: front exterior lighting steamed up/leaks
Market area	Bentley: worldwide (2WBE)
Brand	Bentley
Transaction No.	2050542/6
Level	EH
Status	Approval
Release date

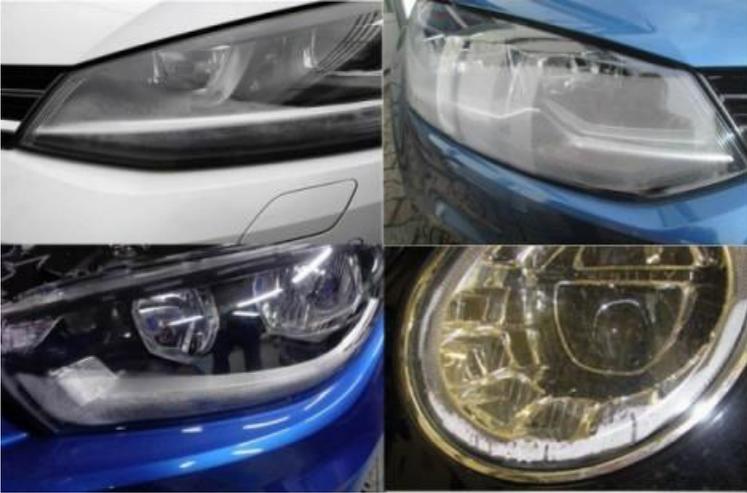
Illustration 1a (example for headlights)

1. The lenses of the headlights (illustration 1a) / front fog lamps (illustration 1b) are steamed up/damp from the inside with minor drips.

Customer statement for 1 (illustration 1a/1b): The lenses of the headlights/front fog lamps are steamed up/damp from the inside with minor drips.

1. Damp air settles on the inner lens of the headlights/fog lamps, with recognisable misting in certain weather conditions (comparable with the steaming up of spectacle lenses when entering a warm room in winter or of the bathroom mirror after a shower).
2. Leak on the headlights/front fog lamps. For example through open covers, a damaged seal of the cap or similar.

1. In case of a headlight complaint the light emission surface on the lens (illustration 3, point 2) must be clear after a journey of 5-10 minutes with sufficient ventilation (for example country road/motorway) and switched-on dipped beam. It is no problem if the remaining surfaces of the inner lens (illustration 3, point 1) are steamed-up after a journey. But the time for the clearing process depends on the outside temperature, the vehicle speed (at higher speeds the ventilation of the headlights is better) and the relative air humidity.

In this case use the argumentation aid (physical situation) under Customer information. In this case a replacement of the headlights would not fix the problem and lead to a repeat repair.

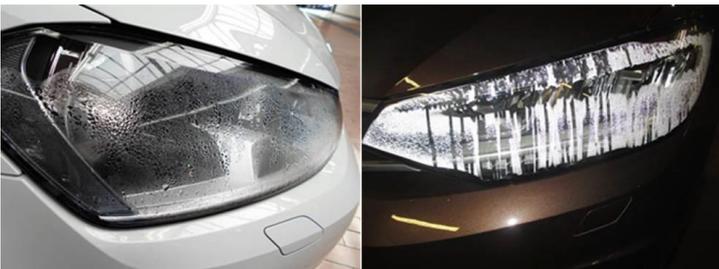
Illustration 2a (example for headlights)

2. Water is in the headlight (illustration 2a) / front fog lamp (illustration 2b), big drips.

Customer statement for 2 (illustration 2a/2b): Water is in the headlights/fog lamps, big drips on the complete lens. Leak on the headlights/front fog lamp.

2. In case of an obvious water ingress/leak (a lot of drips on the inside of the lens, illustration 2) check first the cover and the seals on the headlight/front fog lamp. In case of water ingress (damaged seal, lens and so on) perform the appropriate repairs according to the repair manual/parts catalogue.

Ask the customer to keep an eye on the situation. If despite the above repair the customer complains again about leaking headlights/front fog

lamps and water ingress or lots of drips can still be recognised after the checks, replace the headlights/front fog lamps according to the repair manual/parts catalogue.

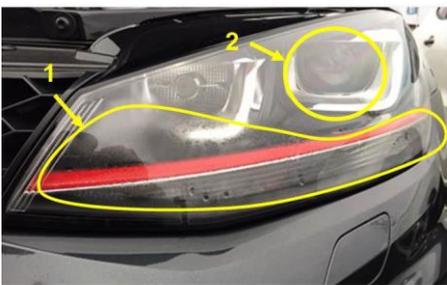
Illustration 3

The above situation is shown in illustration 3:

1 = steaming-up in the headlight

2 = light emission surface

If the headlights/front fog lamps are steamed up, the light emission surface on the lens (illustration 3, point 2) must be clear after a journey of 5-10 minutes with sufficient ventilation (for example country road/motorway) and switched-on dipped beam. It is no problem if the remaining surfaces of the inner lens are steamed-up after a journey.
