Technical product information

Topic	Road wheel inspection procedure
Market area	Russische Föderation (5RU),Australia E04 Bentley rest Asia and Australia (6E04),China 796 VW Import Comp. Ltd (Vico), Beijing (6796),Germany E02 Bentley rest Europe (6E02),Japan E03 Bentley Japan (6E03),Korea, (South) E08 Bentley South Korea (6E08),United Arab Emirates E06 Bentley Middle East and Africa (6E06),United Kingdom E01 Bentley UK (6E01),United States E05 Bentley USA and rest America (6E05)
Brand	Bentley
Transaction No.	2063017/2
Level	EH
Status	Released for publishing
Release date	02-Nov-2022

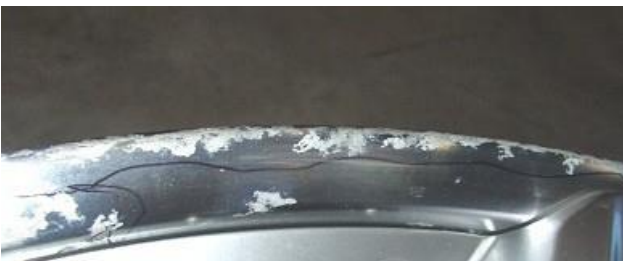
Filiform corrosion in the middle of the rim initially caused by impact damage to the lacquer coat, such as stone chips

- Both Figure 1 and Figure 2 do not show a manufacturing defect

and are not claimable under warranty

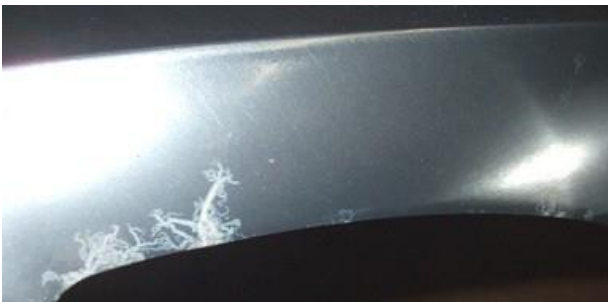
Figure 5

Filiform corrosion coming from sharp edge on the spoke. In this area it is difficult for the supplier to get the specified lacquer coverage

- Both of these could be classed as a manufacturing defect and are claimable under warranty

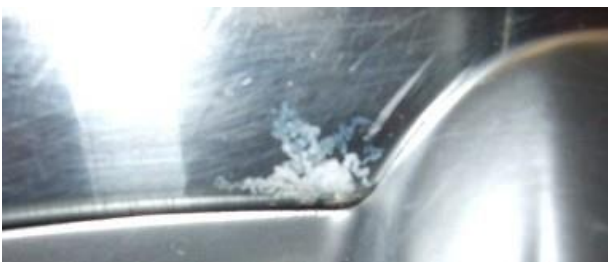
Figure 6

Filiform corrosion coming from behind the inner wheel piece is highly unlikely to be caused by impact damage. It is therefore more likely due to low lacquer coverage

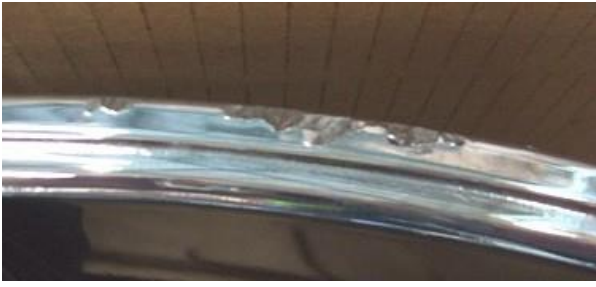
Figure 7
Marks on the rim due to curbing

- Both Figure 7 and Figure 8 do not show a manufacturing defect and are not claimable under warranty Chrome wheels - poor maintenance
- When cleaning chrome wheels, they have to be wiped down and not just sprayed with water as there is still a film of dirt that can remain on the wheels
- There are a number of variables that contribute to pitted wheels, such as brake dust, salt, dust/dirt, ice/snow melting chemicals
- Chrome wheels should never be washed while still hot from driving as they could warp or

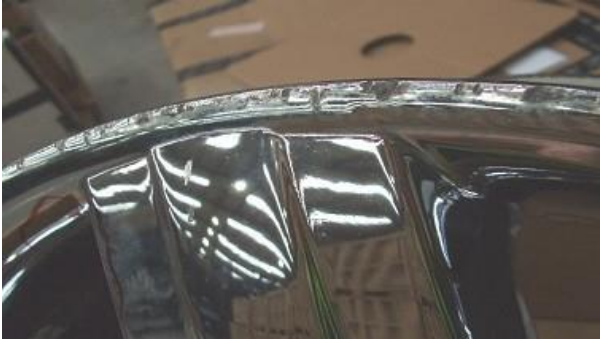
Figure 8
Damage to the rim due to curbing but also damage to the spoke caused by impact damage, such as stone chips

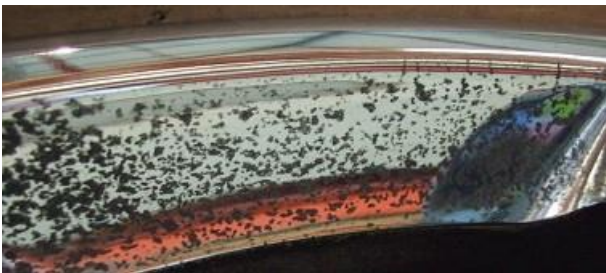
Figure 9
Pitting is not a manufacturing defect and cannot be claimed under Warranty (Figure
