## **Service Bulletin**

Bulletin No.: 22-NA-168

Subject: Diagnostic Tip for Checking Exhaust System for Leaks, Malfunction Indicator Lamp (MIL) Illuminated - DTC P11D5, P14D9, P20EE, P2C7A and/or P0421 Set

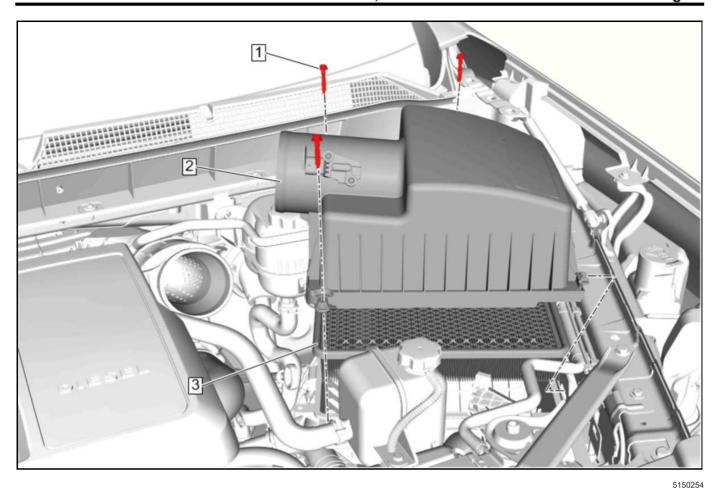
1. Remove the air filter (3) from the air filter housing. Refer to *Air Cleaner Element Replacement* in SI.

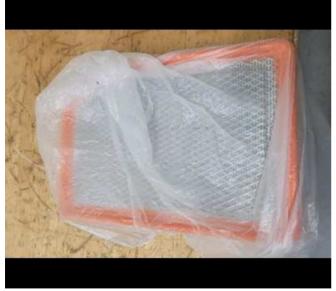
6140930

- 2. Put the air filter in a plastic bag.
- 3. Re-install the air filter into the air filter housing.
- 4. Raise the vehicle.

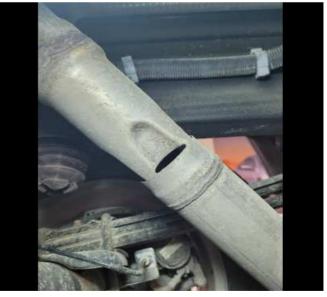
6140932

5. Locate the cooling ports in the exhaust system.

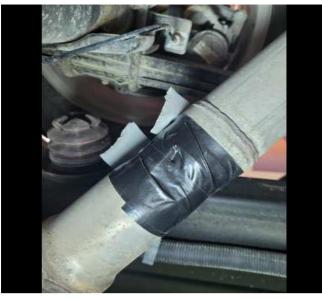
6140943

**Note:** The graphic depicts a single exhaust system. If equipped with a dual exhaust, both cooling holes will need to be taped off and one of the tail pipes sealed with a rag or equivalent.

6. Tape the holes utilizing duct tape or equivalent.

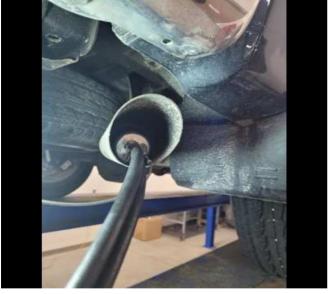
6140928

- 7. Install the inflatable adapter (second largest adapter for our application) for the GE-52250 machine and insert it into the tailpipe.
- 8. Attach the GE-52250 to the adapter and shop air supply.
- 9. Command the vapor test, and adjust the test pressure to 34–55 kPa (5-8 psi).

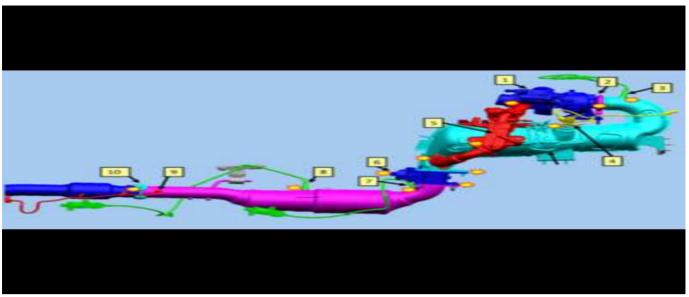
6141008

LM2 After Treatment Exhaust System						
<b>Note:</b> The areas that have been marked on the graphic require inspection for leaks.						
Exhaust Leak Areas of Concern						
1	Turbocharger					
2	V-Band Clamp					
3	NOx Sensor					
4	Def Injector					
5	LP EGR Cooler					
6	EXH. Throttle/Back Pressure Valve					
7	NOx 2 Sensor					
8	NOx 3 Sensor					
9	Particulate Matter Sensor					
10	Norma Band Clamp
