**Drops of Oil or Traces of Oil on Rear Axle Shock Absorber: Observe Specified Procedure (231/22)**

Vehicle Type: **911 GT3 (992) / 911 GT3 with Touring Package (992)**

Model Year: **As of 2021 up to 2023**

Concerns: **Rear axle shock absorber**

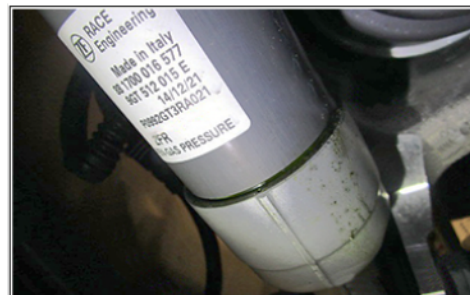
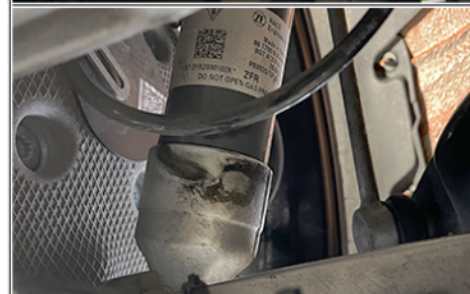
Due to the production process, oil residues may be present on the shock absorbers, which collect at the lower end of the shock absorber and may appear there as oil drops or oil traces. ⇒ *Traces of oil on rear axle shock absorber.*

This is neither a defect nor a malfunction of the shock absorber.

*Traces of oil on rear axle shock absorber*

Action required: If oil drops or traces are present at the lower end of the shock absorber, the following measures are therefore mandatory before replacing the shock absorber:

- Clean soiled area.
- Perform a test drive.
- Re-evaluate shock absorbers.

If oil drops or traces are again present on the shock absorber during the subsequent assessment, check the shock absorber for damage. Replacement of the shock absorber is only justified if oil drops or traces are still present or if there is obvious damage.
