Technical Service Bulletin

66 Front radiator grille trim incorrect for the vehicle

66 22 93 2068096/2 December 21, 2022. Supersedes Technical Service Bulletin Group 66 number 22-92 dated September 28, 2022, for reasons listed below.

Model(s)	Year	VIN Range	Vehicle-Specific Equipment
Q8, SQ8, and RS Q8	2023	000001 – 003082	Not Applicable

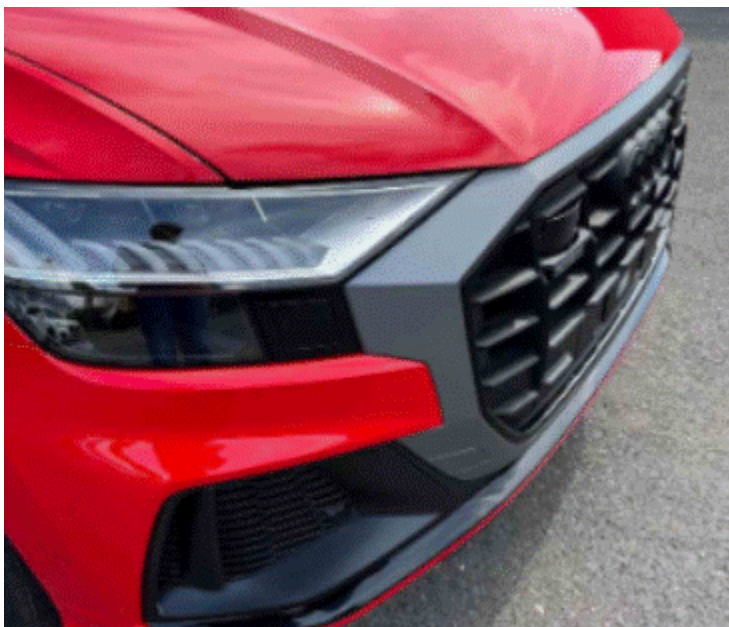
The error in production regarding the radiator grille trim color installed is confirmed (e.g. LY9B Brilliant Black trim intended, L1RR Platinum Grey installed).

The trim that surrounds the front radiator grille installed in production is L1RR Platinum Grey instead of the intended LY9B Brilliant Black trim.

Figure 1. L1RR Platinum Grey radiator grille trim installed. LY9B Brilliant Black trim intended.

Replace the radiator grille trim with the correct LY9B Brilliant Black trim.

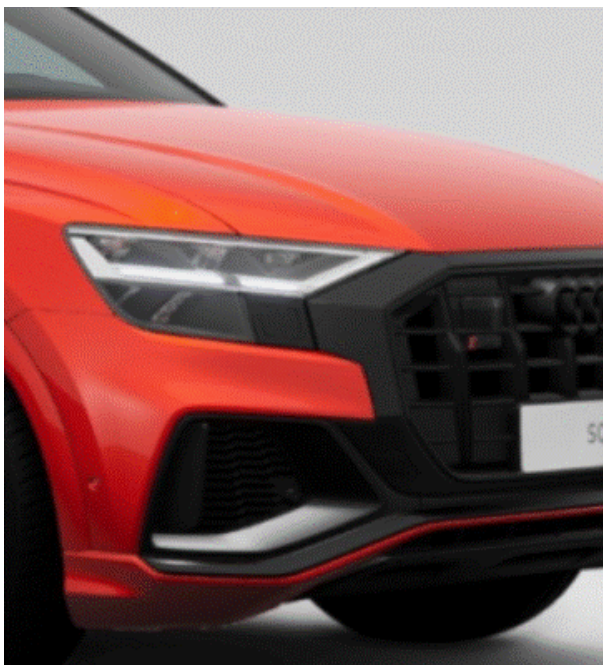
Figure 2 shows the correct configuration with a LY9B Brilliant Black radiator trim.

Figure 2. Correctly configured radiator grille trim in LY9B Brilliant Black.
