SERVICE BULLETIN

**L-SERIES RADIATOR HOSE CLAMP-COOLANT
LEAK**

**GROUP: 0-GENERAL
SERVICE BULLETIN NO: SB-22-031
DATE: 12-21-2022
REF: HMM-221220-F1**

SUBJECT VEHICLES: Certain 2022-2023 Model Year L-Series Trucks Equipped with a Cummins B6.7 Engine.

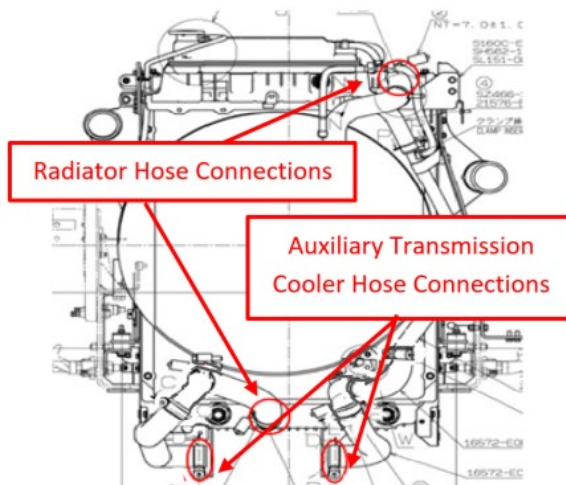
The subject vehicles may exhibit coolant leaking from either the inlet or outlet radiator hose connections of the radiator or auxiliary transmission cooler. This leak may be due to reduced clamp retention at these 4 locations. If a coolant leak is identified coming from any of the 4 locations, this procedure provides installation instructions and directions to install the new style hose clamp at all 4 locations.

1. Is there coolant leaking from any one of the four radiator hose locations?

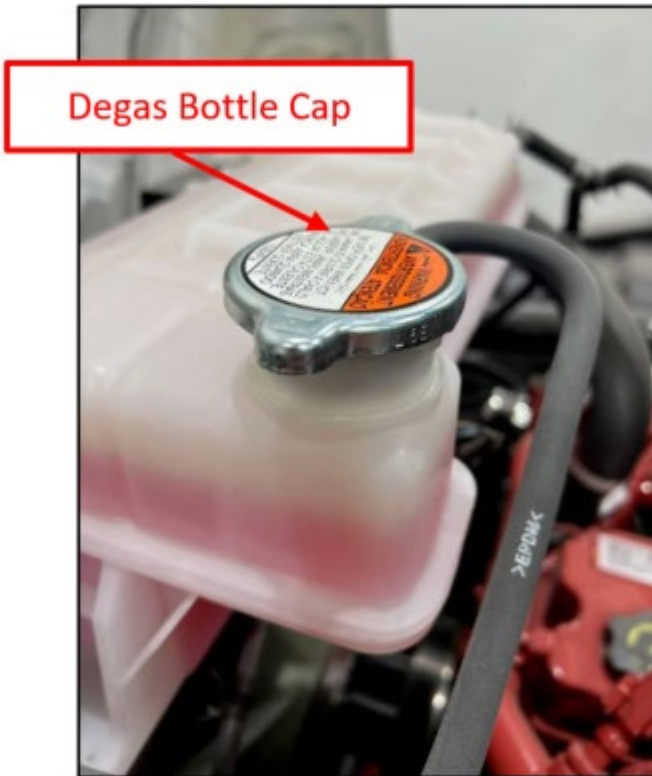
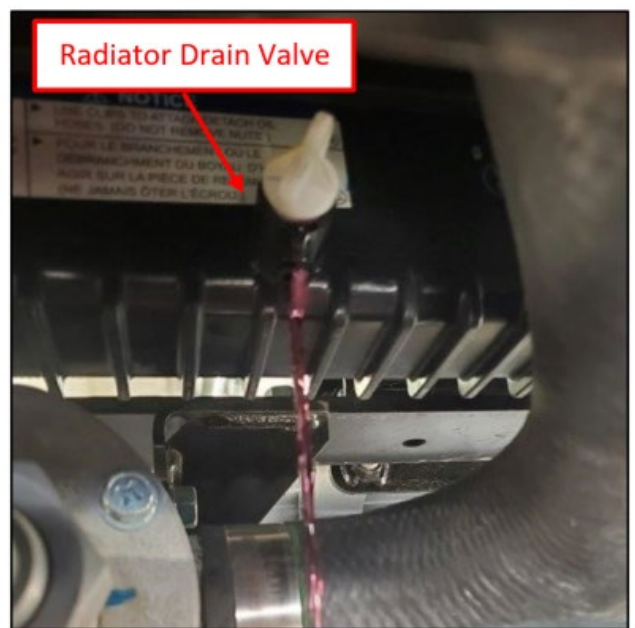
2. Allow the engine and cooling system to cool down to ambient temperature. Remove the engine coolant degas bottle cap from the degas bottle. Open the radiator drain valve and drain the coolant into a suitable clean container. Once the cooling system is drained, close the radiator drain valve.

WARNING: Do not loosen or remove the degas bottle cap or attempt to drain the cooling system until the coolant and engine have cooled to ambient temperature. Loosening or removing the degas bottle cap or draining the cooling system prior to the cooling system cooling down could cause severe personal injury due to scalding.

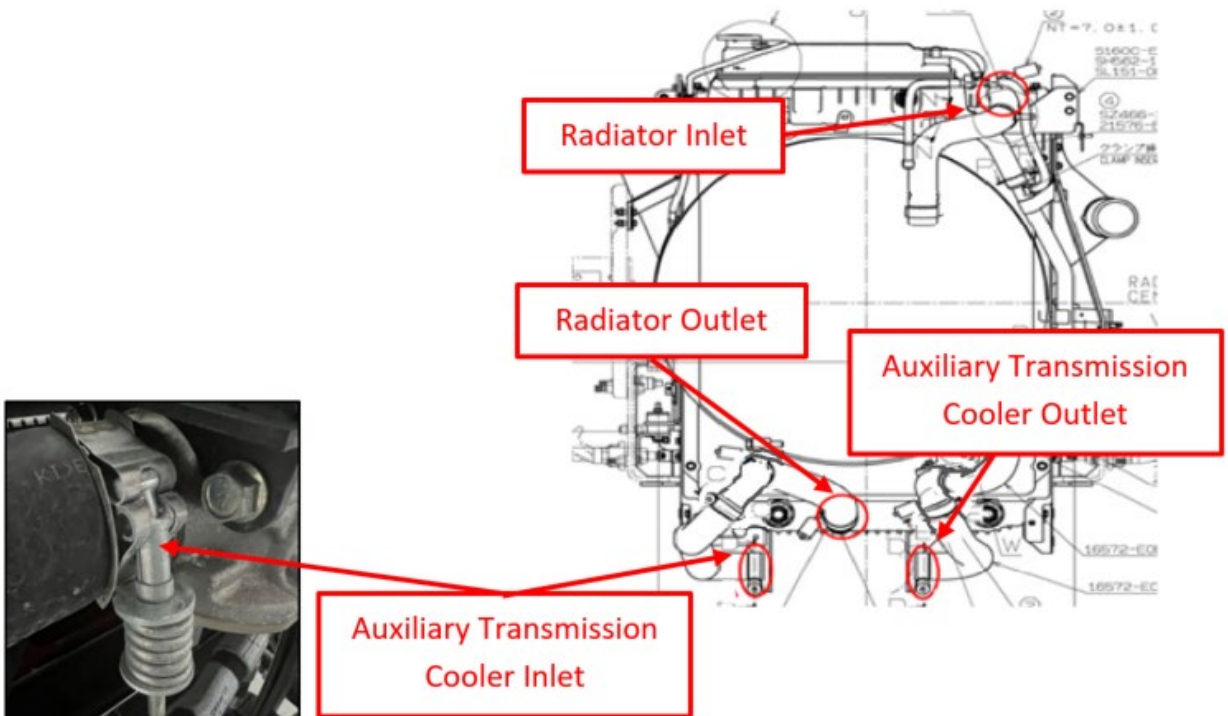
3. Loosen the 4 constant torque coolant hose clamps and disconnect the following radiator hoses at each connection point:

- radiator inlet
- radiator outlet
- auxiliary transmission cooler inlet
- auxiliary transmission cooler outlet

Remove and discard the (4) constant torque clamps.

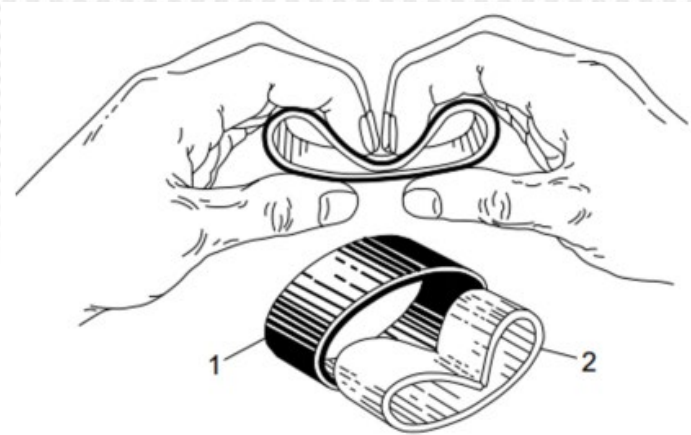
1. Clamp
2. Cardboard Brace

4. Using the new Gates PowerGrip hose clamps, remove the cardboard brace by squeezing the clamp and cardboard brace as illustrated in the picture below. Remove the cardboard brace and discard.

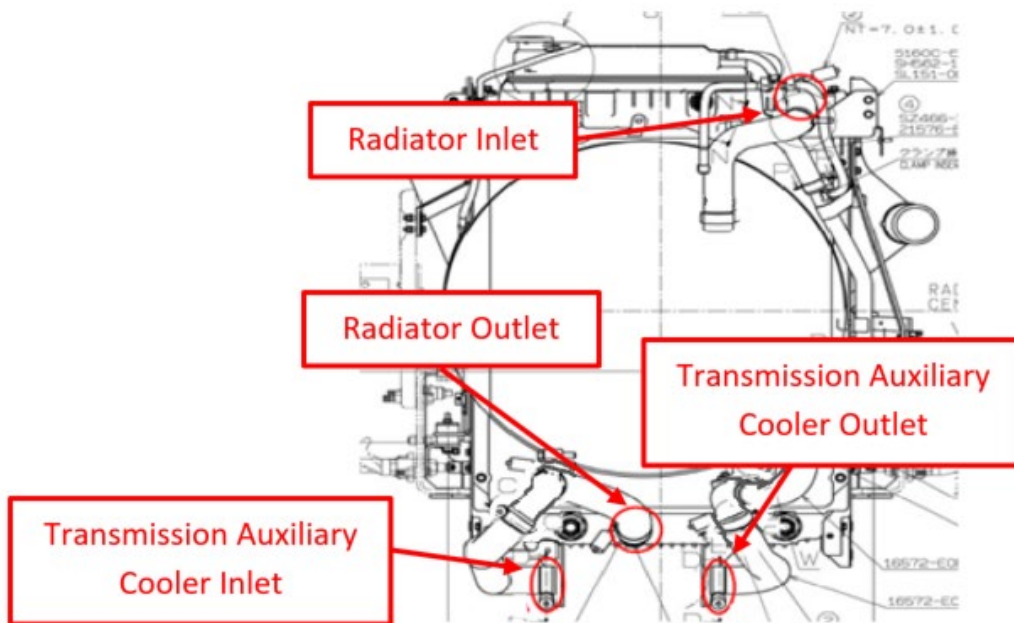
5. Position 1 PowerGrip hose clamp over each of the 4 radiator hoses. Reinstall the 4 radiator hoses to their corresponding connection point.

- radiator inlet
- radiator outlet
- auxiliary transmission cooler inlet
- auxiliary transmission cooler outlet

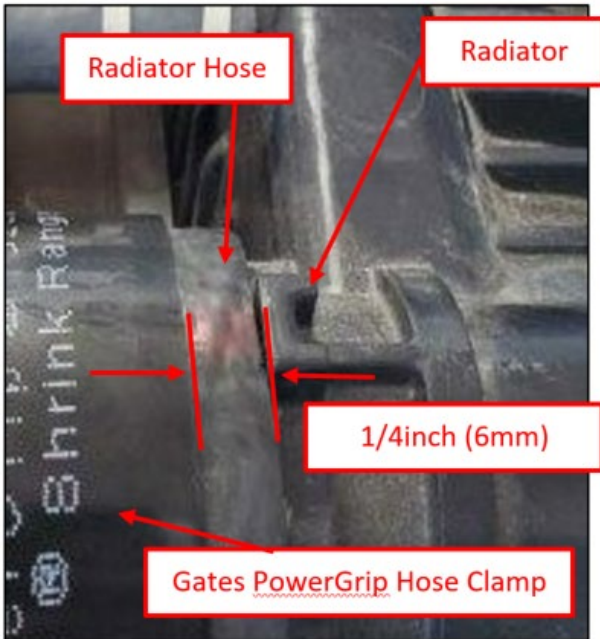
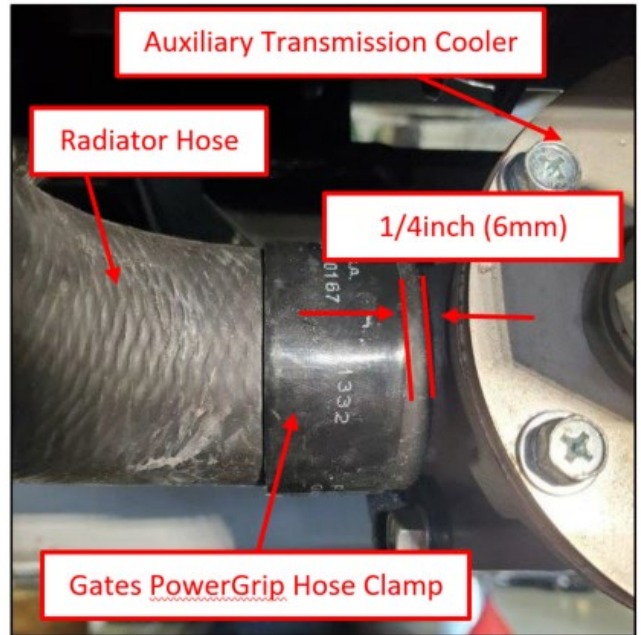
6. Make certain that each of the 4 radiator hose connections are fully seated onto the radiator and auxiliary transmission cooler before proceeding. Position each of the Gates PowerGrip coolant hose clamps 1/4inch (6mm) from the end of radiator hose, see photographs below.

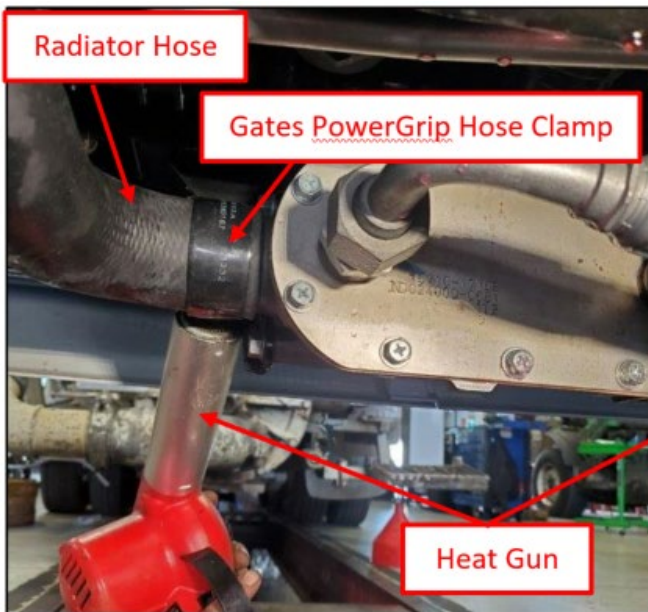
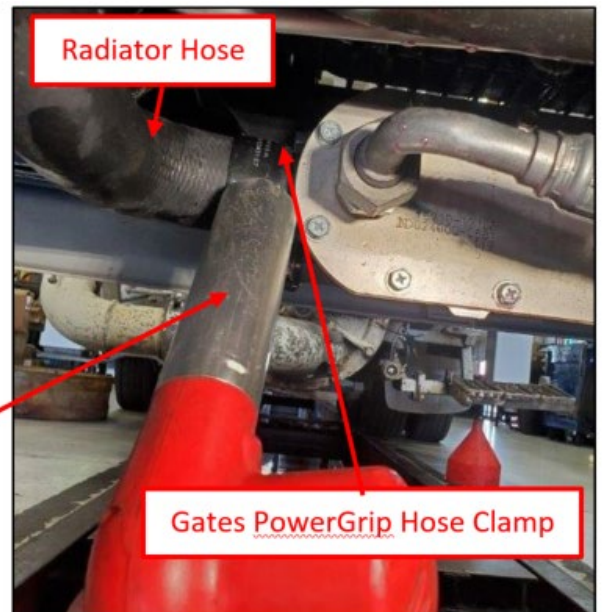
7. The Gates PowerGrip hose clamps will require heat to begin shrinking and tightening them around the radiator hose. While using a heat gun, apply heat to each of the 4 Gates PowerGrip hose clamps. To prevent overheating the hose clamp or radiator hose, continuously move the heat gun evenly heating as much of the Gates Power Grip hose clamp as possible. The clamp should begin to shrink and tighten after 30 to 60 seconds and may take 2 minutes for each clamp location.

NOTICE: Care should be taken to ensure that the Gates PowerGrip hose clamp or radiator hose is not overheated and damaged.

NOTICE: Once the engine reaches operating temperatures, the Gates PowerGrip hose clamps will continue to shrink and tighten at each of the 4 hose connections.
