STAR ONLINE PUBLICATION

Case Number: S2008000103

Symptom/Vehicle Issue: No Start, High Current Fuse Array (HCFA) Location And Testing

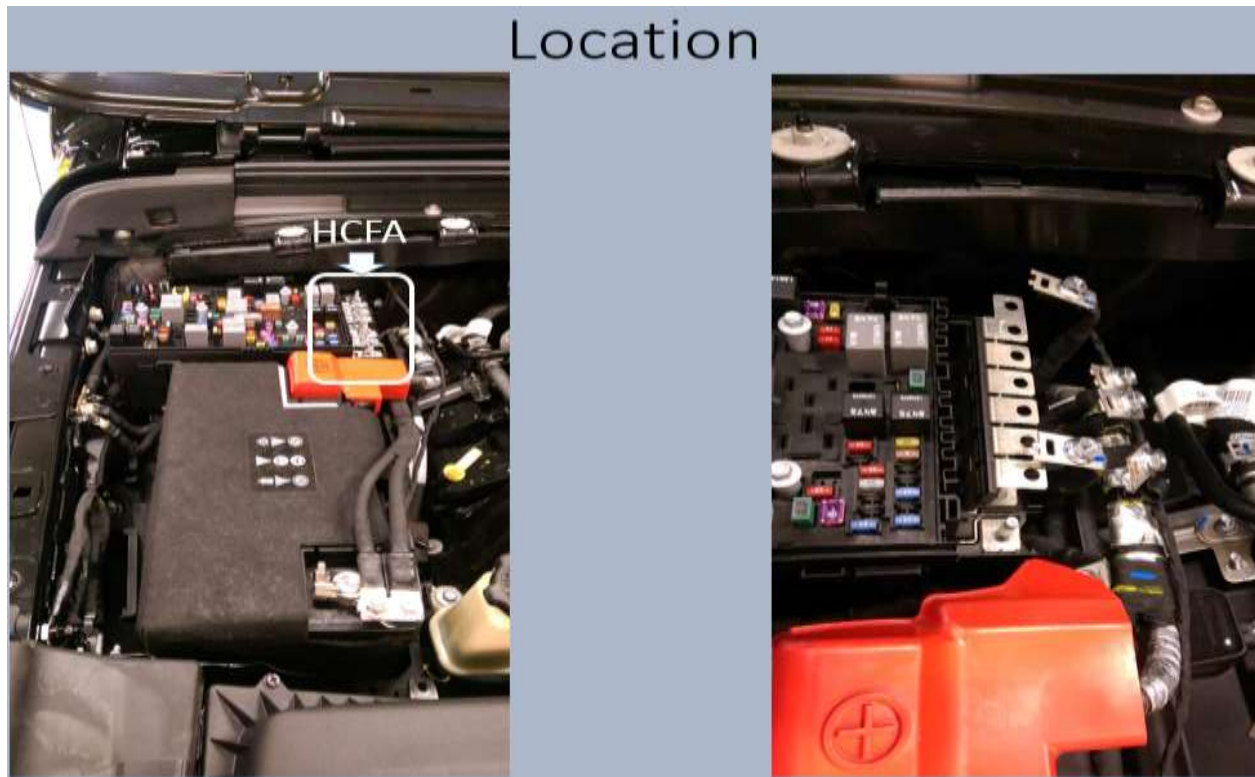
Fig 1

Discussion: HCFA Location, on the passenger side, header location Fig 1, Fig 2.

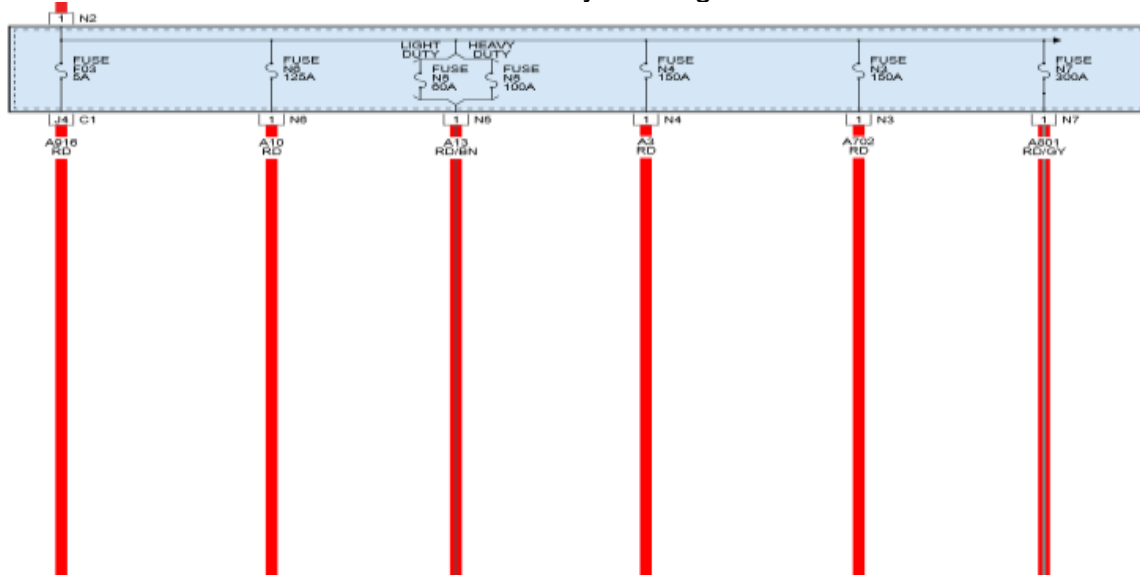
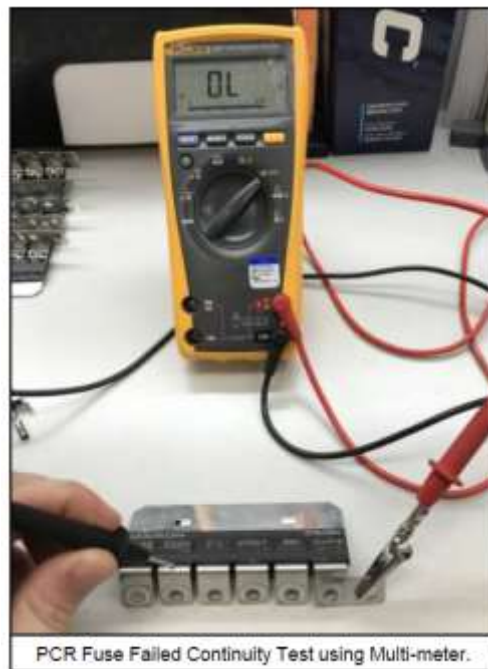
Fuse Array Testing
