| REFERENCE: | Nova Bus Manuals |
| RS N°: | MQR 7621-2068 |

| SUBJECT: | Marker lights failing. |
| JUSTIFICATION: | Destination sign controllers were failing at a high rate. Water intrusion causing signs to fail cracks on lights. |

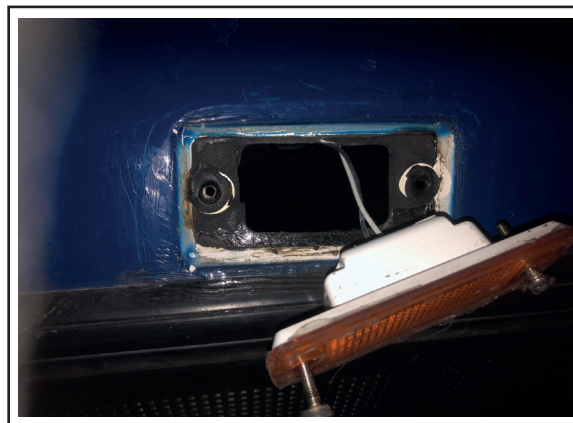
- 1.5. Every marker light gasket will be replaced with new larger gasket.
- 1.6. Prior to replacing gaskets turn on marker lights, confirm all lights are working and none are broken or contain any water intrusion.
- 1.7. All lights must be checked for any silicon which added to prevent the water intrusion need to be replaced.
- 1.8. If any lights are not working or damaged which need to be replaced.
- 1.9. Working lights can be reused along with new gasket.
- 1.10. Replace any failed or broken lights (see Figure 2).

Figure 2 - Broken marker light

- 1.11. Remove the old well nuts and gasket.
- 1.12. Remove any silicon which added.
- 1.13. The old gasket must be completely cleaned from the bus body.
- 1.14. Inspect the area for any damage to the fiberglass shell.
- 1.15. Report any damage as it will need to be repaired.

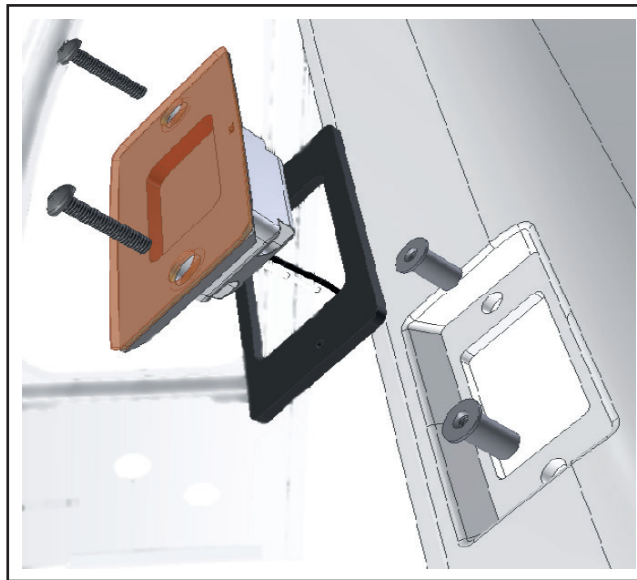
- 1.16. Remove the two screws holding each marker light.
- 1.17. Carefully remove the marker lights. A spatula, a knife or a screw driver might be required to separate the adhesive sealant (Dolchem) (See Figure 3).

Figure 3 - Removal order

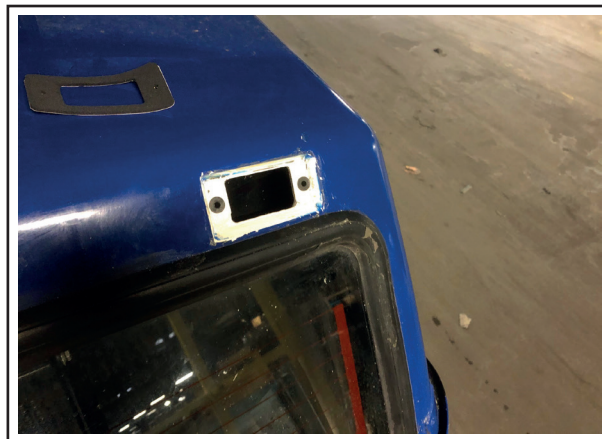
- 1.22. Install the new wellnut G5007158 for each light (See Figure 6).

Figure 6 - Installation of new wellnut

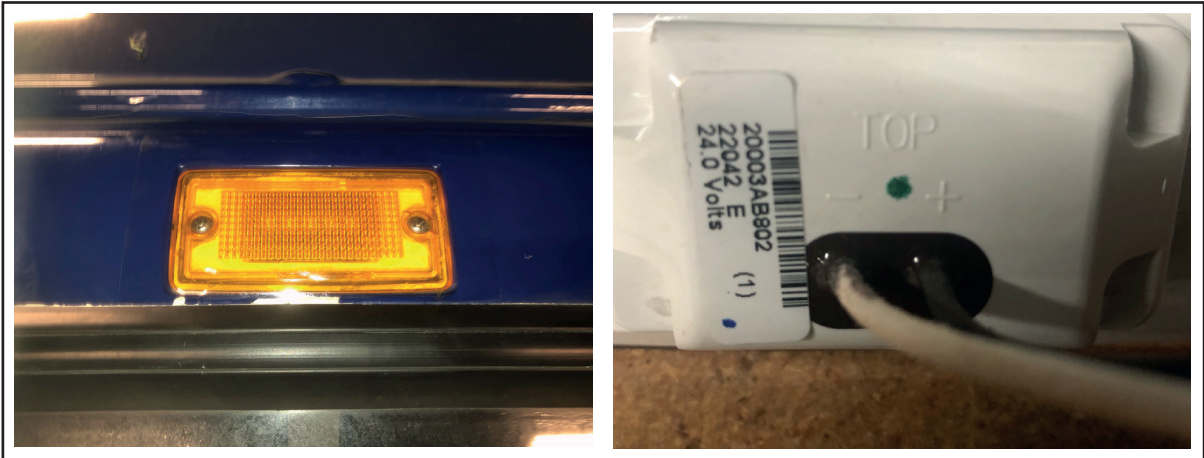
- 1.24. Install the marker light N37779 and make sure it is installed properly, each light is marked with which side is top (See Figure 8).

Figure 8 - Installation of marker light

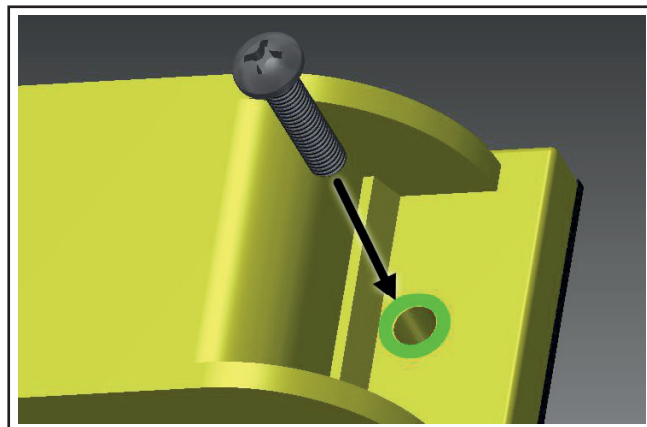
- 1.25. Once the light is in place, but before inserting the screws, apply Dolchem around the screw holes (See Figure 9).

Figure 9 - Adhesive sealant application

- 1.26. Use new screws N32046 and torque to 42 Nm.
1.27. Test marker light to ensure its functionality.
1.28. Check interior of bus or any signs of water intrusion, wet spots or water stains.
1.29. Check all surrounding components for proper functionality make notes and report any unusual findings.
1.30. The vehicle can return in service. ❖
