REFERENCE:	Nova Bus Manuals
SECTION:	01: Body
RS N°:	MQR 7621-2086
EFFECTIVE IN PROD.:	N/A

SUBJECT:	Sika Seams Cracking.
JUSTIFICATION:	Due to the lack of bonding surface between the two large roof top panels, when thermal expansion and contraction occur these panels separate and leave an opening.

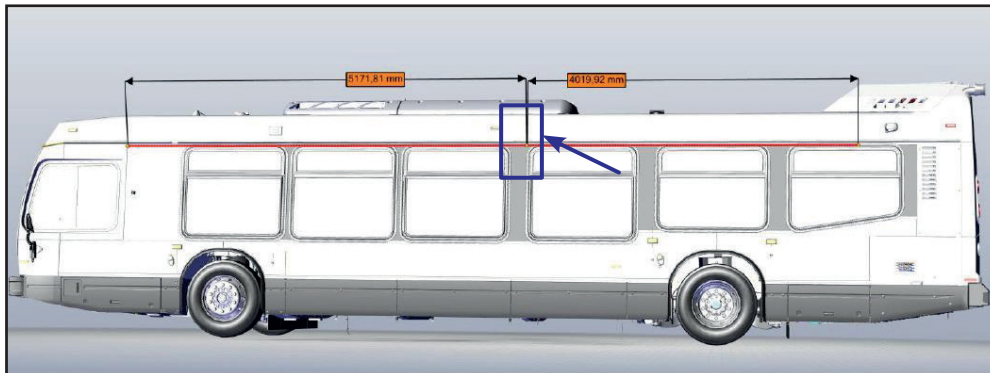
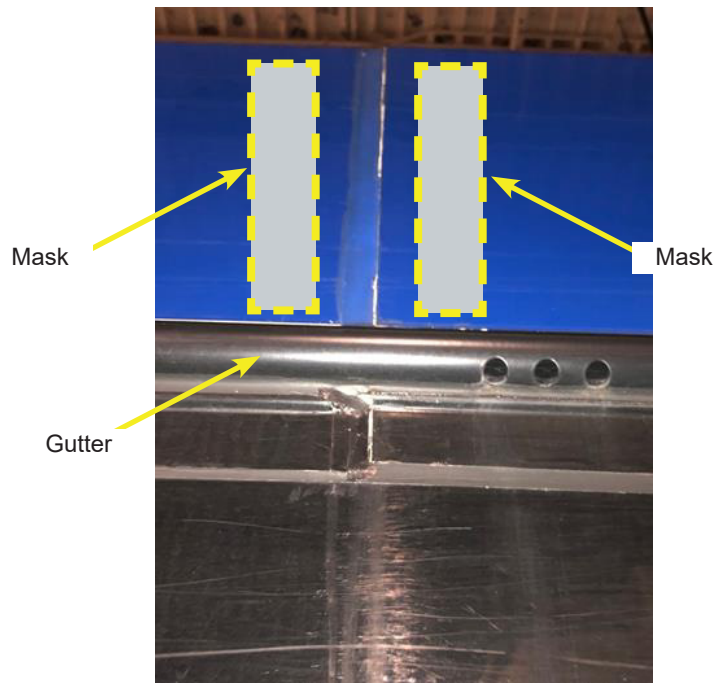
Figure 1 - Mask Area with Tape

- 1.4. Mask area using 3M masking tape N8950481.

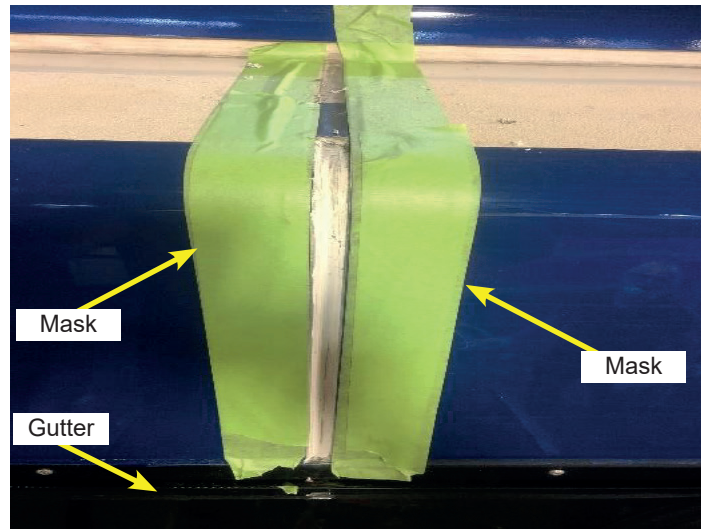
Figure 2 - Remove Sika

- 1.5. Remove Sika seam (above gutter) only up to the horizontal roof surface.

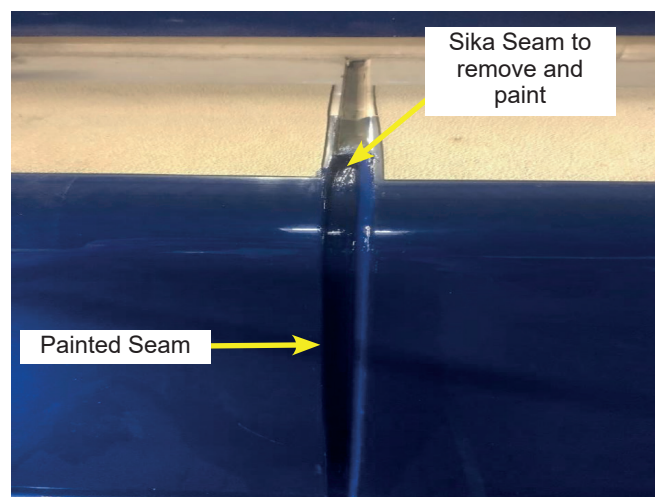
Figure 3 - Apply Paint

- 1.6. Score existing sika zone with scotch brite to obtain a matte finish.
1.7. Remove the dust with a clean dry cloth.
1.8. Use isopropyl alcohol wipe N86735-01 to clean the surface prior to paint application.
1.9. Apply paint N8950491 (Dark Blue), must be 60° F or higher.
1.10. Allow to dry for 15 to 20 mins.
1.11. Apply 2nd coat and dry for 15 to 20 mins.

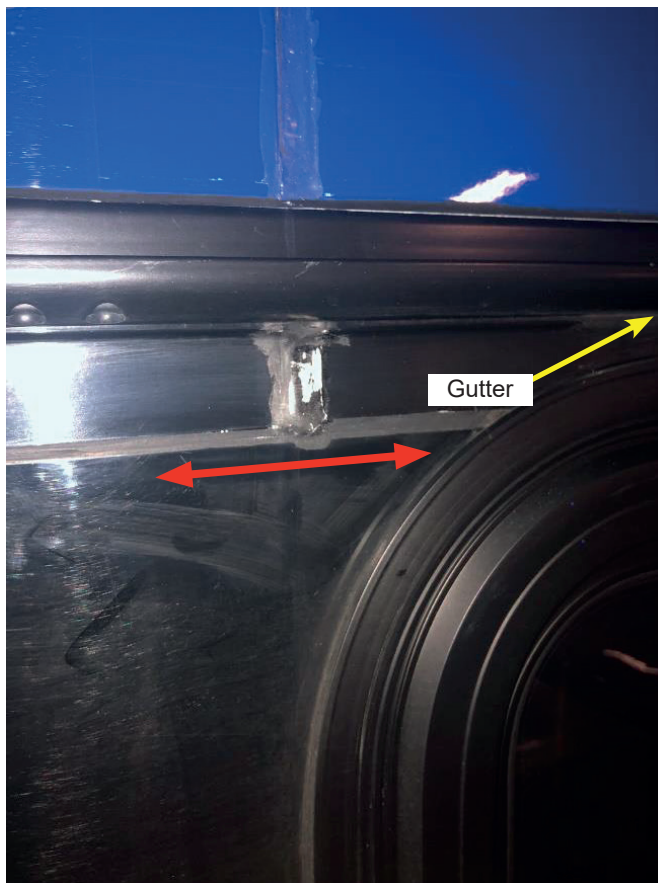
Figure 4 - Surface Cleaning

1.12. Use 3M promoter N8950926 to clean the surface prior to tape.

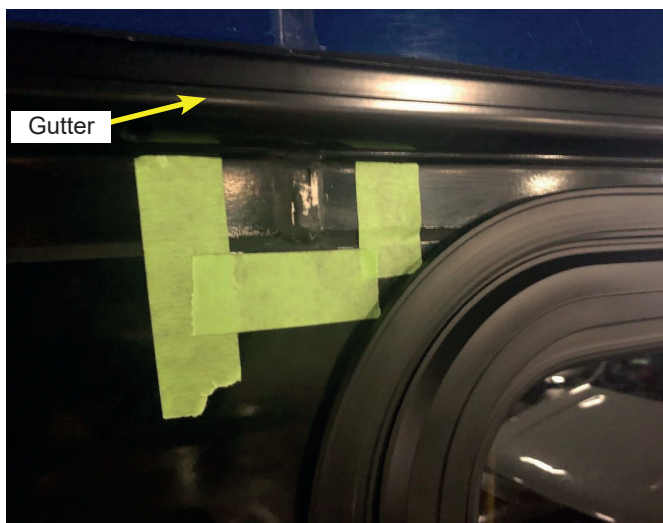
Figure 5 - Mask with Tape

1.13. Mask area using 3M masking tape N8950481.

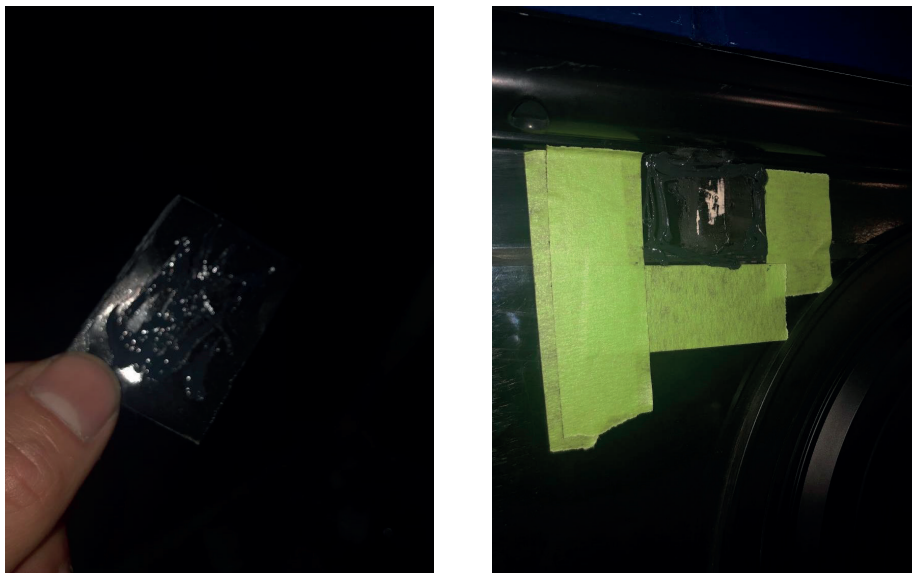
Figure 6 - Apply Adhesive

- 1.14. Apply 3M adhesive N8950925 evenly around the edges and to the back of the 3M tape N8950467.

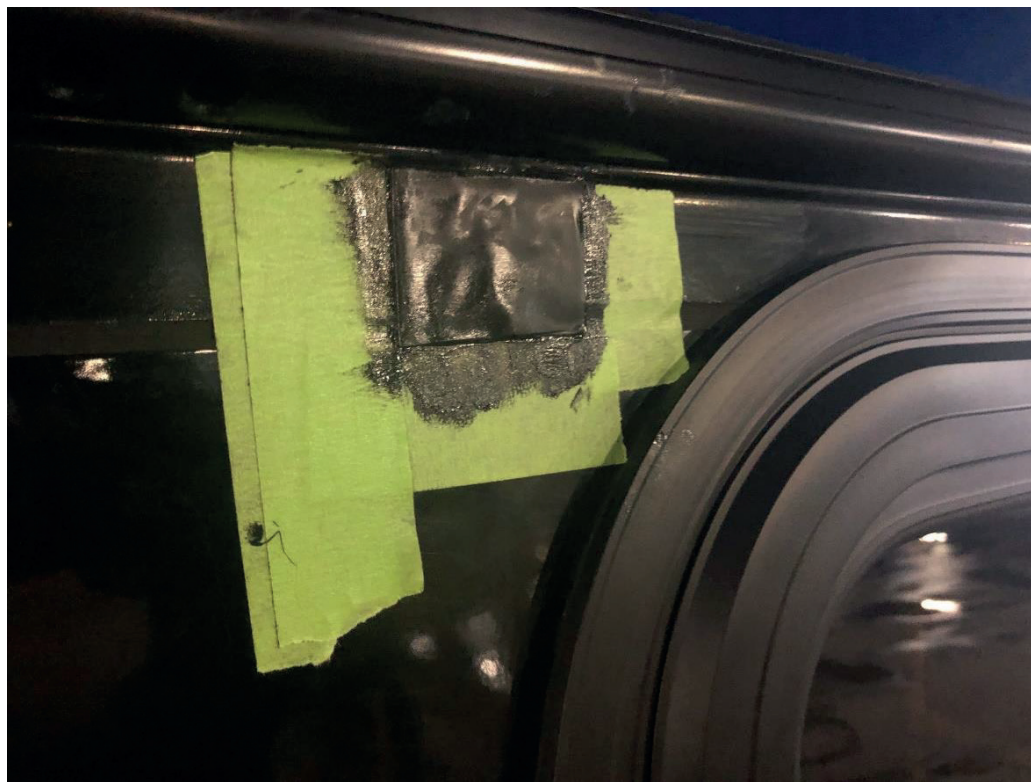
Figure 7 - Apply Tape

- 1.15. Apply tape, press firmly into place be sure to cut the tape inline with the door frame. spread any excess of the 3M adhesive that may have squeezed out from the back around the edges.

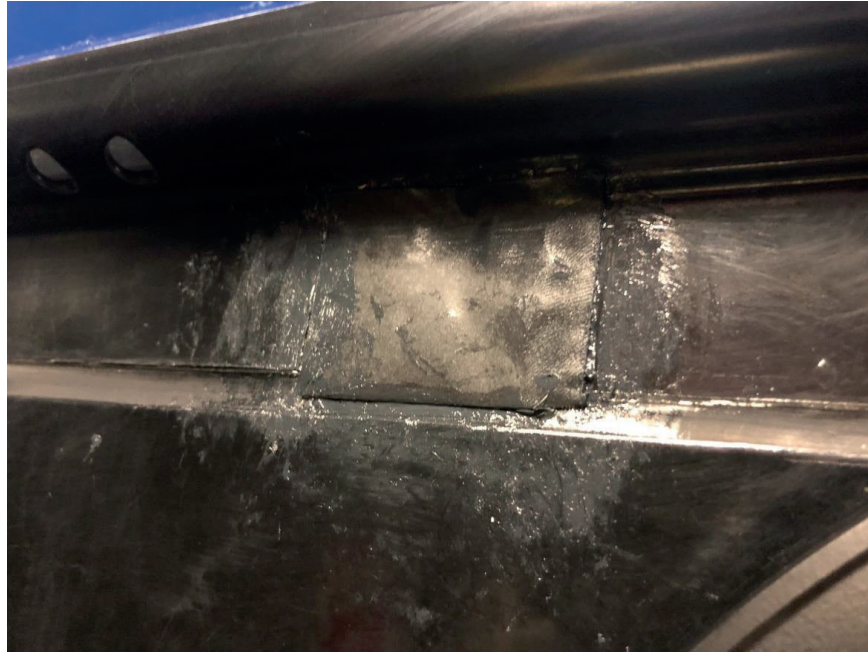
Figure 8 - Remove Masking Tape

1.16. Remove the masking tape.
