REFERENCE:	Nova Bus Manuals
SECTION:	01: Body
RS N°:	MQR 7621-2086
EFFECTIVE IN PROD.:	N/A

SUBJECT:	Sika Seams Cracking.
JUSTIFICATION:	Due to the lack of bonding surface between the two large roof top panels, when thermal expansion and contraction occur these panels separate and leave an opening.

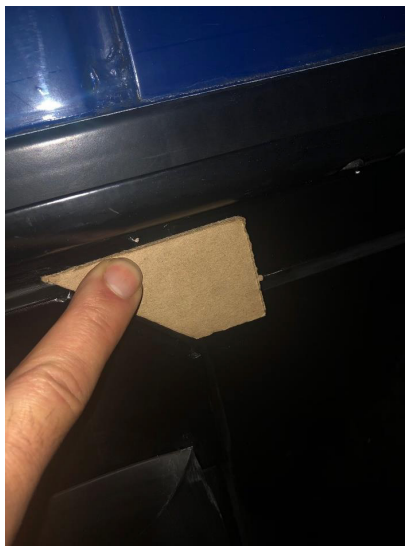
- 1.5. A jig should be used to cut the tape to the desired angle.

Figure 2 - Highlighted area to apply Tape

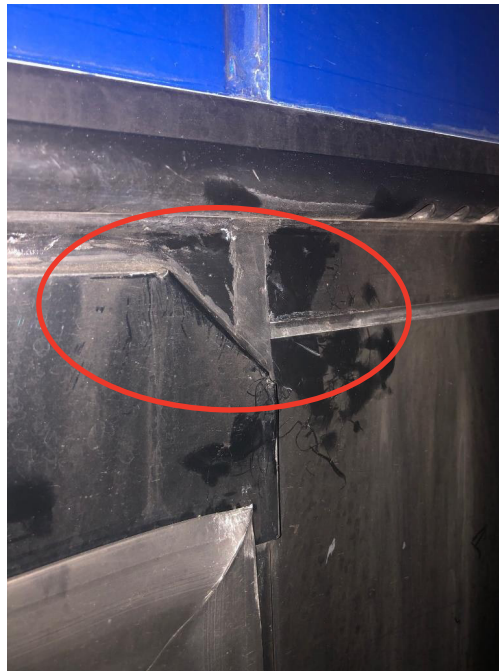
1.6. Use 3M promoter N8950926 to clean the surface.

Figure 3 - Surface Cleaning

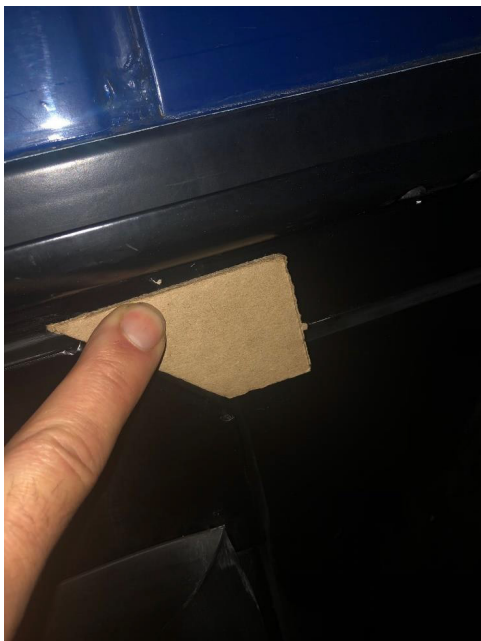
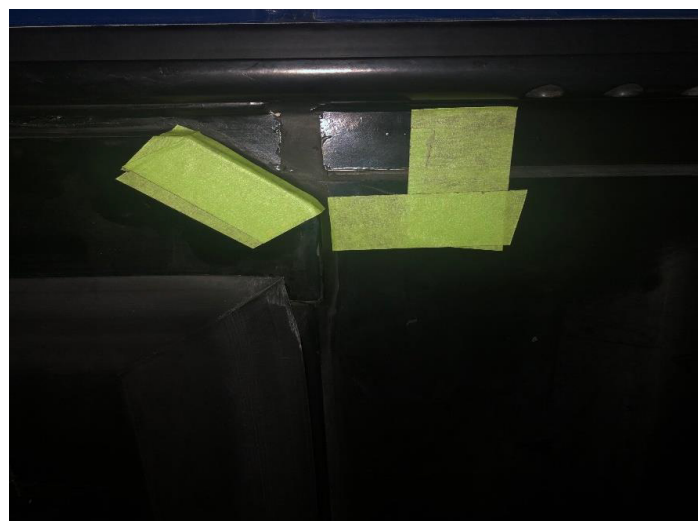
1.7. Use jig to outline tape.

Figure 4 - Apply Tape

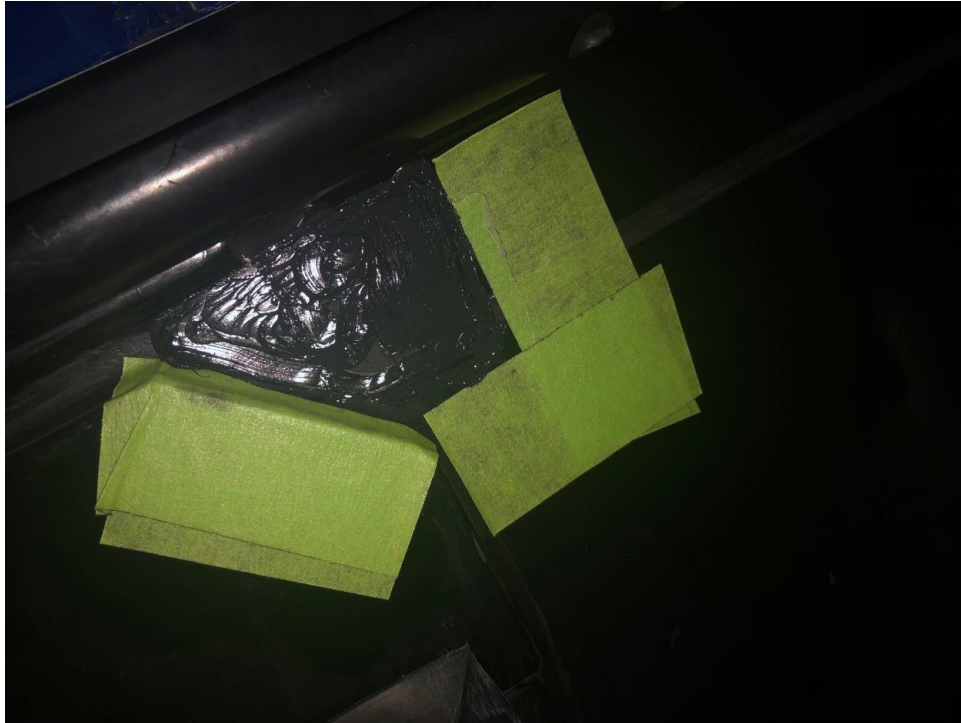
- 1.8. With tape outline, add an even amount of 3M adhesive N8950925.

Figure 5 - Apply Adhesive

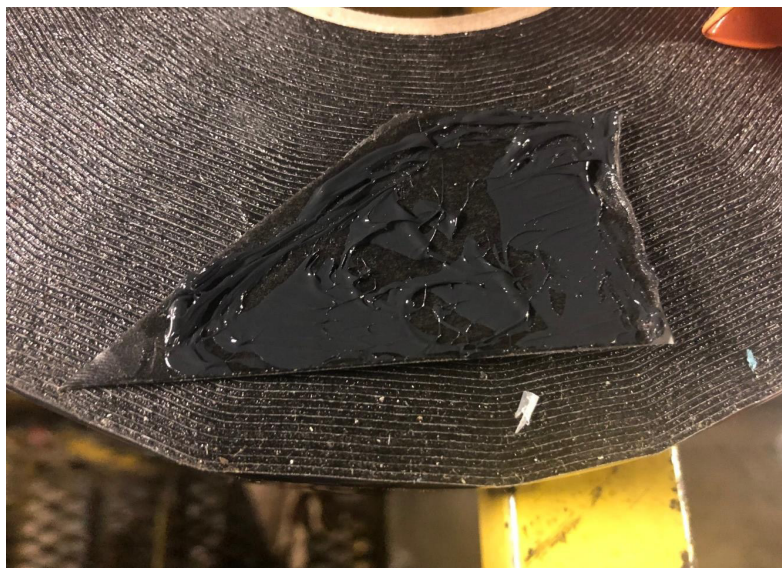
- 1.9. With tape cut, apply even amount of 3M adhesive.

Figure 6 - Apply Adhesive

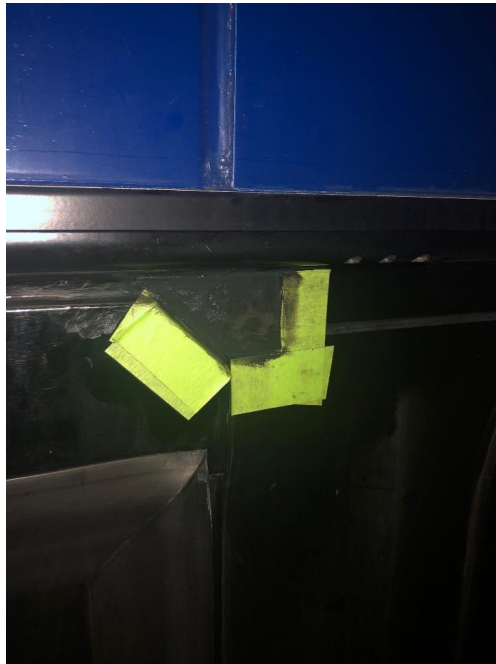
- 1.10. Apply tape press firmly into place be sure to cut the tape inline with the door frame.
- 1.11. Spread any excess of the 3M adhesive that may have squeezed out from the back around the edges.

Figure 7 - Apply Tape on the Door frame

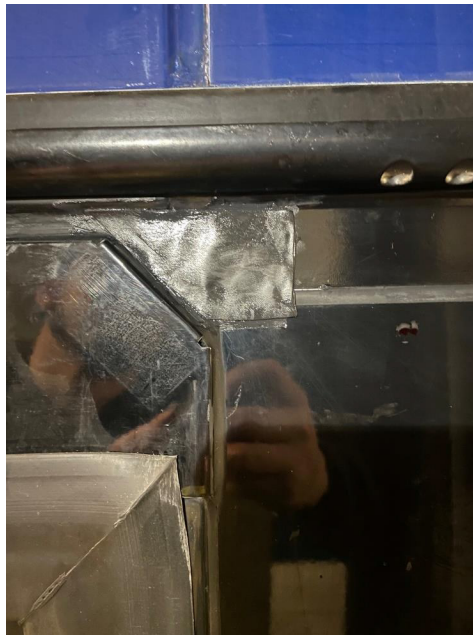
- 1.12. Remove the tape.

Figure 8 - Removal of Tape
