Technical Service Bulletin

10 Oil is lost from the filler cap

10 23 25 2059446/6 January 24, 2023. Supersedes Technical Service Bulletin Group 10 number 22-24 dated August 23, 2022, for reasons listed below.

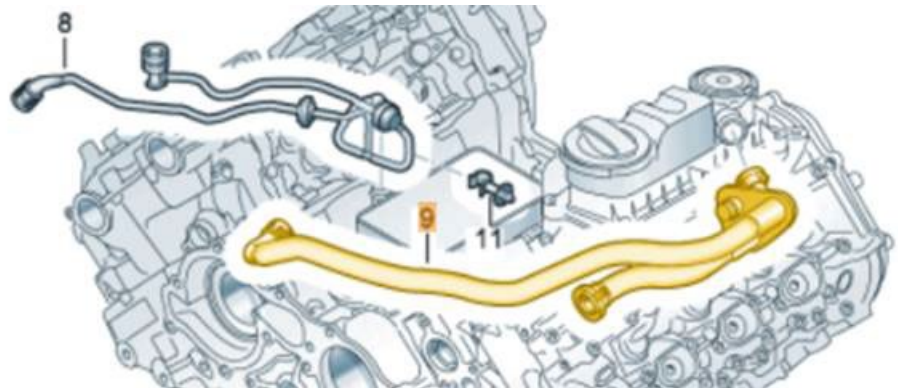
A faulty membrane in the breather line can result in excess pressure in the crankcase and therefore some oil is lost through the filler cap.

Figure 1. Breather line for the Turbocharged V6.

Replace the breather line (different variants available, only order by VIN) by following the Elsa repair manual (Figures 1 and 2).

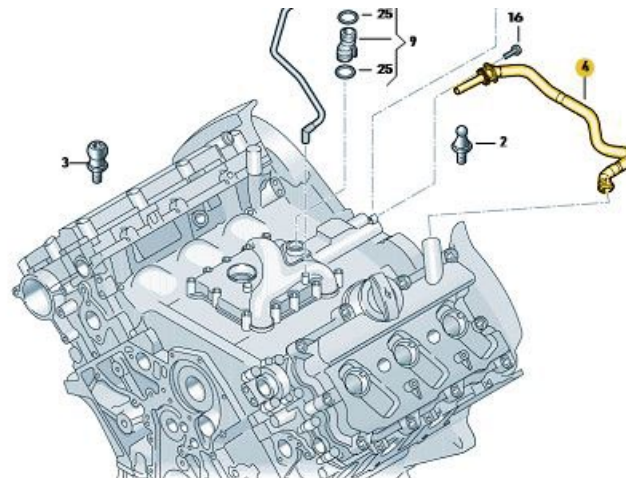
Figure 2. Breather line for the Supercharged V6 (EVO).
