# Technical Service Bulletin

## 64 Faint images appear on the windshield

64 23 86 2047061/4 January 24, 2023. Supersedes Technical Service Bulletin Group 64 number 21-79 dated April 15, 2021, for reasons listed below.

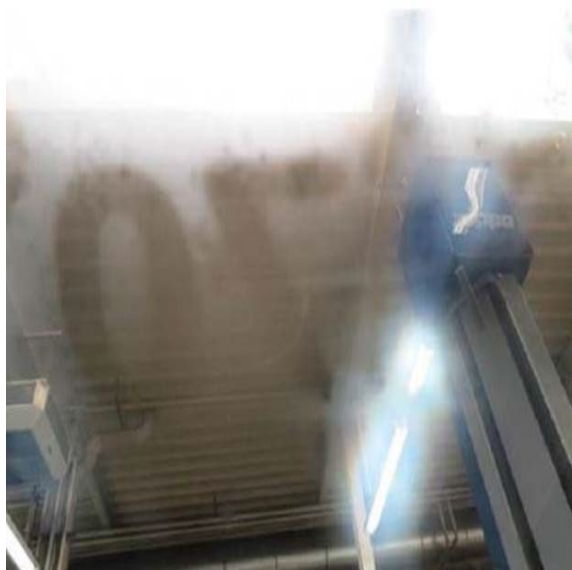
Residue from suction cups or labels can transfer to the glass and, while not visible under normal conditions, can be seen under certain lighting or moisture conditions (Figure 1).

**Figure 1.** Faint images on the window.

This residue can be removed using the cleaning cloth (Figure 2) from the window seal set D 096 330 A2. Apply moderate pressure while cleaning.

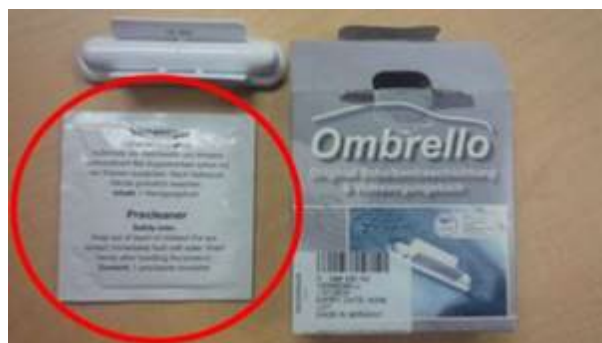
**Figure 2.** Cleaning cloth from the D 096 330 A2 window seal set.

Only use the cleaning cloth. Do not use the applicator that is included in this kit for this purpose.

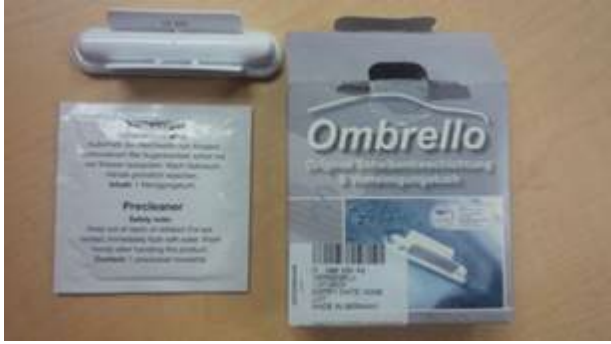
<p>Window Seal Set</p>	01
See ETKA	Fasteners, Bolts, Nuts, and Screws as needed per the Repair Manual	See ETKA/ELSA
