# QUALITY ACTION

### Steering Wheel Bolt

Reference: PC954

## PC954 - 2023 ARIYA STEERING WHEEL INSPECTION

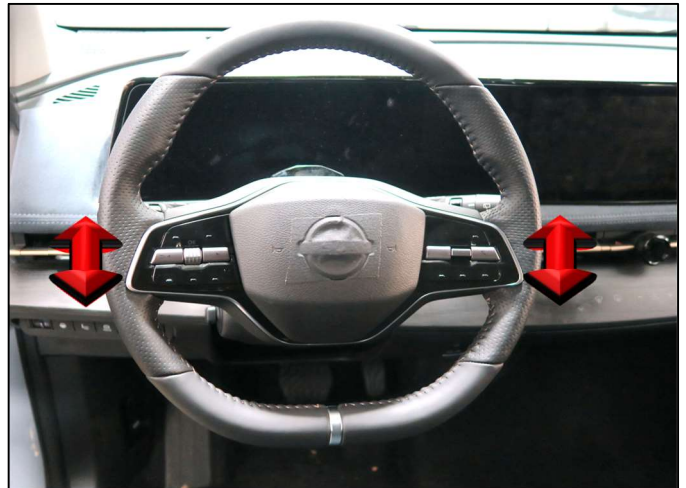
Figure 1

1. Check for looseness between the steering wheel and steering column.
  - Hold the steering wheel at the 3 and 9 o'clock position
  - Rock the steering wheel back and forth

To help avoid damage to the spiral cable in the event the steering wheel is loose, do not forcefully pull rearward (towards you) on both sides of the steering wheel. **Use a rocking motion only.**

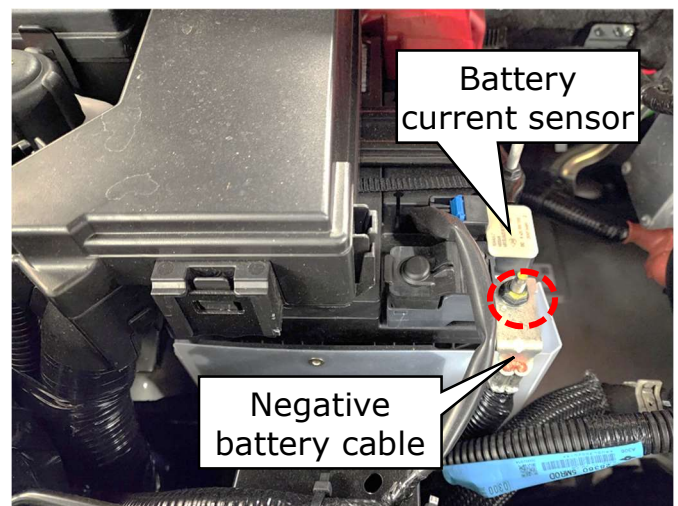
Figure 2

3. Disconnect the 12v battery negative cable from the battery current sensor.
  - Remove the nut securing the negative battery cable to the battery current sensor
  - Lift the cable from the battery current sensor and place next to the battery

To help avoid accidental airbag deployment, injury, or vehicle damage, wait a minimum of 3 minutes before continuing to Step 4.

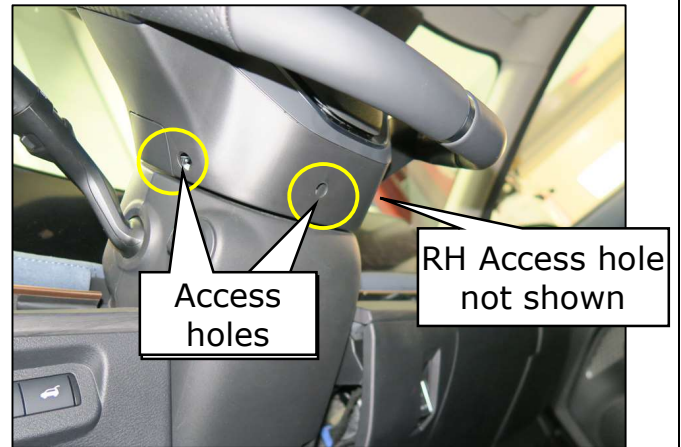
Figure 3

4. Locate the (3) driver airbag release access holes on the sides and the bottom of the steering wheel. (Figure 3)

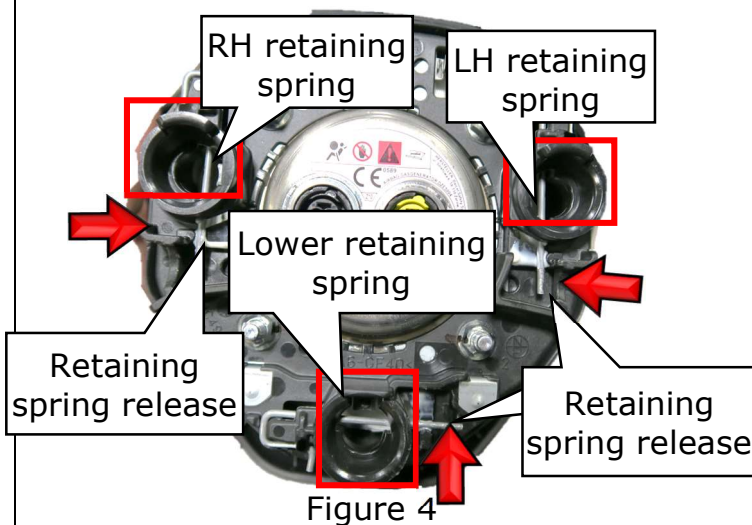
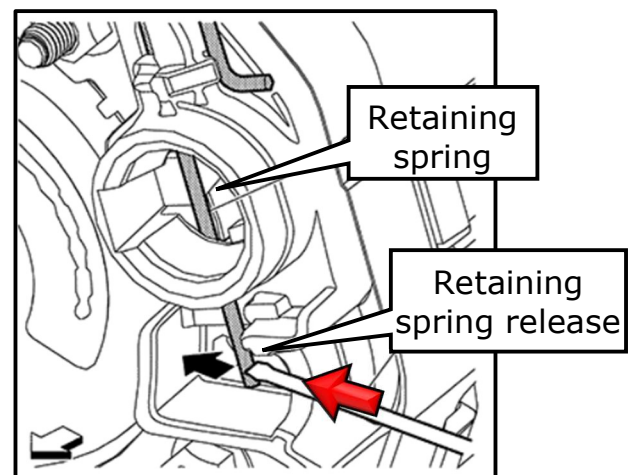
The air bag retainer springs should be released in the following order.

- 1) Lower retainer spring
- 2) LH retainer spring
- 3) RH retainer spring.

- The Driver airbag is secured to the steering wheel with (3) retaining springs.
  - To remove the airbag, each of the retaining springs must be pushed inward with a narrow flat blade screwdriver (Figure 4) (Figure 5)

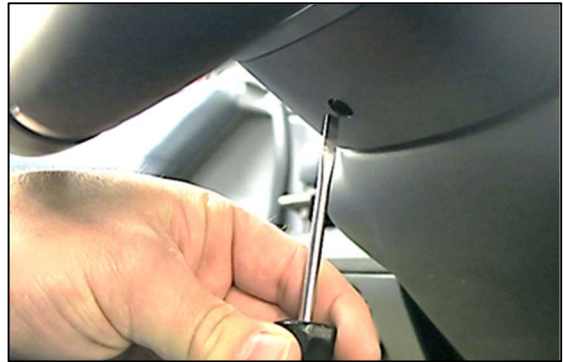
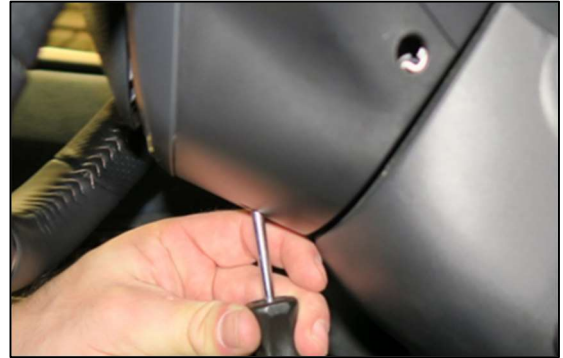
- Insert a narrow flat blade screwdriver with the blade parallel with the steering column into the steering wheel lower access hole, as shown in Figure 6
- Hold the shaft of the screwdriver against the access hole at the angle shown in Figure 7
- Push the spring release upward until the lower portion of the airbag pops outward
  - If the airbag does not move outward, reposition the screwdriver and retry

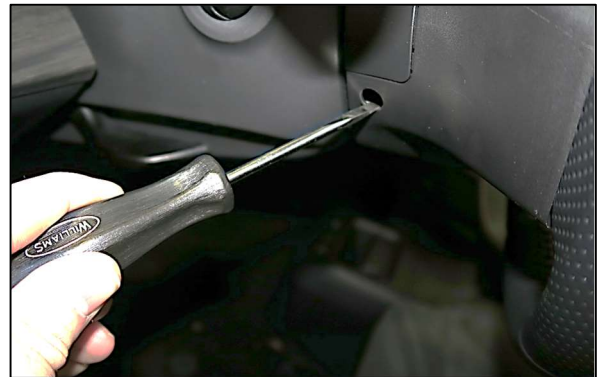
- Insert a narrow flat blade screwdriver with the blade parallel to the steering column into the left steering wheel access hole
- Hold the shaft of the screwdriver against the access hole at the angle shown in Figure 8
- Push the spring release inward until the left portion of the airbag pops outward
  - If the airbag does not move outward, reposition the screwdriver and retry

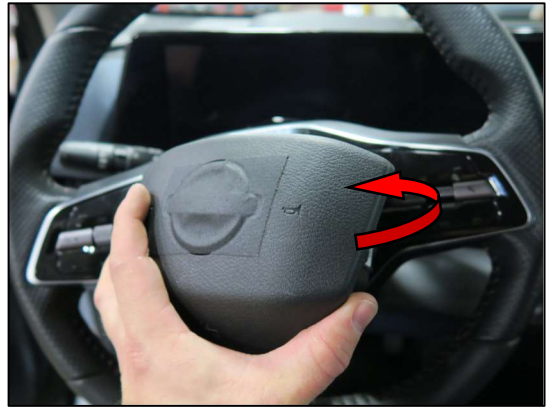
Figure 10

8. Remove the driver airbag from the steering wheel and rotate over to access the wire harness connectors

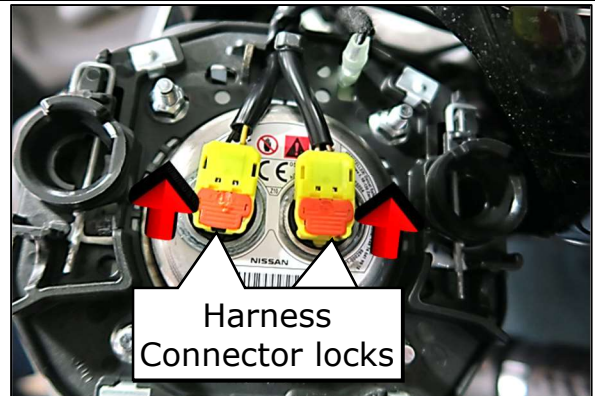
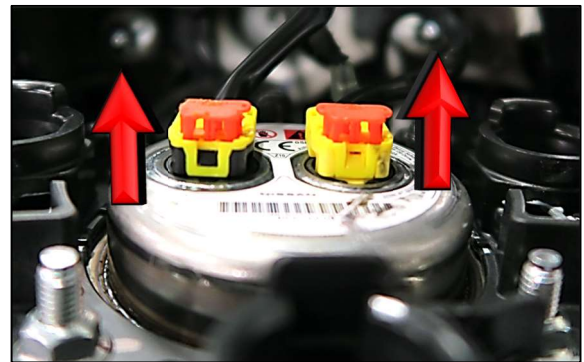
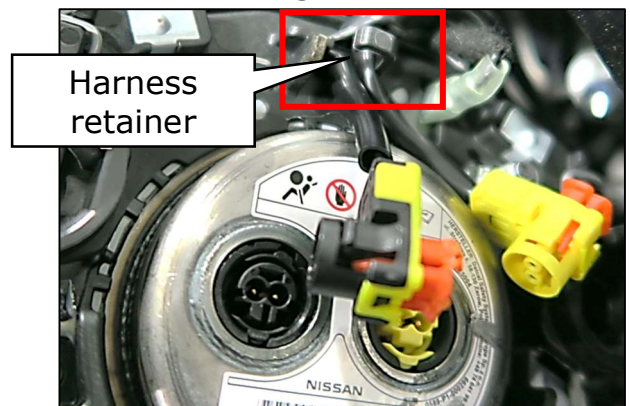
- Using a small flat blade screwdriver, carefully disengage locking tab on the two airbag connectors (Figure 11)
- Lift the two connectors from the airbag (Figure 12)
- Remove the airbag harness connectors from the airbag harness retainer (Figure 13)

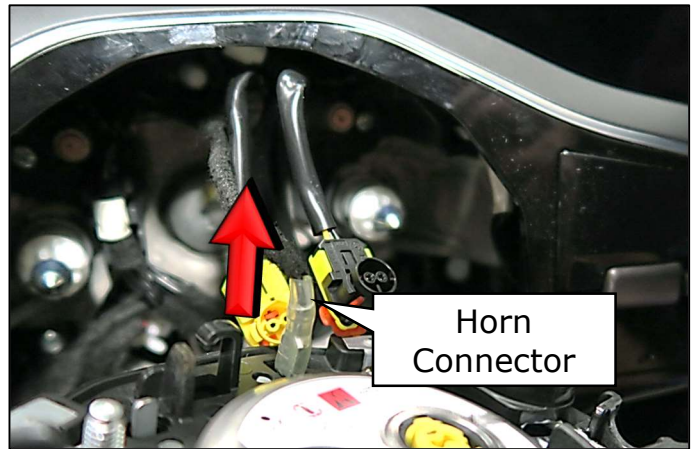
Figure 14

10. Disconnect the horn wire from the driver airbag by pulling the connector upward. (Figure 14)

- Place the airbag in a safe area with the Nissan emblem facing up

To help avoid injury, never place the airbag with the emblem downward.

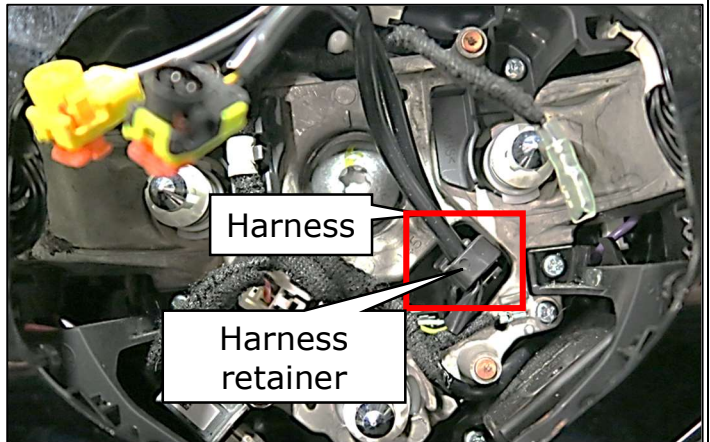
Figure 15

11. Remove the airbag harness connectors from the steering wheel harness retainers (Figure 15).

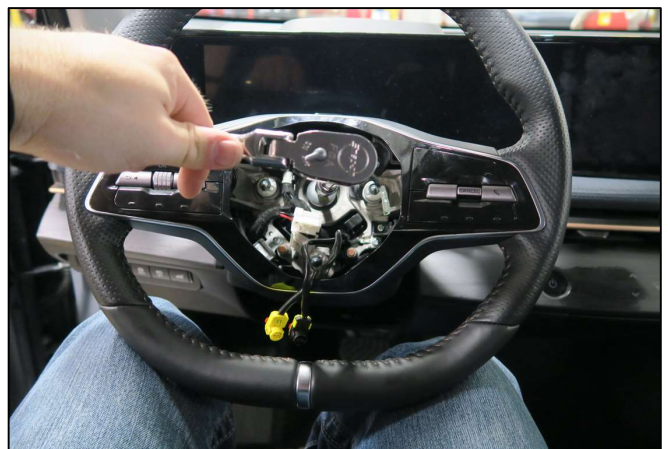
Figure 16

12. Using a T50 Torx bit, remove the steering wheel bolt (If present).

- Discard the bolt, it will **NOT** be reused

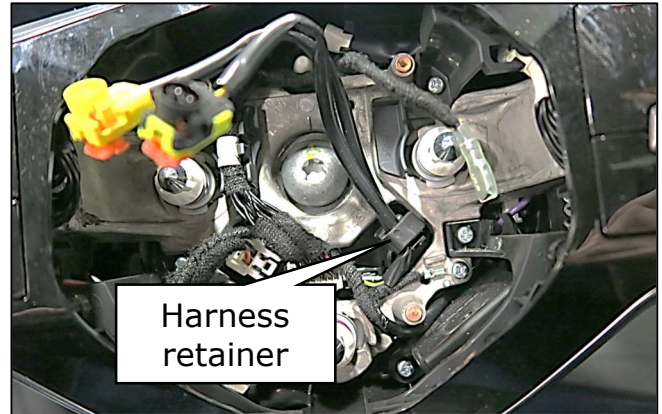
13. Install the **NEW** steering wheel bolt and torque the bolt to 44 N•m (4.5 kg-m, **32 ft-lbs**)

- Route the airbag harness into position in the harness retainer

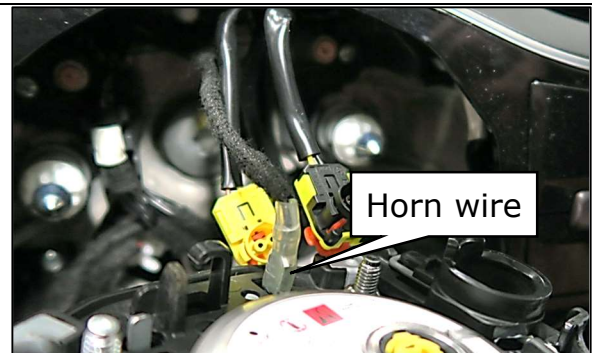
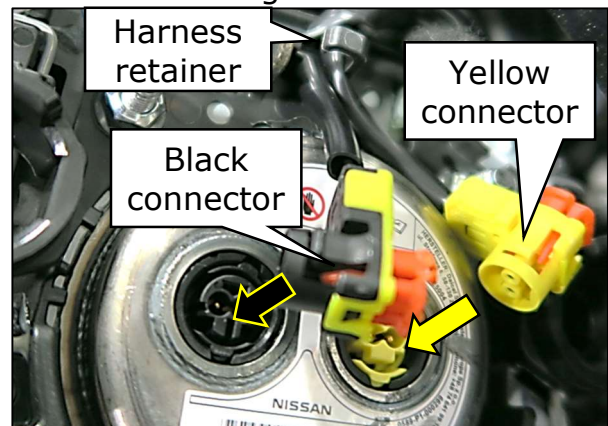
- Reconnect the horn wire (Figure 17)
- Route the harness through the airbag harness retainer (Figure 18)
- Reconnect the black and yellow airbag connectors to the appropriate location on the airbag
- Be sure each connector is fully seated against the driver airbag
- Push each connector body all the way down on the airbag
- Push each connector lock (orange tab) downward until flush
  - If the connector lock is pushed down but is **NOT** flush, disengage the lock, and remove and reinstall the connector
- Pull upward on each connector body to verify they are fully seated

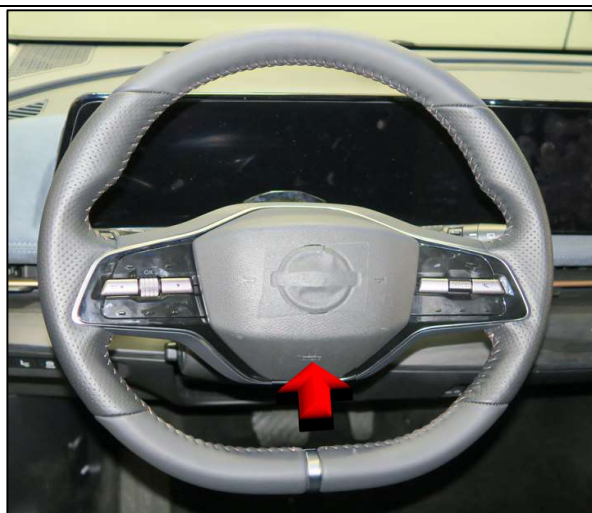
Figure 20

- Turn the airbag over and position over the steering wheel, making sure it is properly aligned
- Push the airbag into the steering wheel until a click sound is heard (Figure 20)
