66 Front radiator grille trim incorrect for vehicle

66 23 96 2069488/1 February 16, 2023.

Model(s)	Year	VIN Range	Vehicle-Specific Equipment
Q8, SQ8, and RS Q8	2023	000001 – 019153	Not Applicable

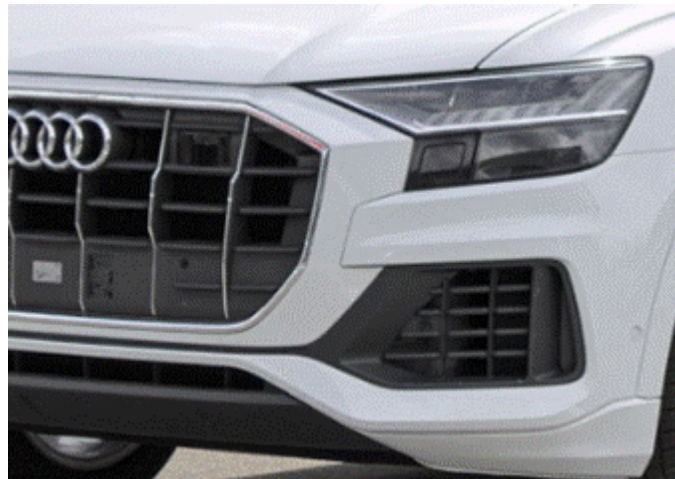
Figure 2 shows the correct configuration with a radiator grille trim in body color.

Figure 2. Correctly configured radiator grille trim in body color.

Replace the radiator grille trim and paint in body color.
