| Applicable Vehicles | | | | | |
|---|---|---|---|---|---|
| ID.4 | 2021-2023 | All | All | All | All |

| Revision Table | | | |
|---|---|---|---|
| 2069638/1 | 3/2/2023 | 87-23-01TT | Original publication. |

Evaporator Drain - Correct body installation location.

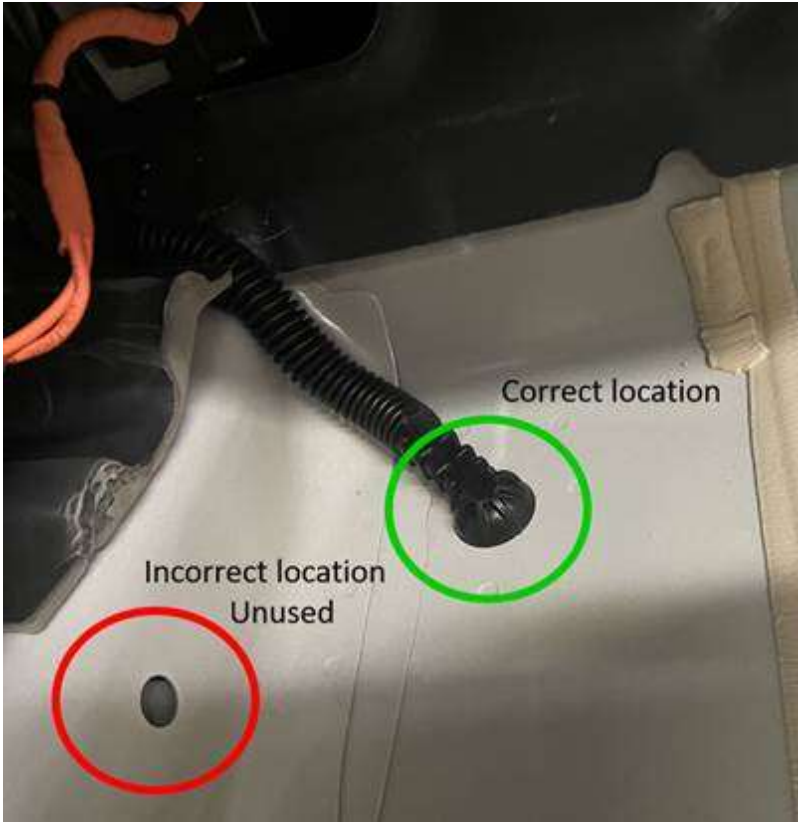
Figure 1.

Possibility of installing the evaporator drain tube in an incorrect location in the body.

There are two stamped holes in the passenger floor pan area. During replacement/reinstallation the evaporator drain tube can be installed incorrectly in the wrong unused stamped hole as seen in figure 1.

When replacing/reinstalling the evaporator drain use the stamped hole in the passenger floor pan to the right of the hole in the body tunnel as shown below.
