REFERENCE:	Nova Bus Manuals
SECTION:	10: Transmission and Control
RS N°:	MQR 7621-2486
EFFECTIVE IN PROD.:	N/A

SUBJECT:	Transmission Coolant Pipes
JUSTIFICATION:	P-clamps holding the transmission coolant pipes can break and cause coolant leaks.

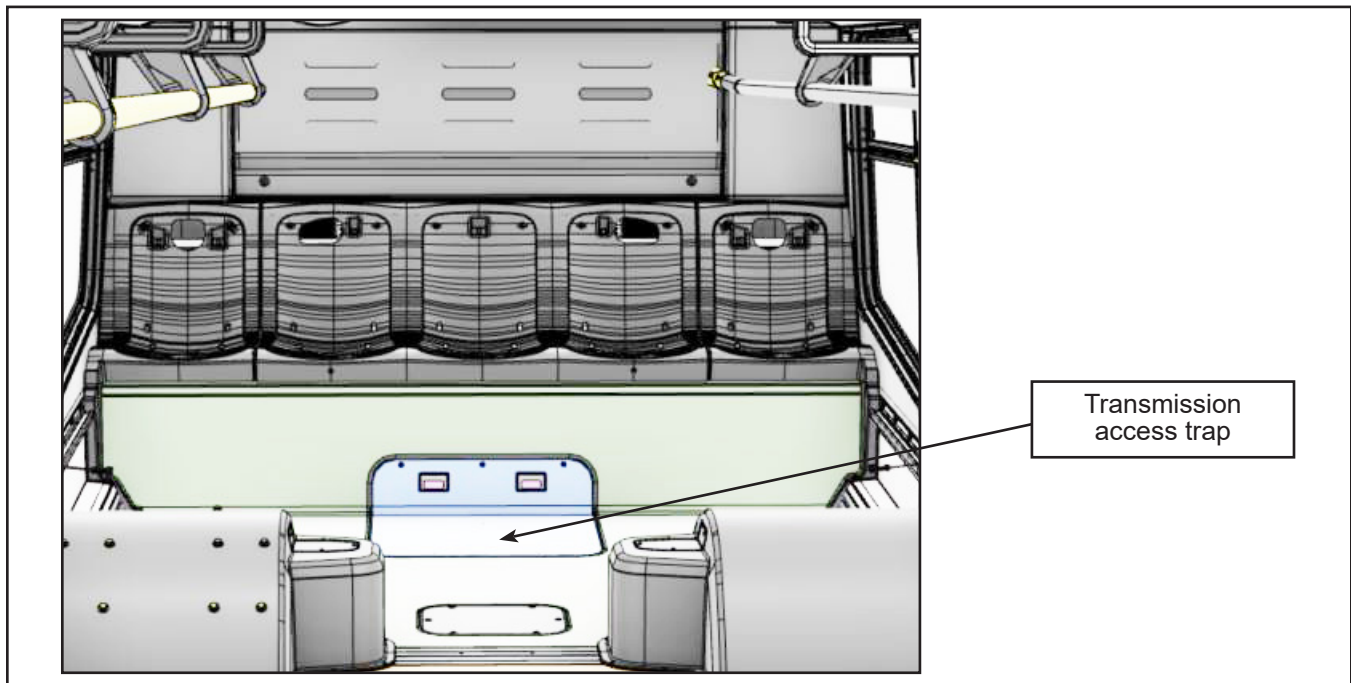
Figure 1 - Transmission Access Trap

- 1.1. Park the vehicle on an even surface with the transmission on neutral.
- 1.2. Apply the parking brake and set the master control switch to the **stop** position.
- 1.3. Set the battery disconnect switch in the battery compartment to the **off** position.
- 1.4. Locate and open the transmission access trap at the rear of the vehicle (Figure 1).

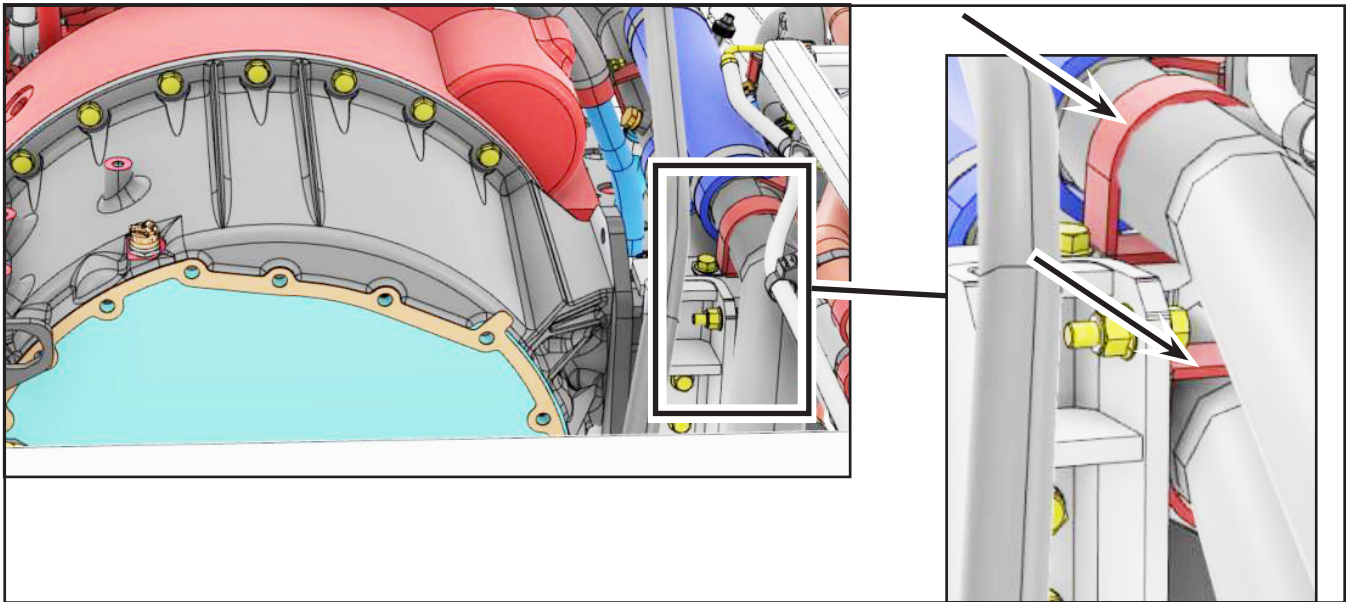
Figure 2 - The two P-clamps Securing the two Transmission Coolant Pipes

- 1.5. Locate the two P-Clamps mounted on the engine cradle bracket that secure the two coolant pipes (Figure 2).
- 1.6. Remove the two P-clamps, the screws and the nuts. Discard the P-clamps (Figure 3).
- 1.7. Prior to their installation, it is recommended to pre-bend/preform the 2 new P-clamps N31320-09 to facilitate their installation.
- 1.8. Install the two new P-clamps with the removed screws and nuts. Torque to the torque value of 17 ± 2 lb-ft (23 ± 2 N•m).
- 1.9. Close the transmission access trap.

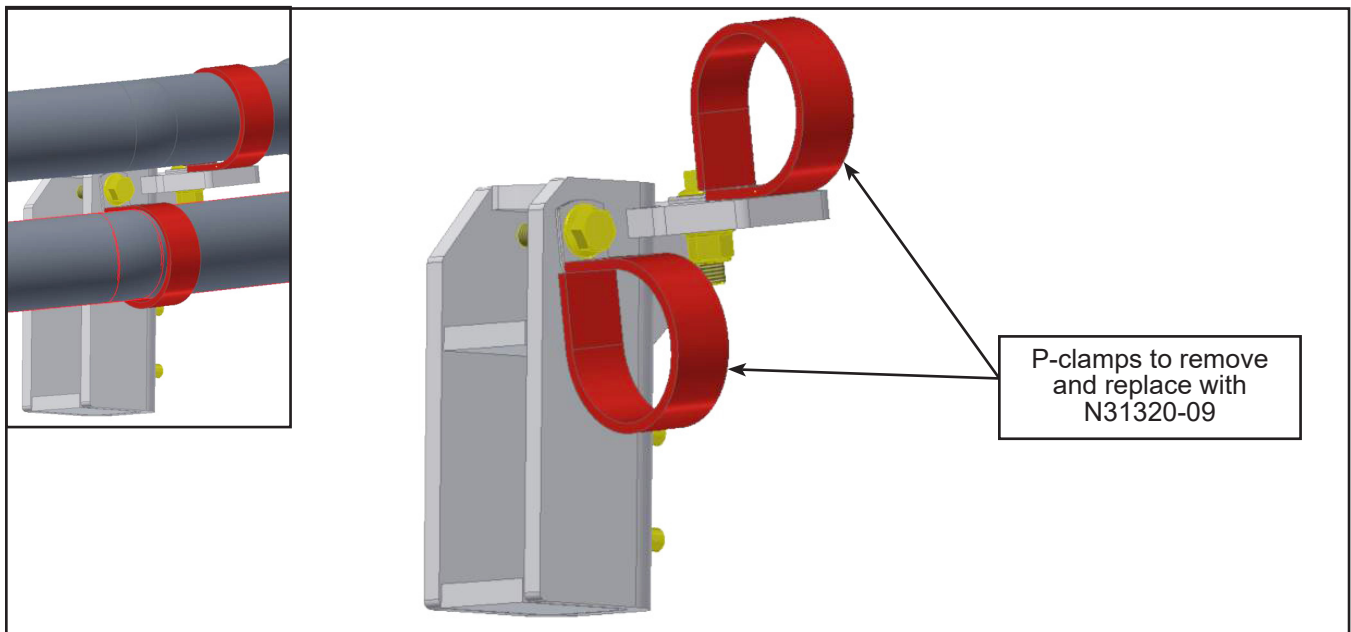
Figure 3 - P-clamps to Replace
