Oil In Coolant - Cross Contamination From Oil Cooler - 13L VGT Engines

13L VGT engines manufactured between January 2020 and August 2022 may experience coolant contaminated with oil due to oil cooler failure. This failure may be due to excess material buildup on the coolant duct cover that results in interference with the oil cooler.

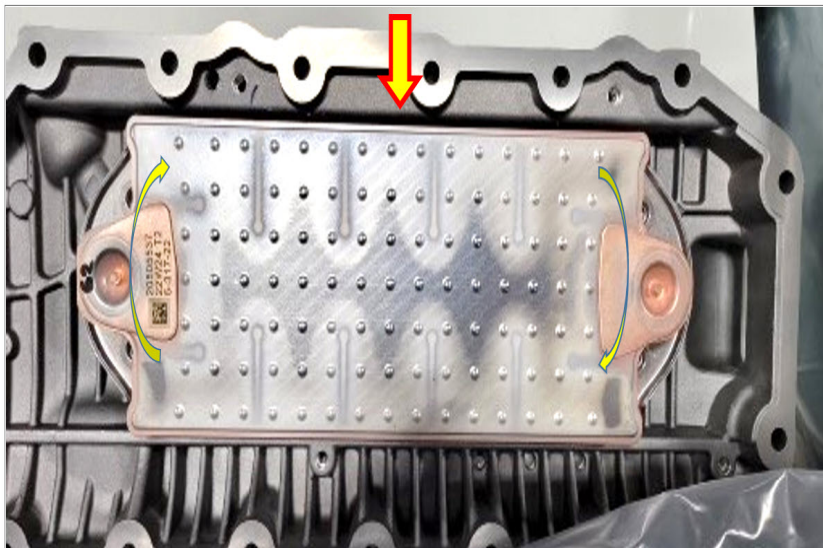
Oil Cooler not seating in CDC

Arrow ↓ indicates area of contact for the oil cooler to the Coolant duct cover. The oil cooler rocks back and forth on the contact point to the coolant duct cover.

If the coolant duct cover's appearance matches the suspected part picture above, **both the oil cooler and the coolant duct cover should be replaced** to prevent future failure.

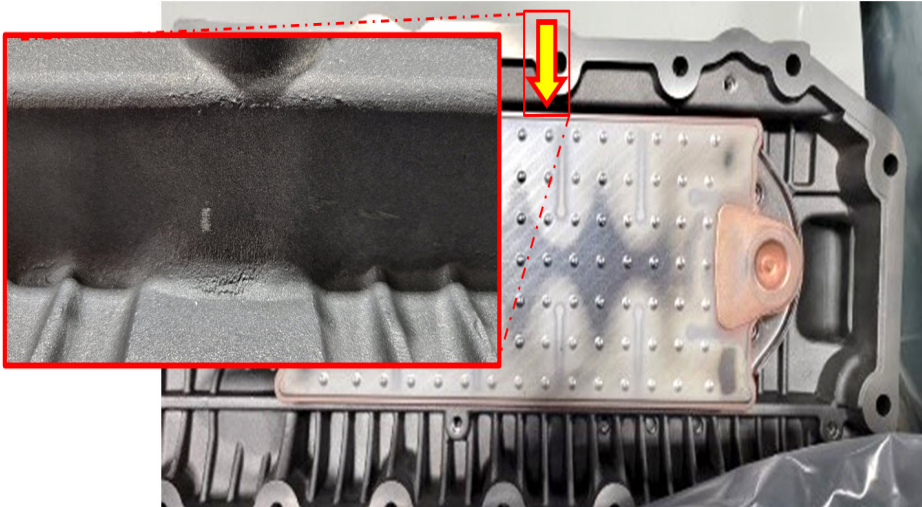
Oil Cooler not seating in CDC

Arrow ↓ indicates area of contact for the oil cooler to the Coolant duct cover.
The contact point to the coolant duct cover is seen visibly when the oil cooler is removed after installation is attempted.

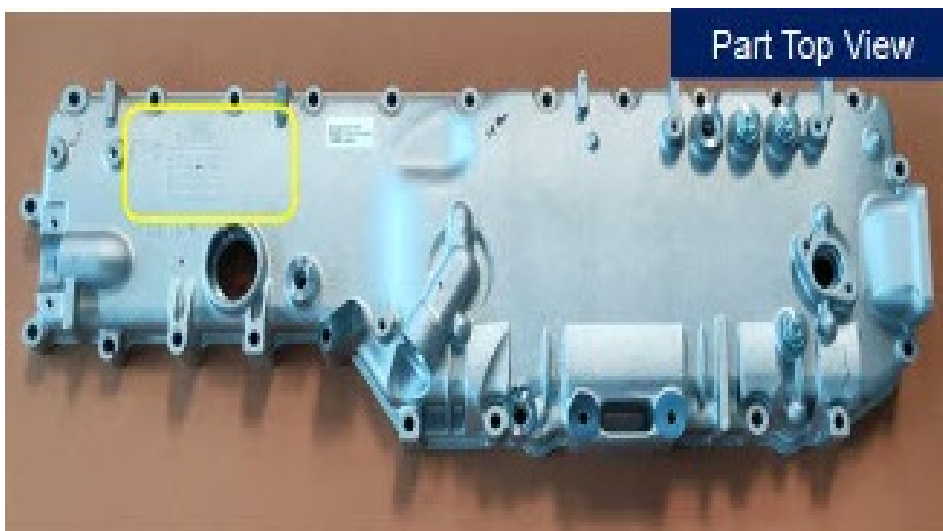
The casting date can be located and checked using the picture below as a guide.

Location of casting information

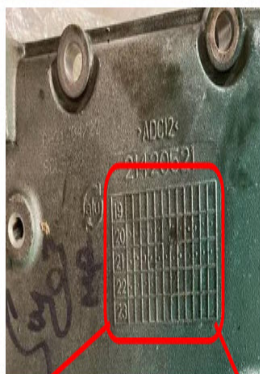
Suspected Part

Meaning:

- 4 dots in 2022
- Casting produced in Apr-22 month

Judgement:
It is Risky part as it is produced before Sep-22 and to be taken out

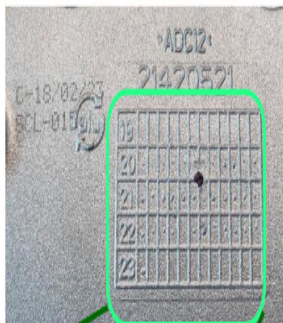
Good part

Meaning:

- 1 dot in 2023
- Casting produced in Jan-23 month

Judgement:
It is Ok as the part produced in or after Sep-22

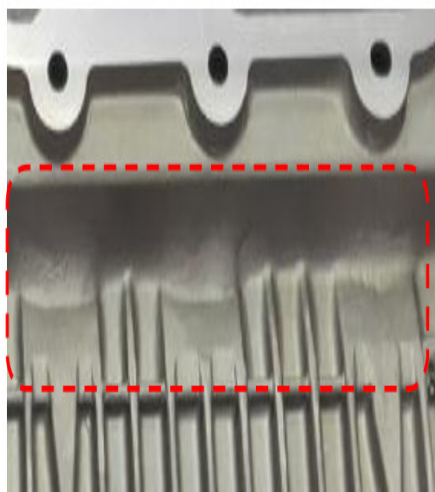
Suspected part

If the casting date falls within the possible affected range, the location below should be inspected to determine if it may have contributed to the failure.
