GROUP	NUMBER
AUTOMATIC TRANSMISSION	23-AT-001G
DATE	MODEL(S)
	G70 (IK), G80 (DH), G80 (RG3), G90 (HI), GV80 (JX1), GV70 (JK1)

AUTOMATIC TRANSMISSION SOLENOID DTC P0741, P0743, SUBJECT: P0748, P0753, P0758, P0763, P0768, P076A, P076D, P0773, P0785, P078A, P2709

DESCRIPTION: When servicing a vehicle with a "Check Engine light" and any of the DTCs listed below, follow the Service Procedure to replace the related solenoid and E-module or park position switch.

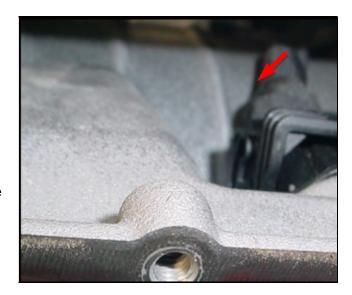
- 3. Visually check the control wiring harness between the TCM and transmission for a damaged wire or connector. Check for an open/short circuit.
 - If so, repair or replace the control harness and drive the vehicle to confirm the repair.
 - If no damage is found, go to Step 4.
- 4. Record the audio preset stations and disconnect the negative battery terminal.
- 5. Locate the harness connector on the passenger side of the transmission.

Press the tab in the center of the latch and push the latch upward.

Push the connector up to disconnect the connector from the valve body.

To gain better access to the connector, place a support under the rear transmission support, loosen the bolts about ½ inch and lower the support about ½ inch.

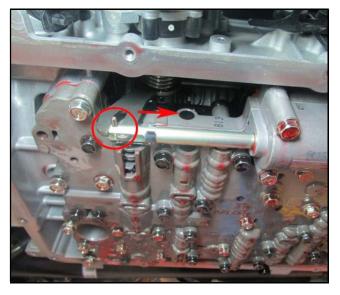
Confirm the manual valve pin faces outward from the valve body.

18. Place the valve body on a transmission jack.

Rotate the park switch counter-clockwise and carefully raise the valve body and insert the manual valve into the shift lever.

Install the valve body fully into the transmission case.

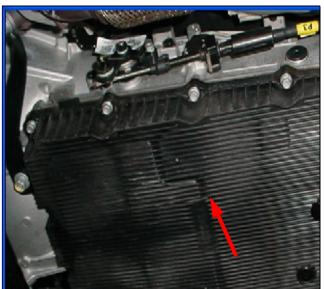
Use only SP-IV-RR ATF, P/N 00232-19052.

24. Remove the overflow plug.

Use a fluid pump or suction gun to add **SP-IV-RR** ATF through the fill plug until ATF flows from the overflow plug.

Reinstall the fill plug and overflow plug.

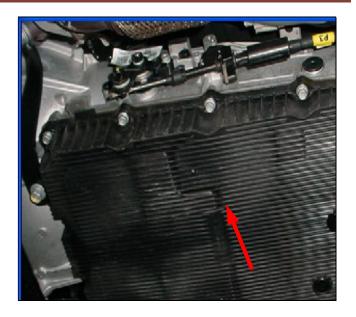
ATF TEMPERATURE = 122~140°F (50~60°C) SHIFT LEVER IN "P" AND ENGINE RUNNING

26. Start the engine, shift to Park and raise the vehicle on a hoist.

Remove the fill plug and overflow plug.

Add **SP-IV-**RR ATF through the fill plug until the ATF flows out the overflow.

Reinstall the overflow plug.

Torque: 16~18 lb-ft (2.3~2.5 kgf.m, 22~24 N.m)

Reinstall the fill plug and washer.

Torque: 25~32 lb.ft (3.4~4.4 kgf.m, 33~43N.m)
