Technical Service Bulletin

90 Audi virtual cockpit: display distorted due to broken screen

90 23 18 2065960/2 March 17, 2023. Supersedes Technical Service Bulletin Group 90 number 22-43 dated January 31, 2022, for reasons listed below.

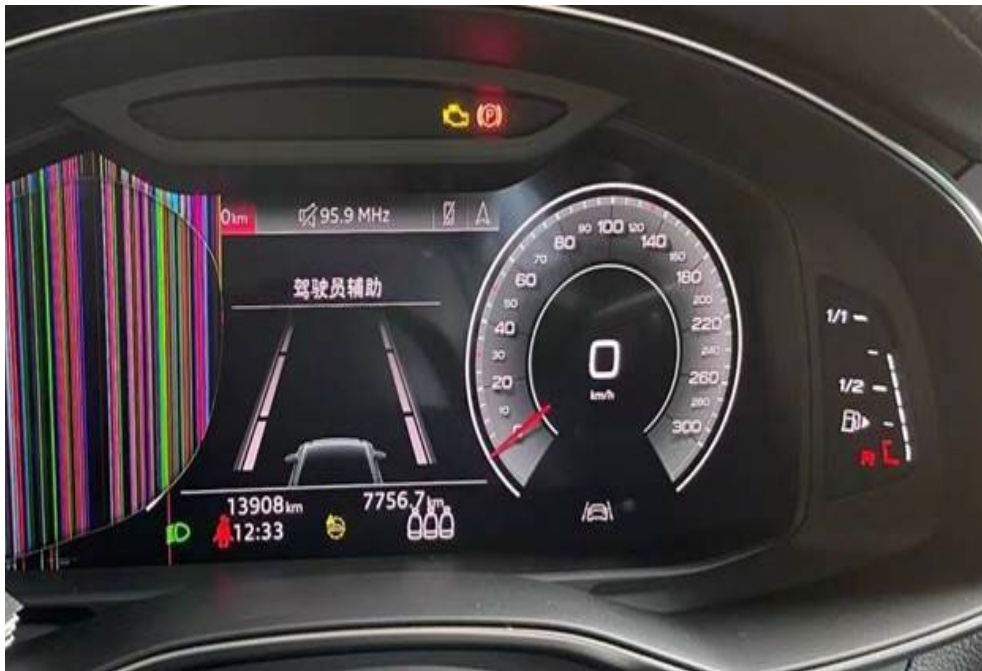
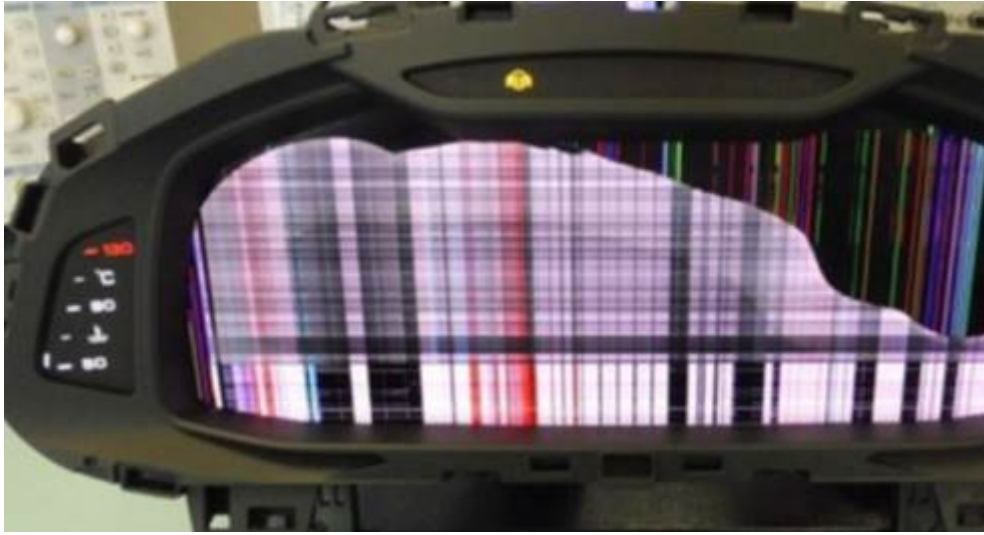
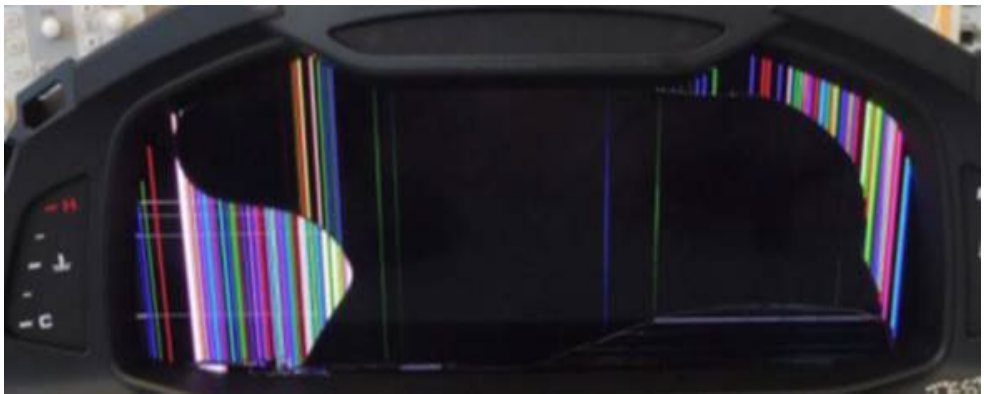
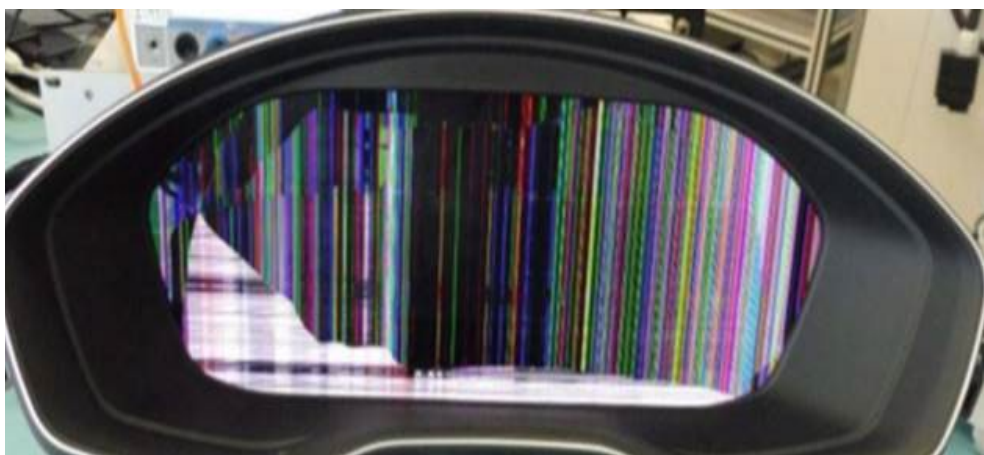
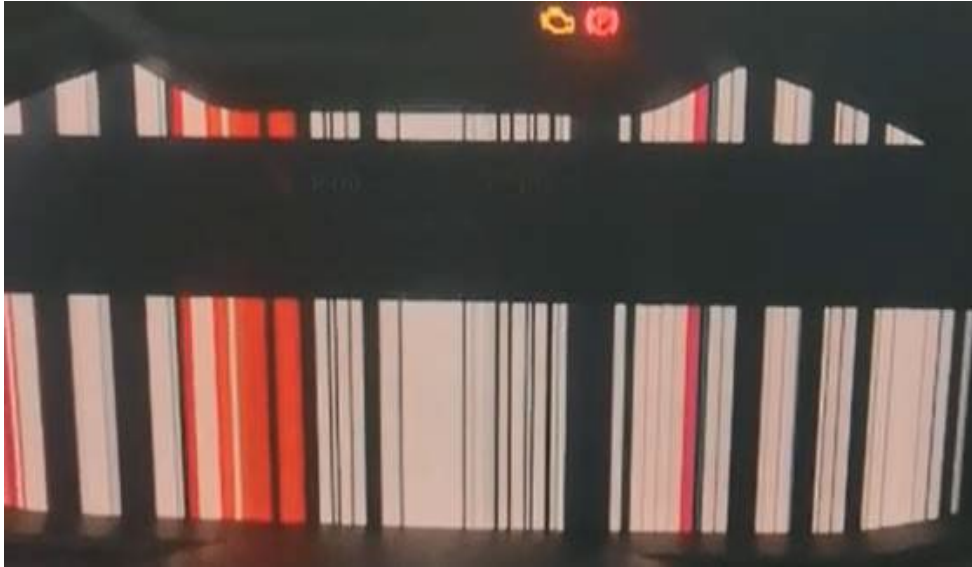
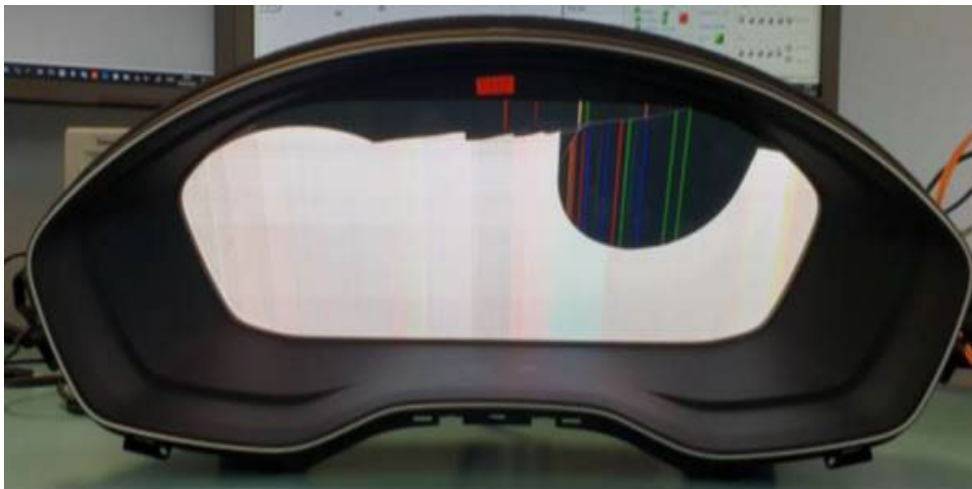
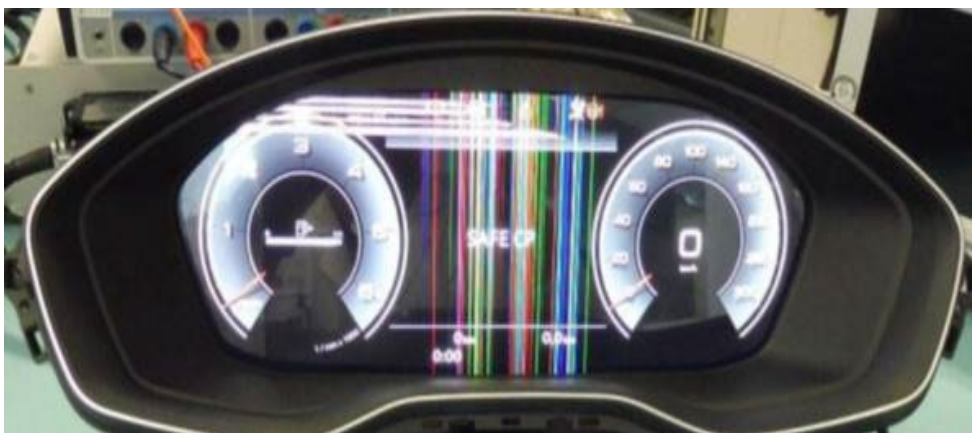
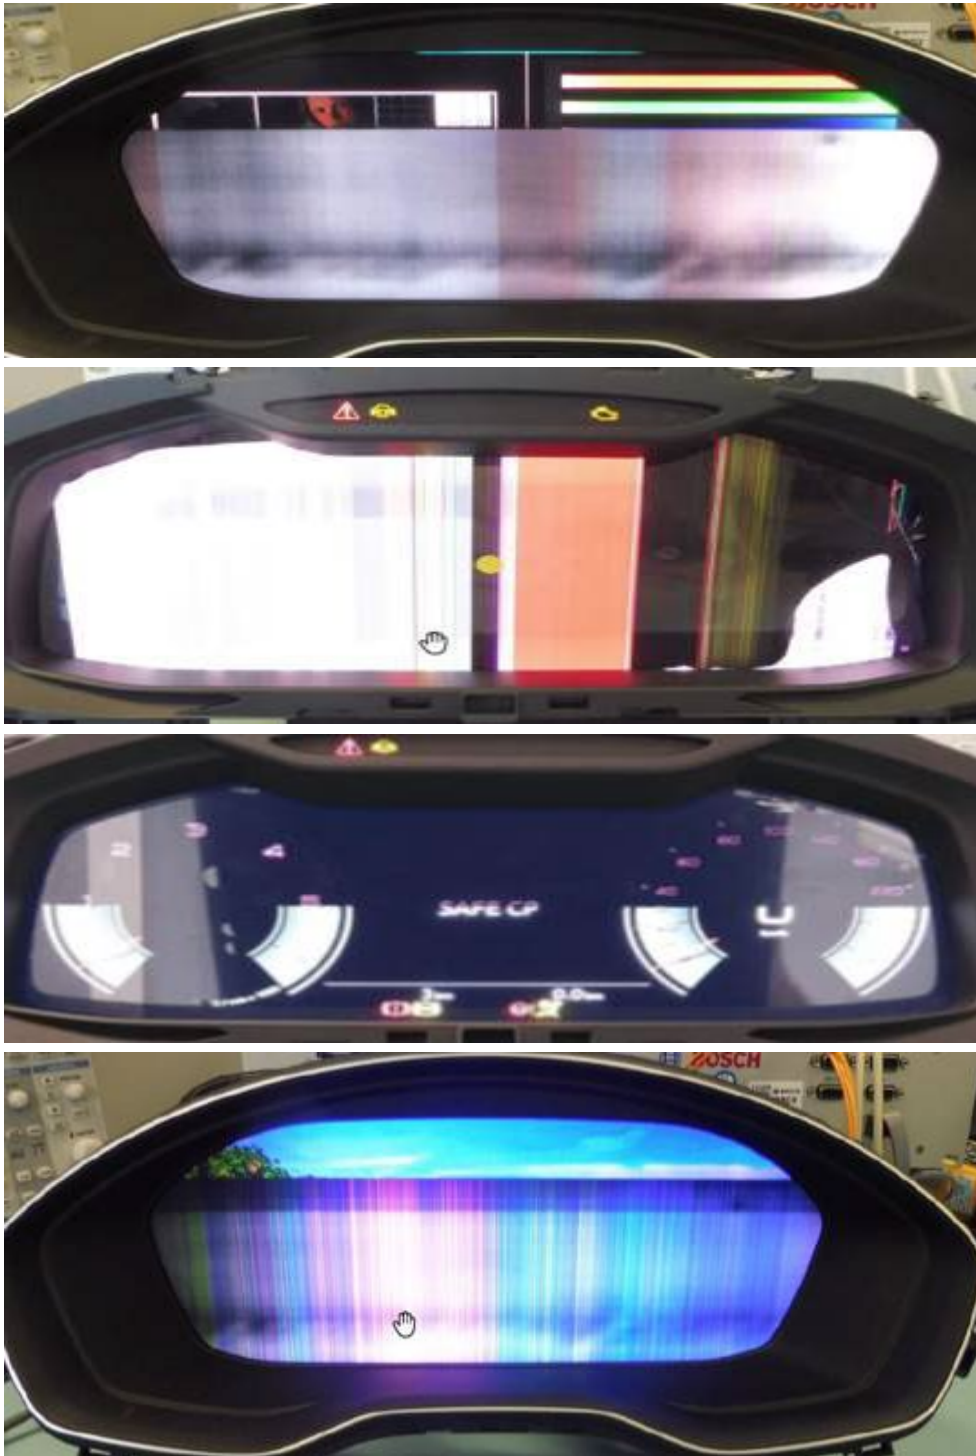
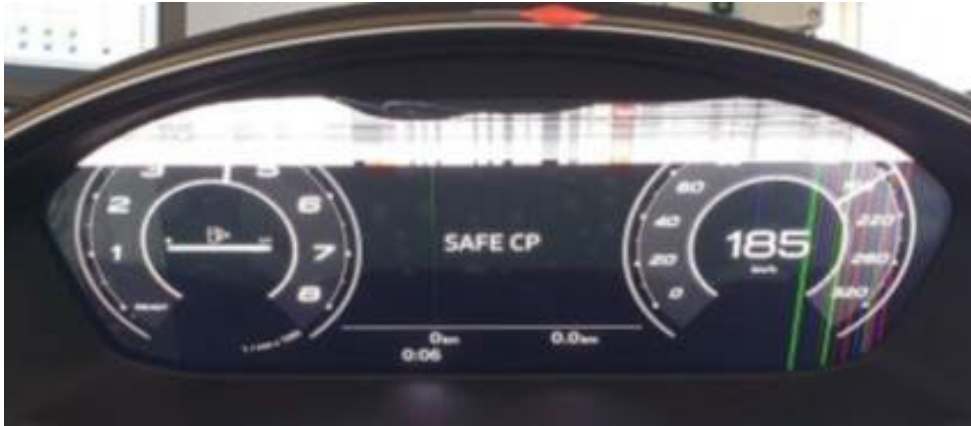
The Audi virtual cockpit display is distorted.

There are cracks in the Audi virtual cockpit display.

The following photos show examples of the complaint:

Extensive analysis has shown that the display layer under the uppermost display film has a crack.

This crack is the result of external force being applied to the display of the Audi virtual cockpit, either directly to the front of the screen, or to the display housing.

While the uppermost display layer, the transparent film, is not broken or cracked, it may show witness marks where the force was applied (e.g. fingerprints, scratches, polishing marks)

The external force which caused the crack and the complaint may have been exerted during improper cleaning of the Audi virtual cockpit, repair work on the dash panel, an accident or a user incorrectly assuming that the display of the Audi virtual cockpit has the functions of a touchscreen.

The complaint may not be visible right after excessive force was applied, as the lower display layer may be damaged and experience fatigue cracking as a result of the initial force event. This may take a couple hundred miles of driving.

If the vehicle has an odometer reading of over 600 miles, material and/or production issues can be ruled out as the source of the complaint.

Therefore, **warranty claims for vehicles with over 600 miles will not be reimbursed by warranty.**

This damage is due to outside influence and is not covered by any Audi Warranty.
