Countries: CANADA, UNITED STATES Document ID: IK2300015  
 Availability: ISIS, IsSIR Revision: 0  
 Major System: ELECTRIC VEHICLE Created: 3/7/2023  
 Current Language: English Last Modified: 3/8/2023  
 Other Languages: NONE Author: Josh Bowman  
 Viewed: 85

Title: Electric Vehicle Coolant Pipe Contact

Applies To: Electric CE Buses

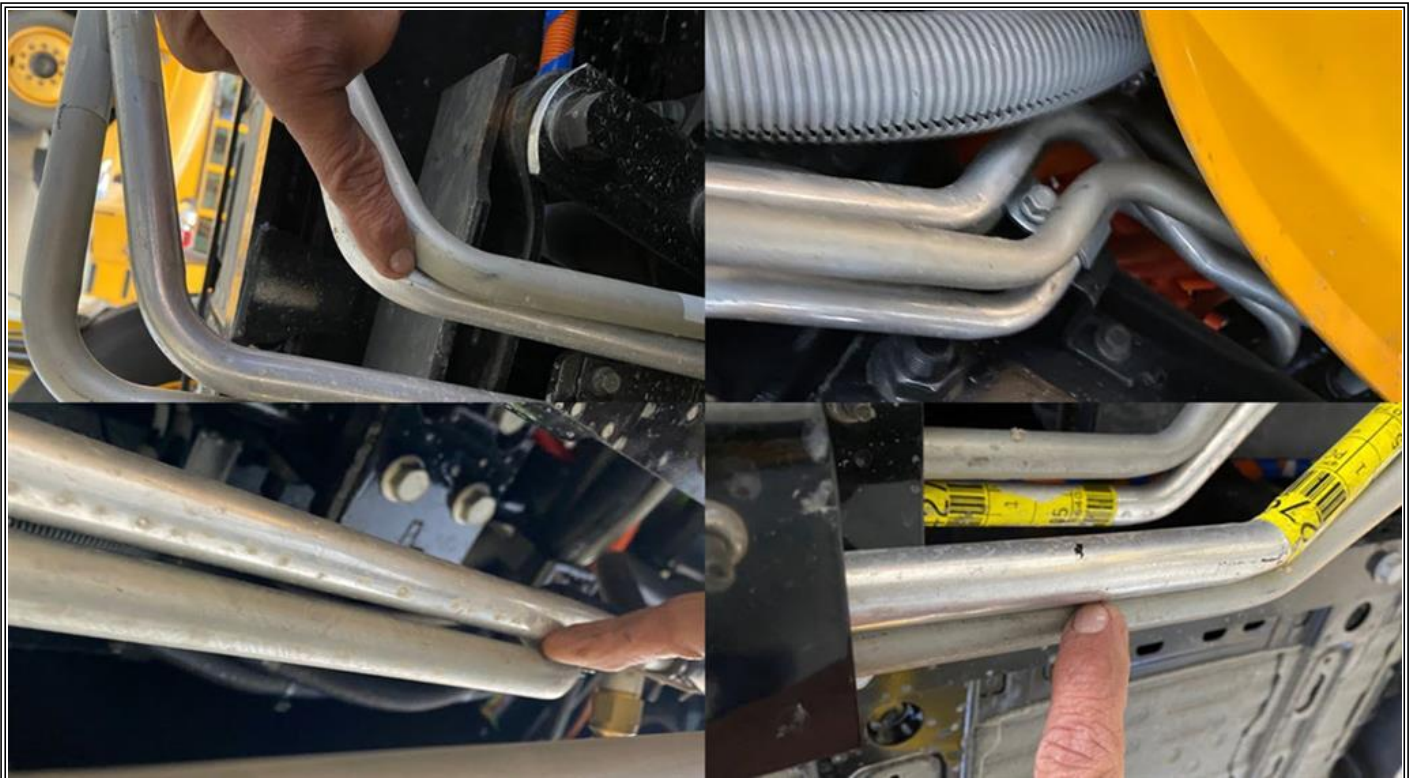
Certain Electric CE Buses may be found with under chassis coolant pipes making contact. This contact **does not** result in a failure, nor does it violate any Federal Motor Vehicle Safety Standards (FMVSS) or California Code of Requirments (CCRs), however there may be subjective concerns brought up around the coolant pipe contact. If those concerns are raised to pass any state inspection, this document will guide the user through the proper steps to provide the separation needed.

None - State inspector(s) may deem the under chassis coolant pipe contact not acceptable

Figure 1: Examples of coolant pipe contact

1. Bring vehicle into shop area and park vehicle on a dry level surface.
2. Shift transmission into Park or Neutral and set parking brake.
3. Turn ignition to Key OFF position
4. Install wheel chocks.
5. For strap location #1 (Figure 2, Item 1), measure 5" (127mm) from the leading edge of support (Figure 2, Item 3) and install cable strap (PN 35358731)
6. For strap location #2 (Figure 2 Item 2), measure 12" (305mm) from the leading edge of support (Figure 2, Item 3) and install cable strap (PN35358731)

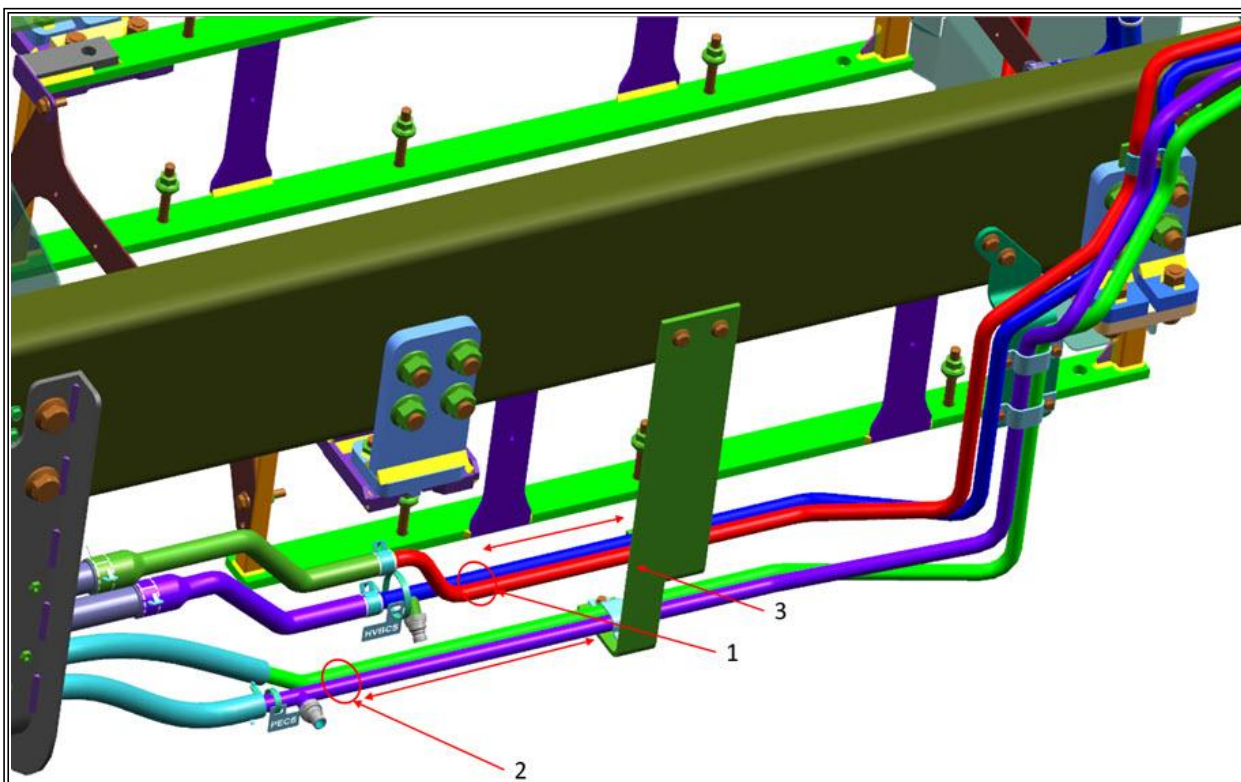
**Figure 2: Cable Strap Locations 1 & 2**

- Item 1: Cable Strap Location #1 (3535873C1)
- Item 2: Cable Strap Location #2 (3535873C1)
- Item 3: Support Bracket

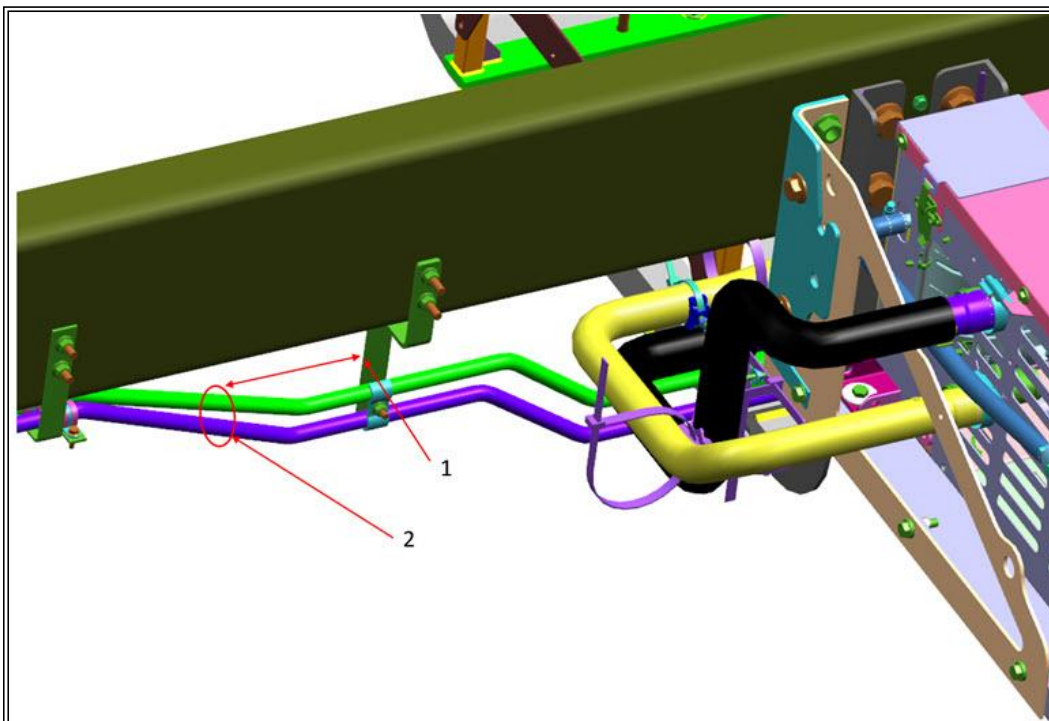
**Figure 3: Cable Strap Location 3**

- Item 1: Support Bracket
- Item 2: Cable Strap Location #3 (3535873C1)

7. For strap location #3 (Figure 3, Item 2), measure 9" (228mm) from the leading edge of support (Figure 3, Item 1) and install cable strap (PN 35358731)

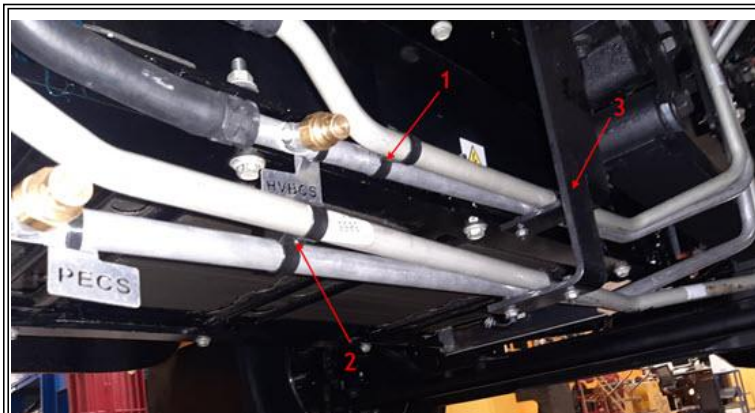
**Figure 4: Installed Cable Straps Location 1 & 2**

- Item 1: Cable Strap Location #1 (3535873C1)
- Item 2: Cable Strap Location #2 (3535873C1)
- Item 3: Support Bracket

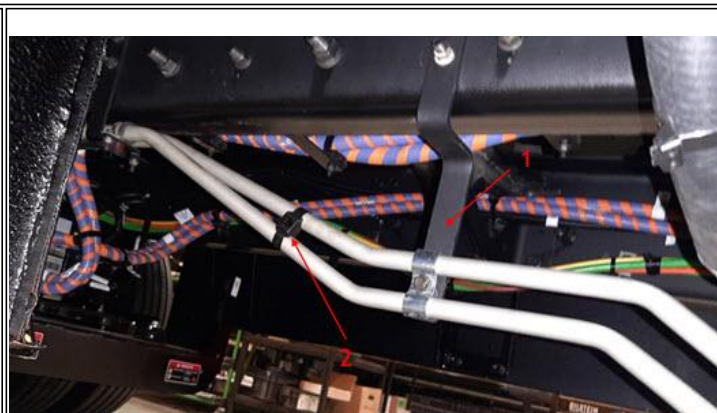
**Figure 5: Installed Cable Strap Location 3**

- Item 1: Support Bracket
- Item 2: Cable Strap Location #3 (3535873C1)
