# Service Bulletin

Bulletin No.: 23-NA-017

**Subject:** High Pitched Squealing, Moan or Whistling Noise at Idle

Brand:	Model:	Model Year:		VIN:		Engine:	Transmission:
		from	to	from	to		
Chevrolet	Silverado 2500HD/3500HD	2022	2023			L8T	
GMC	Sierra 2500HD/3500HD

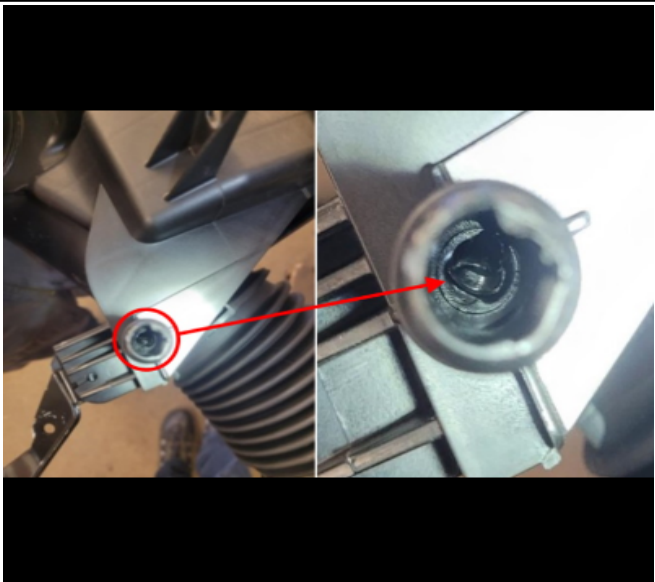
<b>Involved Region or Country</b>	North America
<b>Condition</b>	Some customers may comment that a high pitch squeal, moan or a whistling noise can be heard at idle Some technicians may comment that the noise can be heard at the rear main seal of the engine and may continue for a few seconds after the engine is shut off.
<b>Cause</b>

<p style="text-align: right;">6270638</p> <p>This condition may be caused by excessive crankcase vacuum from a restriction on the PCV of the air cleaner outlet duct.</p>
<b>Correction</b>	If the noise has been validated, remove the oil cap or oil level indicator to verify that the noise has been eliminated. If the noise has been eliminated, replace the air cleaner outlet duct.

Refer to *Air Cleaner Outlet Duct Replacement* in the Service Manual.
