**April 7, 2023**

## Buzzing or Whining When Adjusting Power Front Seat Forward and Backward

Supersedes 19-024, dated November 12, 2019, to revise the information highlighted in **yellow**.

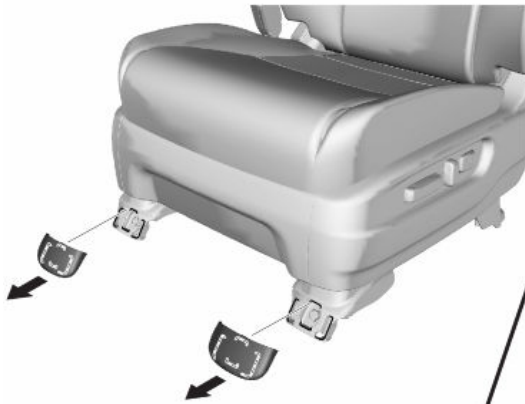
*FRONT SIDE*

1. Remove the seat track end covers to expose the seat mounting bolts.

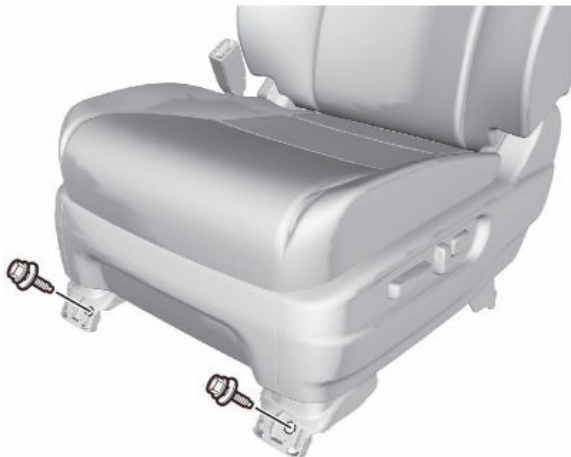
*FRONT SIDE*

2. Remove the four seat mounting bolts.

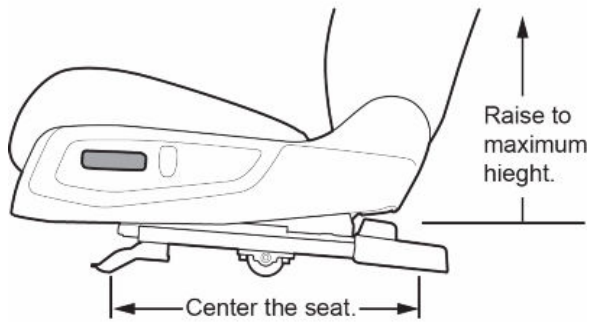
3. Prepare the seat for removal.

- Adjust the seat slide to the middle of its travel.
- Raise the seat to its maximum height (driver's seat only).

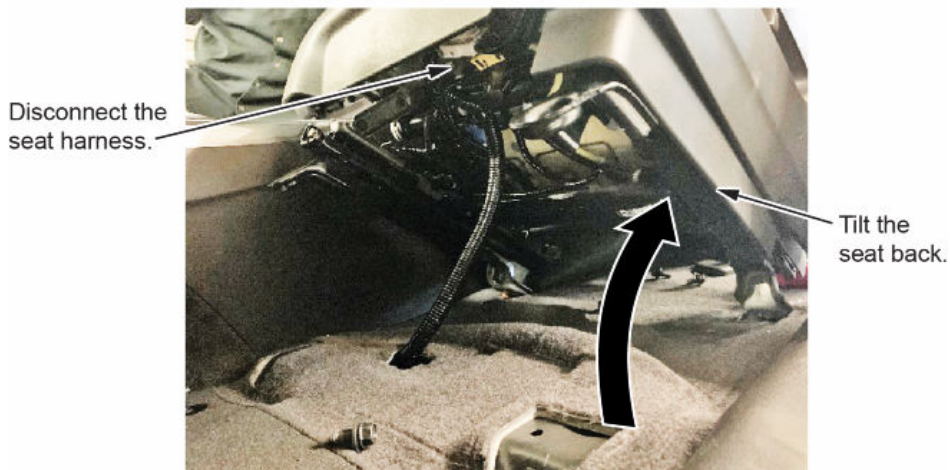
6. Tilt back the entire seat and disconnect the seat harness.

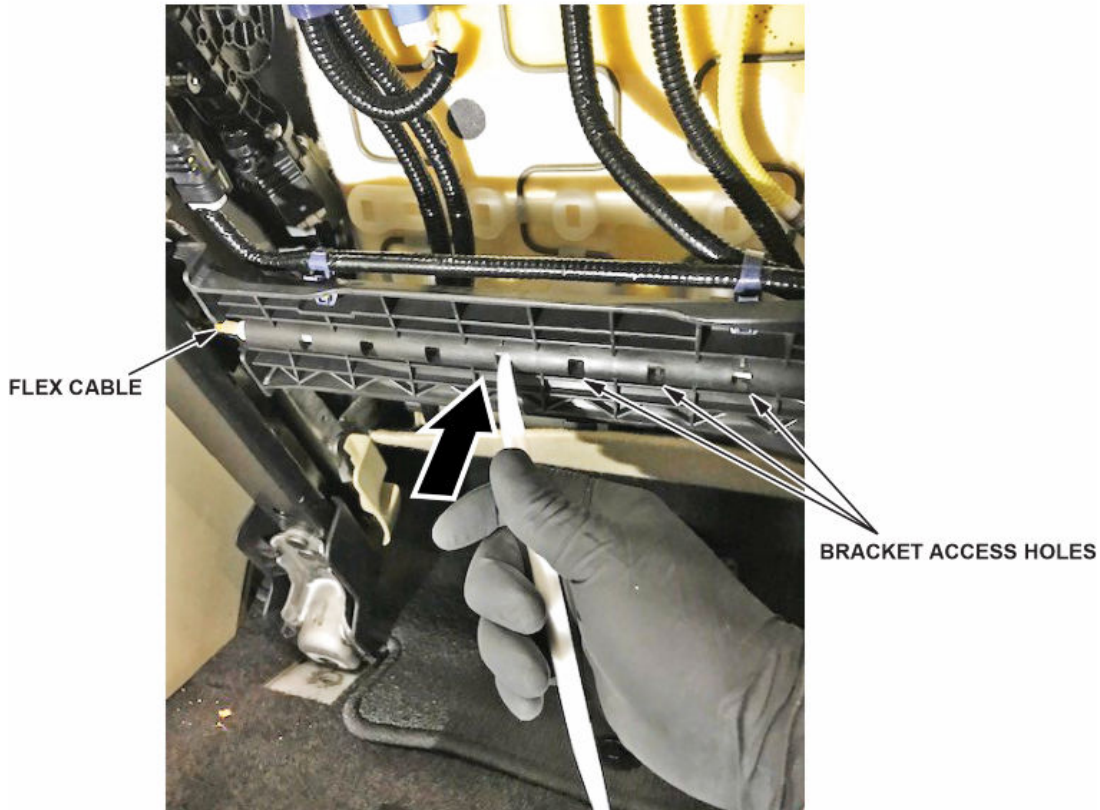
7. Insert a plastic trim tool or flathead screwdriver through the bracket access holes one at a time until the cable is released from the bracket.

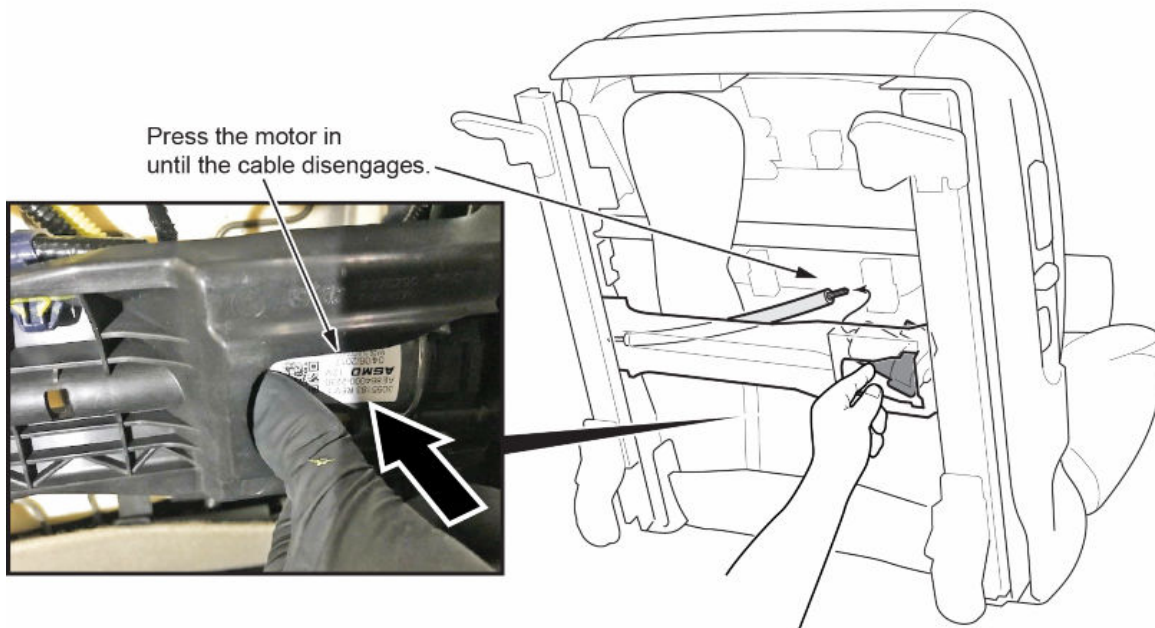
8. Disconnect the flex cable from the motor side first by gently pushing in on the motor at the cable end to disengage it from its mounting bracket. This will help when removing and replacing the flex cable assembly.

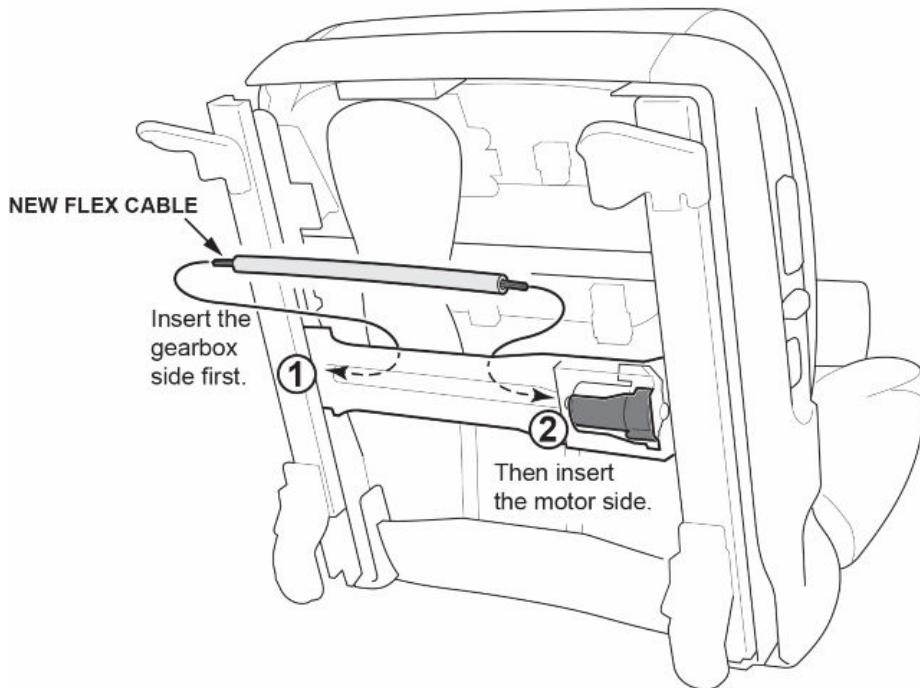
10. Install the new flex cable in the reverse order of removal. Start by inserting the cable into the seat rail gearbox side, then fully insert the other end into the motor.

NOTE: Make sure to not bend or kink the cable during installation.

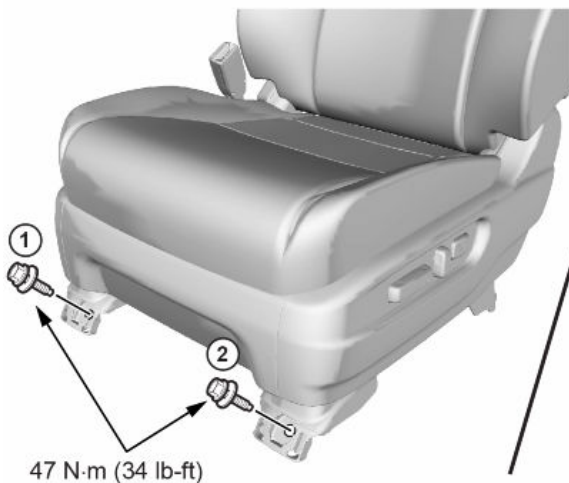
**FRONT SIDE**

11. Snap the cable end of the motor back in to its mounting bracket, and make sure the flex cable is fully inserted and horizontal.
12. Center the flexible plastic tube on the flex cable.
13. Snap the flex cable assembly back into the plastic bracket, and make sure it is straight. If the cable is not straight and flat it will make noise when the seat is adjusted.
14. Connect the seat harness and harness clip.
15. Connect the 12-volt battery.
16. Install the seat, then hand tighten the bolts.
17. Torque the bolts to specification as shown.
