**SERVICE BULLETIN**

**APPLICABILITY:** 2020MY Legacy and Outback **NUMBER:** 07-189-21R  
**SUBJECT:** Front Door Window Regulator- Erratic Operation **DATE:** 02/15/21  
**REVISED:** 04/05/23

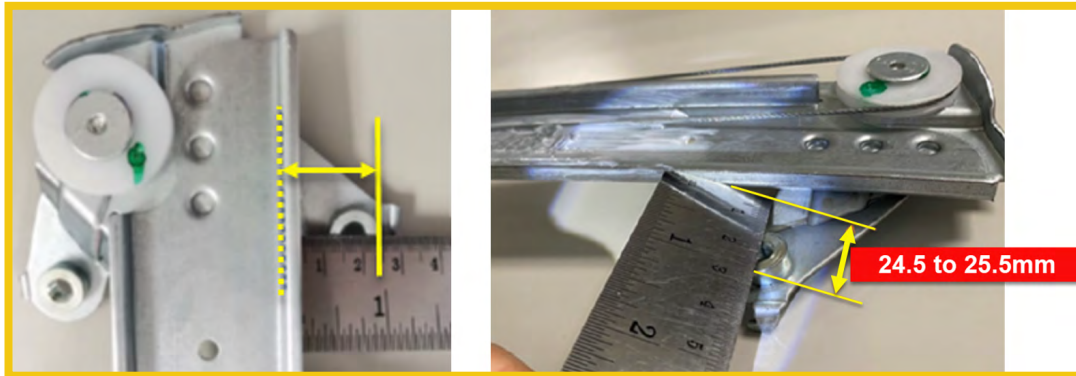
**STEP 2:** Measure the regulator upper roller frame to confirm the regulator was correctly assembled. If the measured distance between the outside of the rail guide (see dashed line below) and the outer side of the mounting nut is not within **24.5 to 25.5mm**, the regulator will require replacement. A 30mm wide ruler is recommended.

This bulletin announces availability of new front door window regulator assemblies in response to limited concerns of erratic operation of the anti-entrapment feature and / or the door glass either not closing or closing very slowly. The change was made to control the upper mount of the regulator which allows the glass to ride in the center of the sash frame and not rotate on the frame causing a binding condition.

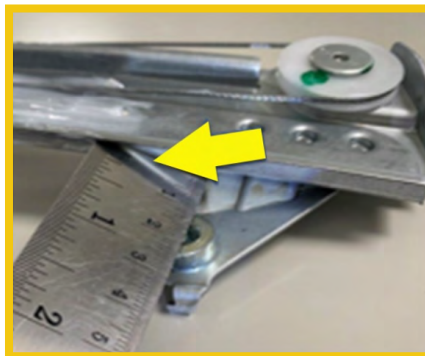
**IMPORTANT NOTE:** ALWAYS confirm there is no gap between ruler and the frame.

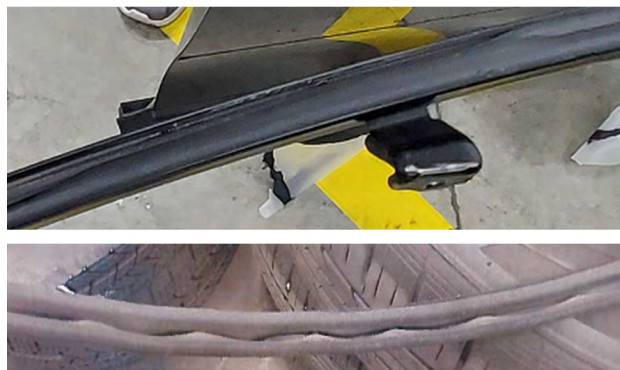
**STEP 3:** Inspect the glass run channel AFTER regulator replacement is complete. If it is physically damaged or does not allow proper function of the regulator / glass, it must be replaced. Photos of damaged glass run channels are supplied below for reference.

When inspection determines replacement is required, the service procedures for window regulator assembly and glass run channel replacement remain unchanged. Always refer to STIS and review the full requirements of the repair being performed. The Service Manual procedures contain information critical to performing an effective repair the first time, every time. This includes but is not limited to important SAFETY precautions, proper inspection criteria, necessary special tools, required processes and related one-time-use parts needed for a complete and lasting repair.
